CITY OF BELMONT

Arboricultural Report

Internal report: private property TPO assessment

SITE ADDRESS: 78 Armadale Road, Rivervale 6104

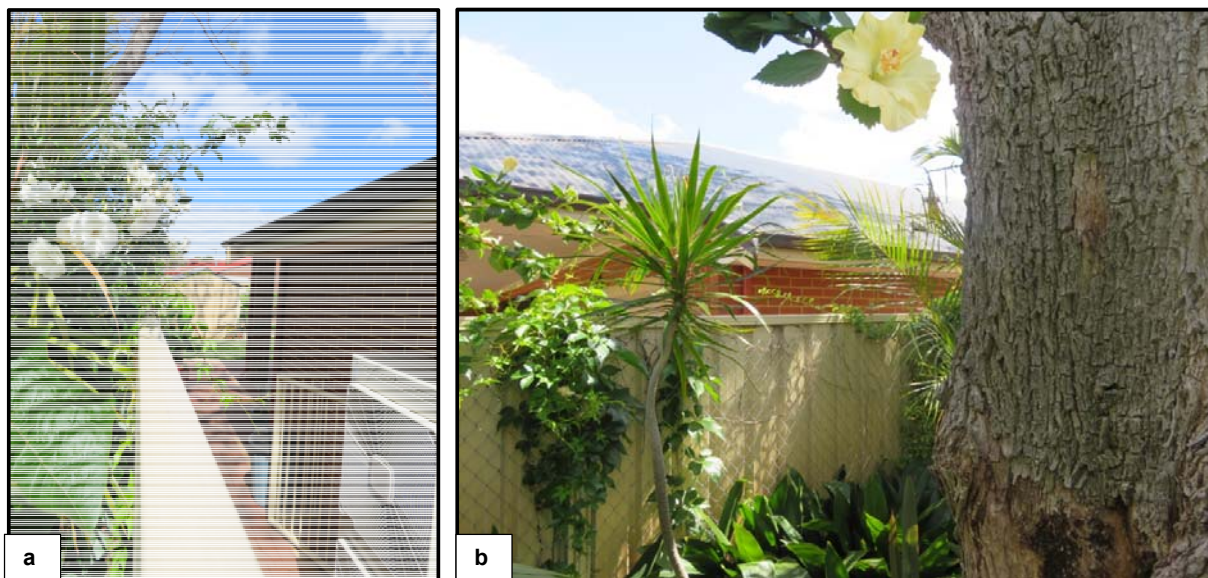
Figure 1a–b. Dividing fence to No. 76 Armadale Road with subject tree in foreground (b)

At the nearest point, the colorbond dividing fence to **No. 76** is 1.9m from the base of the tree and the neighbouring house approximately 3.4m (figure 1a–b).

There is no evidence of instability associated with the construction of the adjacent house (in 2011) which stands just outside the structural root zone.

The space between the fence and the building is brick-paved. Routine maintenance may, therefore, involve the periodic cutting of surface rootlets that have uplifted a paver/s. Removal of these type of shallow rootlets does not affect the stability nor the health of the tree because they are within context (species' tolerance and size) proportionately not significant.

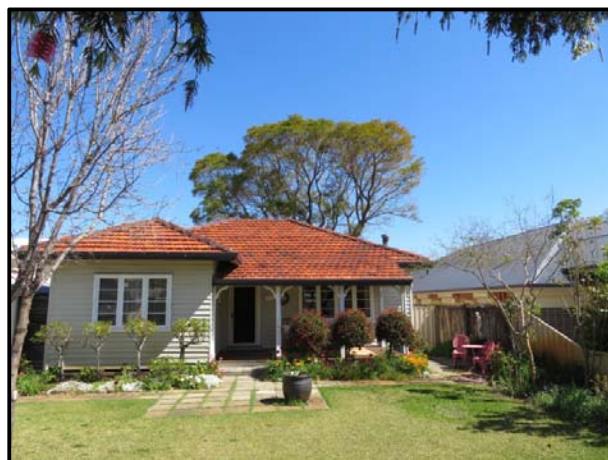
Top left: north-eastern aspect with the subject tree at rear (street view)

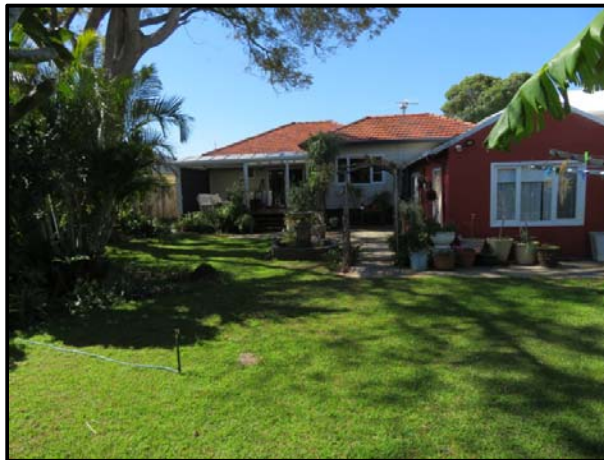
Top right: rear setback with the tree in left of picture

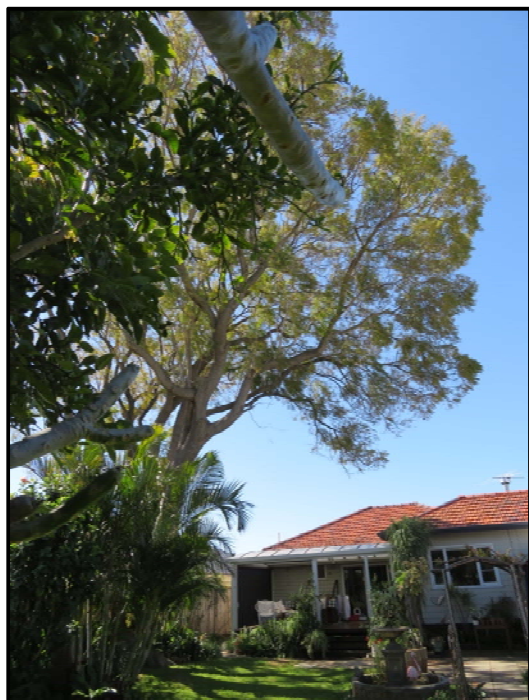
Centre left: southern aspect, rear yard

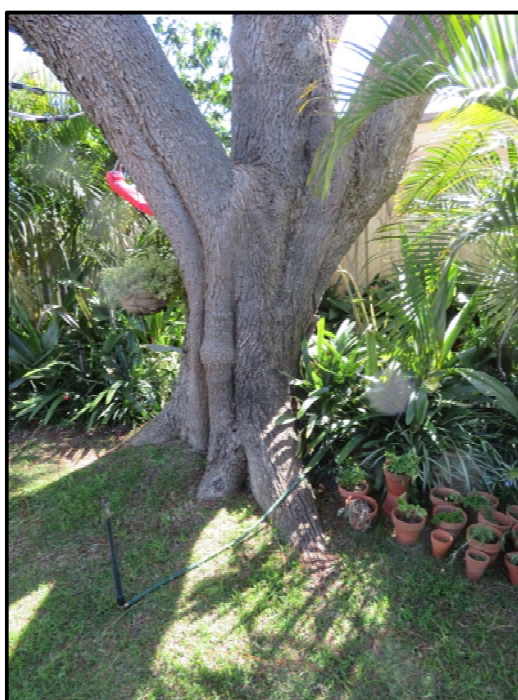
Centre right: base of the subject tree

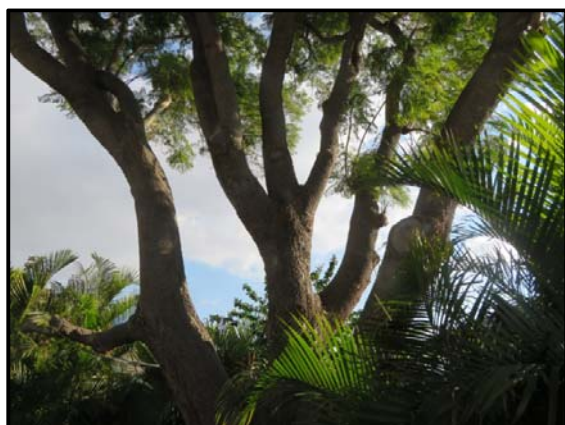
The subject jacaranda expresses good vigour, displays an excellent branch framework and is overall structurally sound. It is an excellent example of the species that makes a substantial contribution to the amenity of the property — the estimated remaining life expectancy is at least 40 years.

Left: lower branch framework

To maintain the structural integrity of the crown, minimise all pruning so to prevent an epicormic response.
