Considered Opinion Marina East Public Art Installation

24 April 2020

Marina East Project - Boardwalk Art Installation

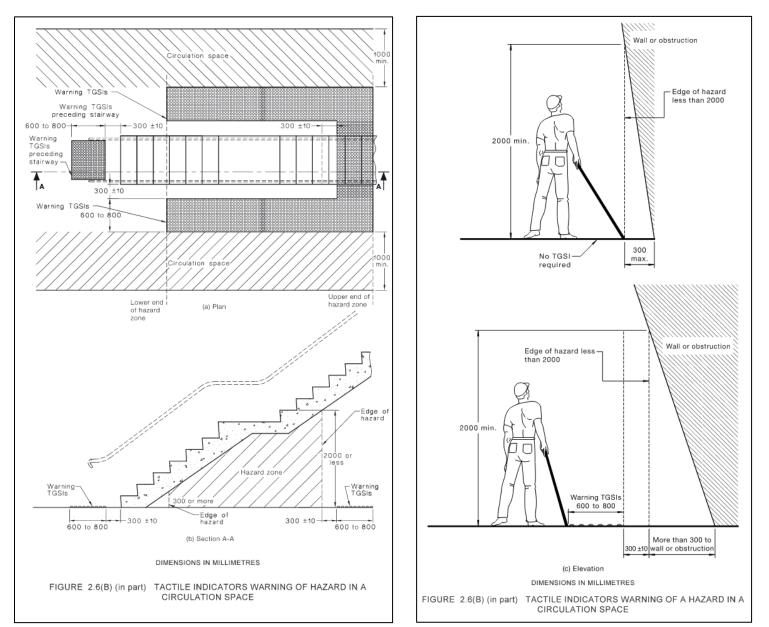
Warning style tactile ground surface indicators (TGSIs) are a valid and compliant solution to address the hazard. If this approach is adopted, the warning TGSIs installation would need to be in the same arrangement as depicted in AS1428.4.1 2009 Figure 2.6(A) and (B) *(replicated below).*

That is, for any component of the artwork protruding for more than 300mm and within the height range less than 2000mm, warning TGSIs would be required to be installed to effectively "enclose" the hazard. This could be delivered in two ways. Firstly, install warning TGSIs only around the elements that protrude by more than 300mm, or, alternatively, enclose the entire artwork with warning TGSIs at ground level, set 300mm off the protruding parts of the artwork, that is:

- Installed in a non-uniform pattern, to match the line of the artwork; or
- Installed 300mm off the furthest protruding part, i.e. 700mm plus 300mm and enclose the artwork with a rectangle shape of warning TGSIs.

As conveyed by Mr Attiwell, any installed TGSIs would need to be installed in the required 30% luminance contrast and to the set out /depth of AS1428.1 2009 Clause 2.3 and 2.6.
