TREE ASSESSMENT RESULTS

A total of **323** 'significant trees' were inspected against the previously mentioned criteria.

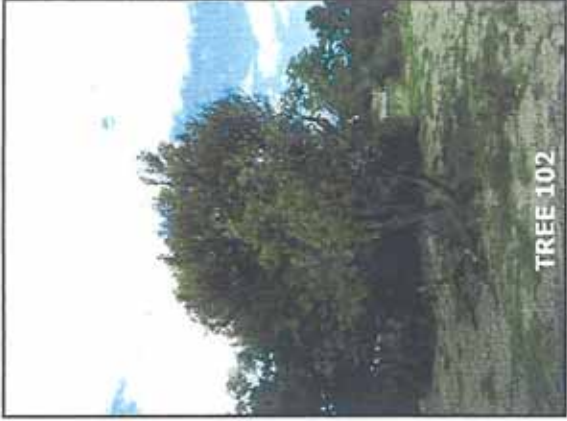
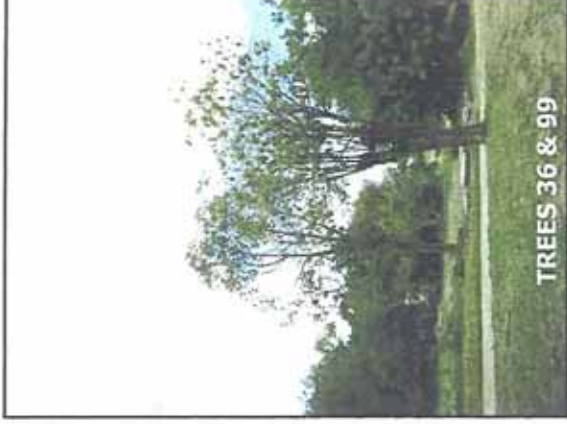
As with any tree population there are a number of dead and declining specimens which are strongly recommended for removal.

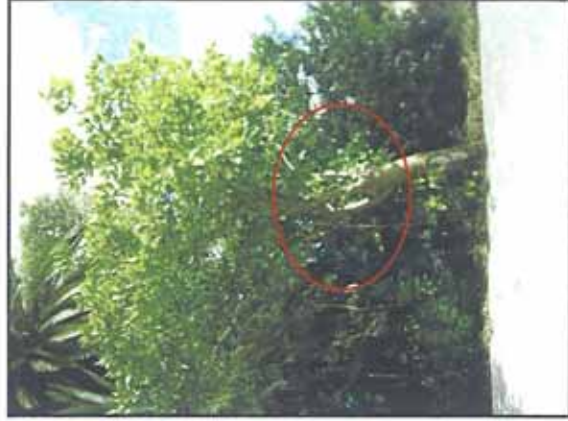
Flame Tree (*Erythrina indica*)
Previously lopped, poor stem attachment, potential future issues

There are also a number of specimens with poor structural form (as seen in the above images). Retention of trees with a poor structural form has long proven to lead to an increased potential for future tree related issues to arise (i.e. stem failures).

As such these specimens are also recommended for removal.

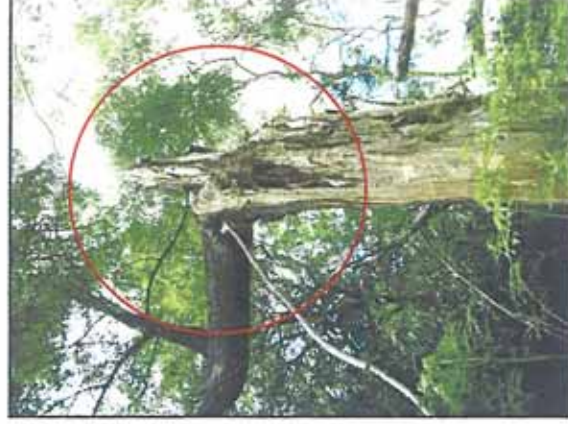
White Cedar (*Melia azedarach*)
Top has snapped out.

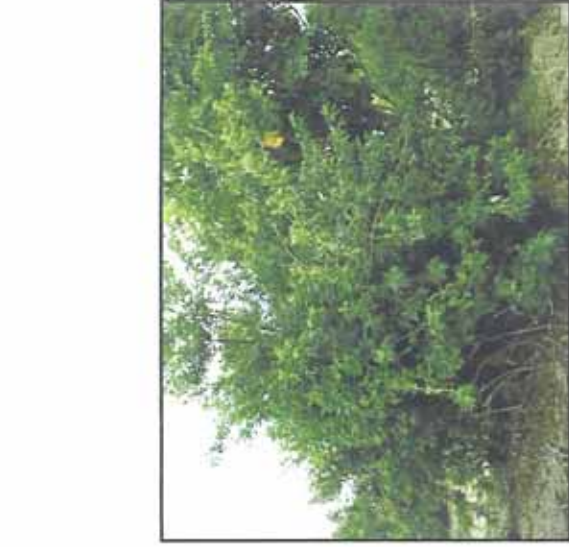
Brazilian Pepper (*Schinus terebinthifolius*)
Seen as an undesirable species due to their natural growth characteristics, potential for suckering, and canopy management issues.

There are also a number of 'undesirable' species, and specimens, which if retained are expected to cause an increased extent of future tree related issues (i.e. site safety, litter, pest/disease issues), which will undoubtedly lead to increased maintenance (expense) requirements, and an increased potential for litigation issues to arise.

In total, **148** trees are **recommended for removal**.

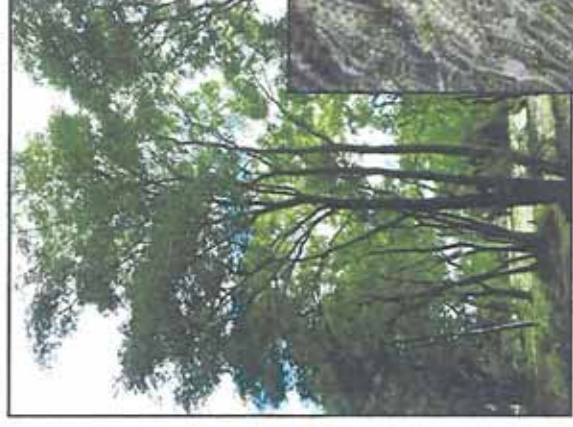
White Cedar (*Melia azedarach*)

Although there are some fine specimens on site, they are also seen as undesirable species due to suckering issues, litter issues, and the presence of the White Cedar Moth.
