## **Heritage Impact Statement**

## Ascot Kilns Conservation Project

## Heritage Impact Statement

November 2021

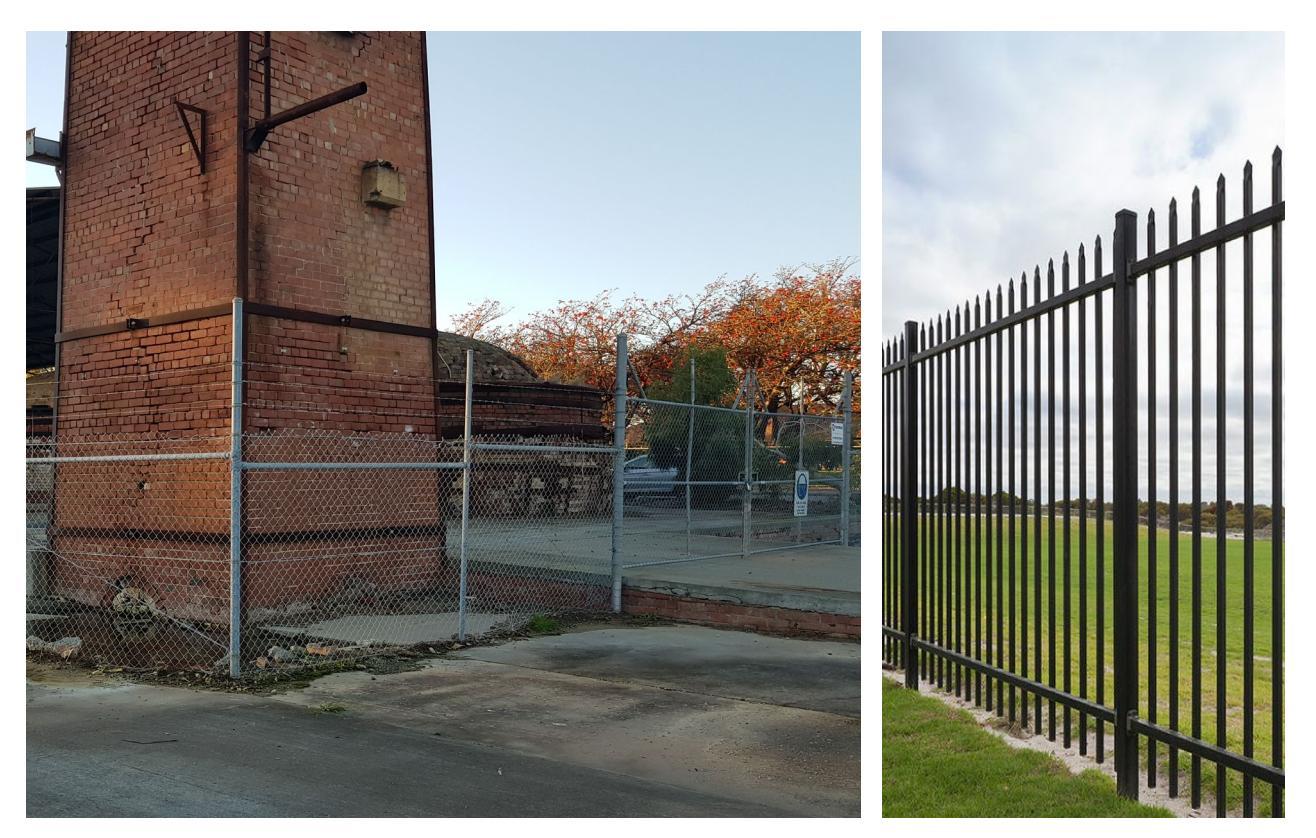
Majority of the site boundary is delineated by a 2.4-metre-high chain link and barbed wire fence. An additional length of fencing surrounds the kilns and the two individual chimney stacks at the southern end of the site.

On the northeast side of the site is fibre cement fencing in poor condition with some broken sections leaving the site open towards the adjoining property.

Figure 4 Existing chainmesh and barbed wire fencing to be replaced with new garrison fencing on the right

The fencing will be replaced with sturdier tubular garrison fencing and gates around the structures only, with the boundary fencing to be completely removed. The impact is neutral as it maintains the visual access of the structures, but it will be more secure with the tougher more durable material.

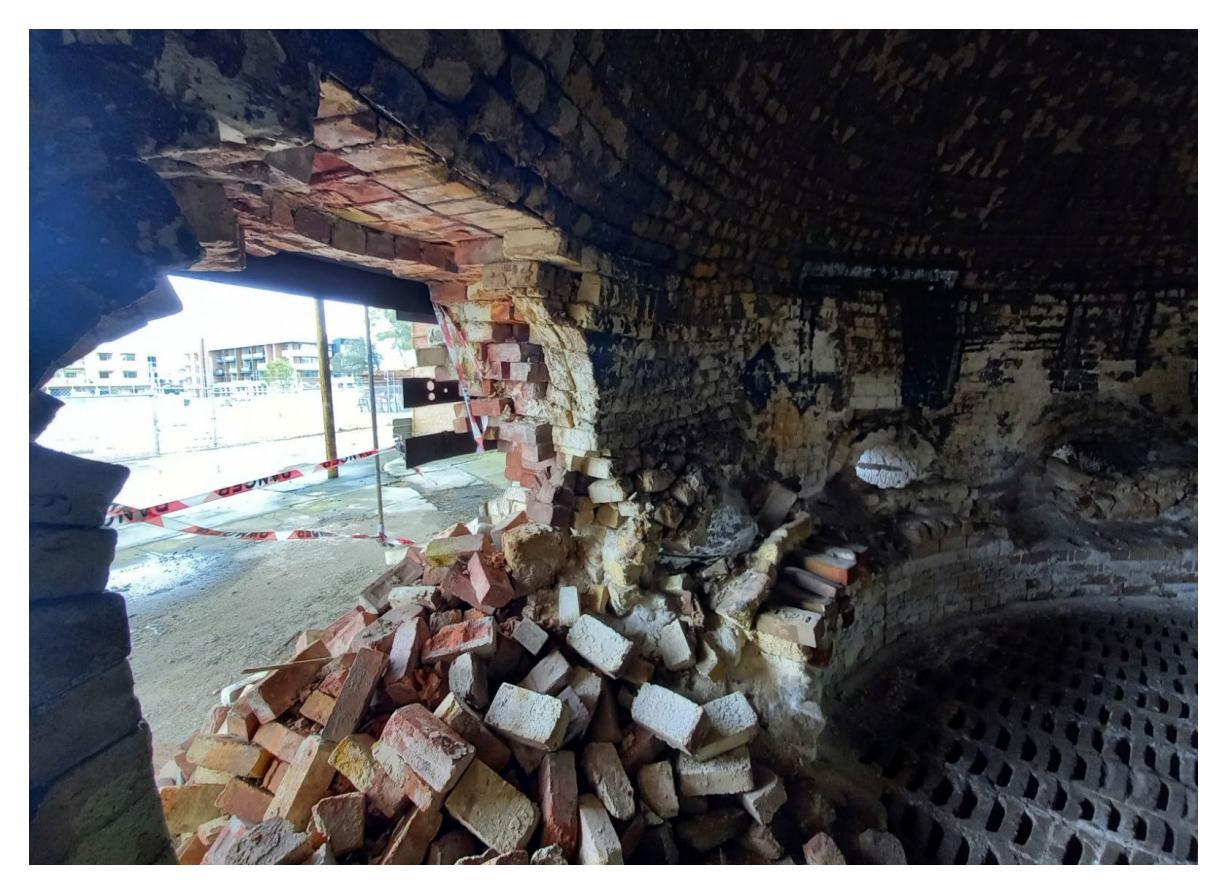
Four of the arched entrances into the kilns have or are near collapse and need repair. All the arches require a measure of restoration to stabilize the masonry.

Figure 5 One of a few archways which have collapsed and require careful restoration

• Reconstruction of the archways which have collapsed

All the archways which are collapsed will be reconstructed. The Article 20.1 of the Burra Charter states: "Reconstruction is appropriate only where a place is incomplete through damage or alteration, and only where there is sufficient evidence to reproduce an earlier state of the fabric."

In most instances the opposite archways are intact and will be used as the evidence for the repair work. Despite the use of the original bricks already on the site the reconstruction will not be able to recreate the patina of the arches impacting on its authenticity, but it will provide stability to the kilns.

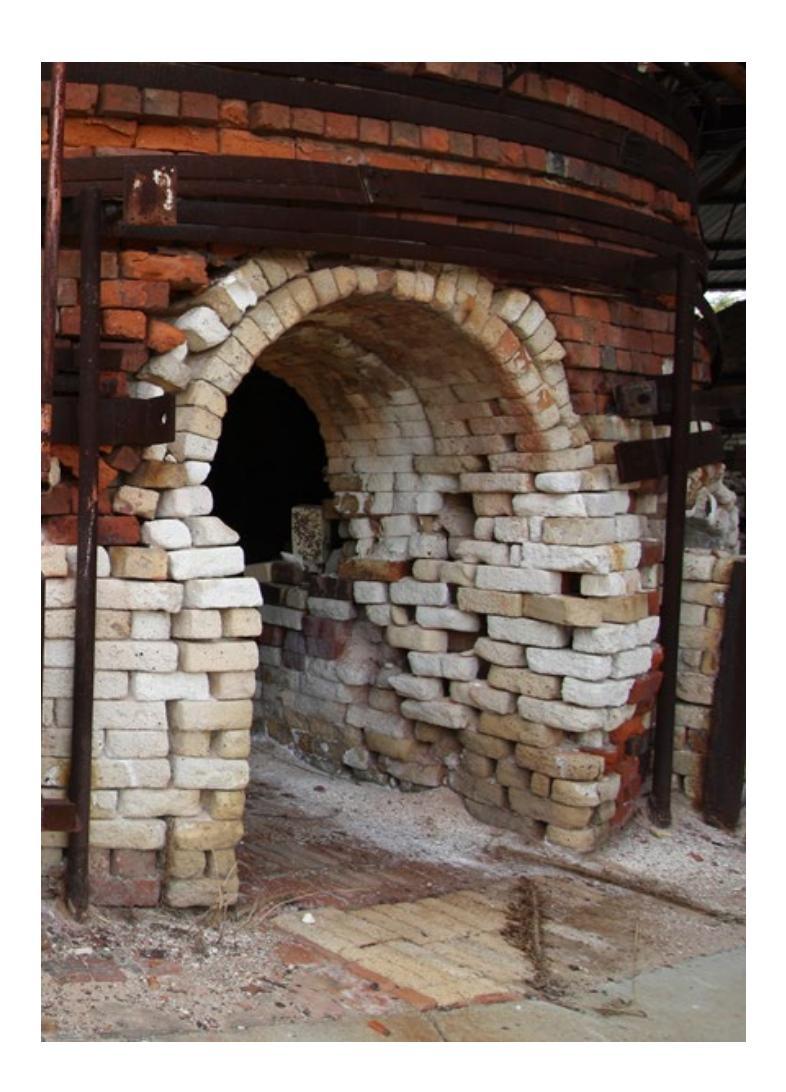
## Figure 6 An example of an archway requiring restoration to avoid further structural damage and eventual collapse of the circular kiln

• Installation of a steel structural mesh support

Where the archways are intact, they will be restored by reassembling loose bricks and repointing. The structural engineer will determine where additional support by way of a steel mesh is required to be installed to the underside of the archways. This intervention has the benefit of preserving the relatively sound brick arches and their existing patina.

It does introduce an intrusive element, the steel mesh members, which will partially conceal the view of the bricks and impact the presentation of the kilns. They will be supported on the ground and will not require additional footings making them reversible and minimising impact to the structures.

Each archway will be treated on a case-by-case basis, reinstating the integrity of the archways through restoration and reconstruction where required while also retaining their patina by the introduction of the intrusive steel element only to necessary openings.

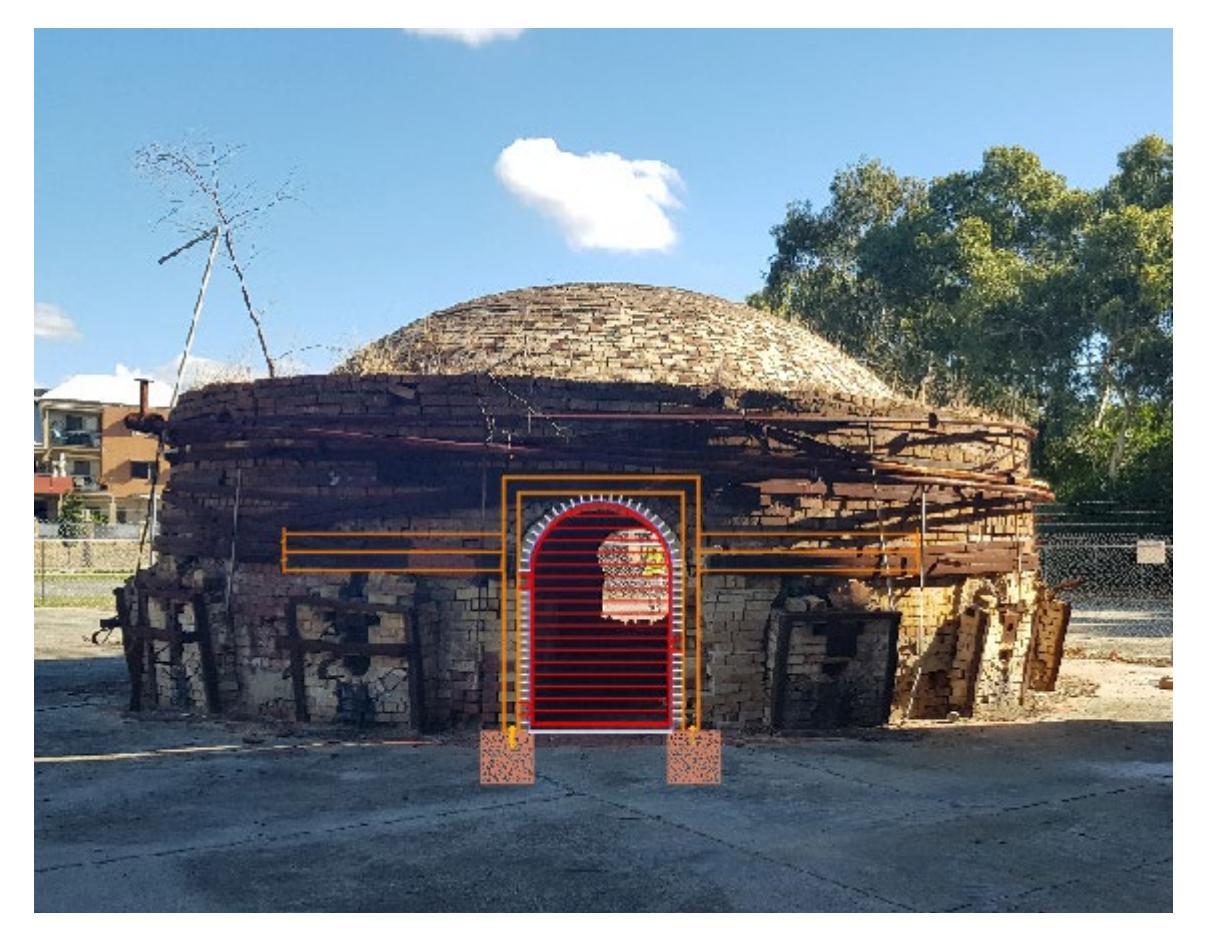
Figure 7 Proposed structural steel portal and gate to support the lower straps of the "bursting" kiln

A structural steel portal is proposed to be installed to fasten the lower steel straps which are currently disconnected and loosen to create additional tension necessary to stabilize the kilns. To minimize any impact on the masonry, the portal has been designed to be self-supported, with a concrete pad footing located outside each archway. A lightweight gate with steel frame and black coloured tensioning wire will be fixed to the frame, allowing visibility of the arched entrances and the interior of the kilns. Despite the intrusive nature of the gate, it is necessary to prevent unauthorized access and acts of vandalism that have compromised the place in the past.

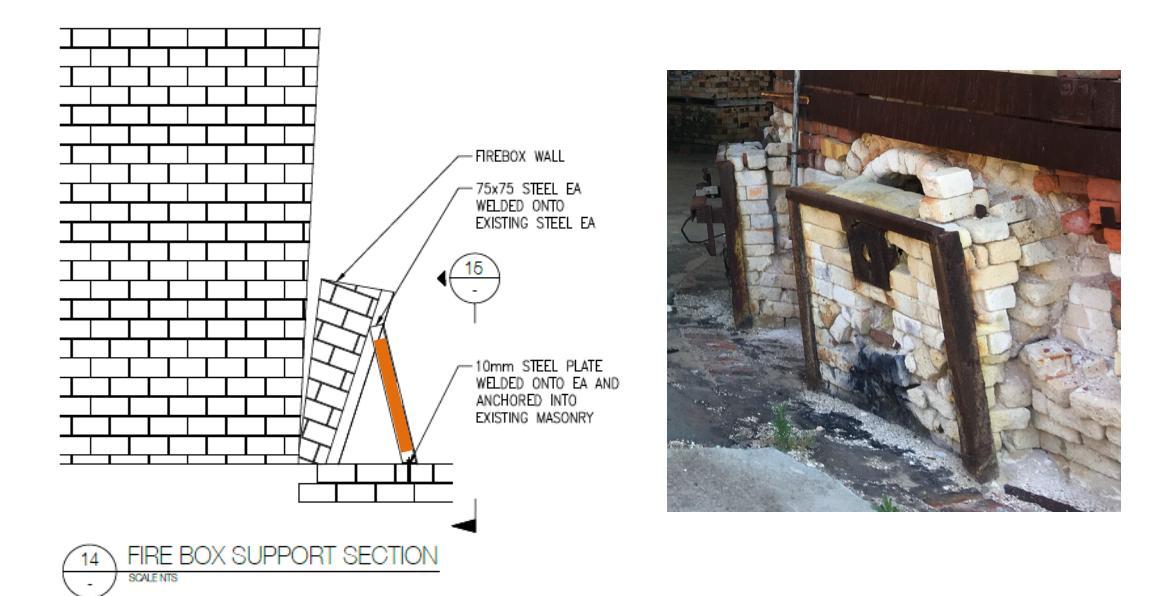
The fireboxes are pulling away from the kiln walls. To retain this patina but still provide support a steel plate has been designed to prop up the fireboxes at each end with anchoring to the existing masonry pavers. This intervention is visually intrusive and to minimise the impact the short plates will be painted black. These supports are essential to prevent eccentric loading that could lead to further deterioration of the kilns.

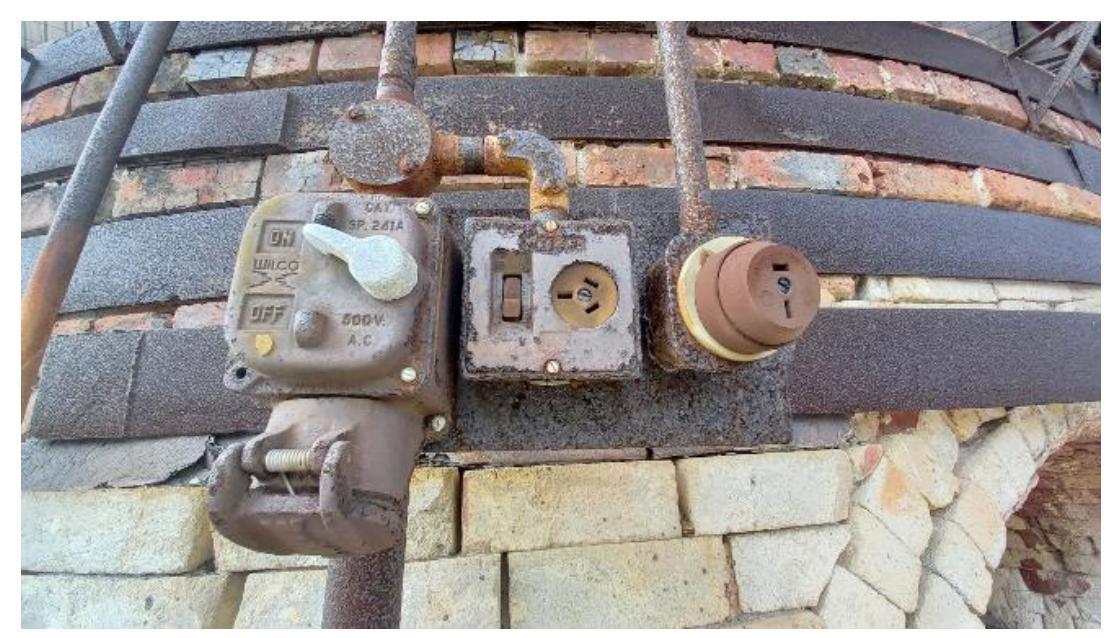
There are redundant pipes running at high level above the kilns. They are rusted and in poor condition. Most of these will be removed, including the vertical droppers around the kilns.

Figure 9 Example of valves and services boxes to be retained in situ

The top level of service pipes running along the edge of the dome will be retained as a remnant of the evolution of the change of fuel from wood to oil in the burning process. This will give context to some of the valves which will be retained in situ as there is minimal equipment left from the working site. This will enhance scientific value.

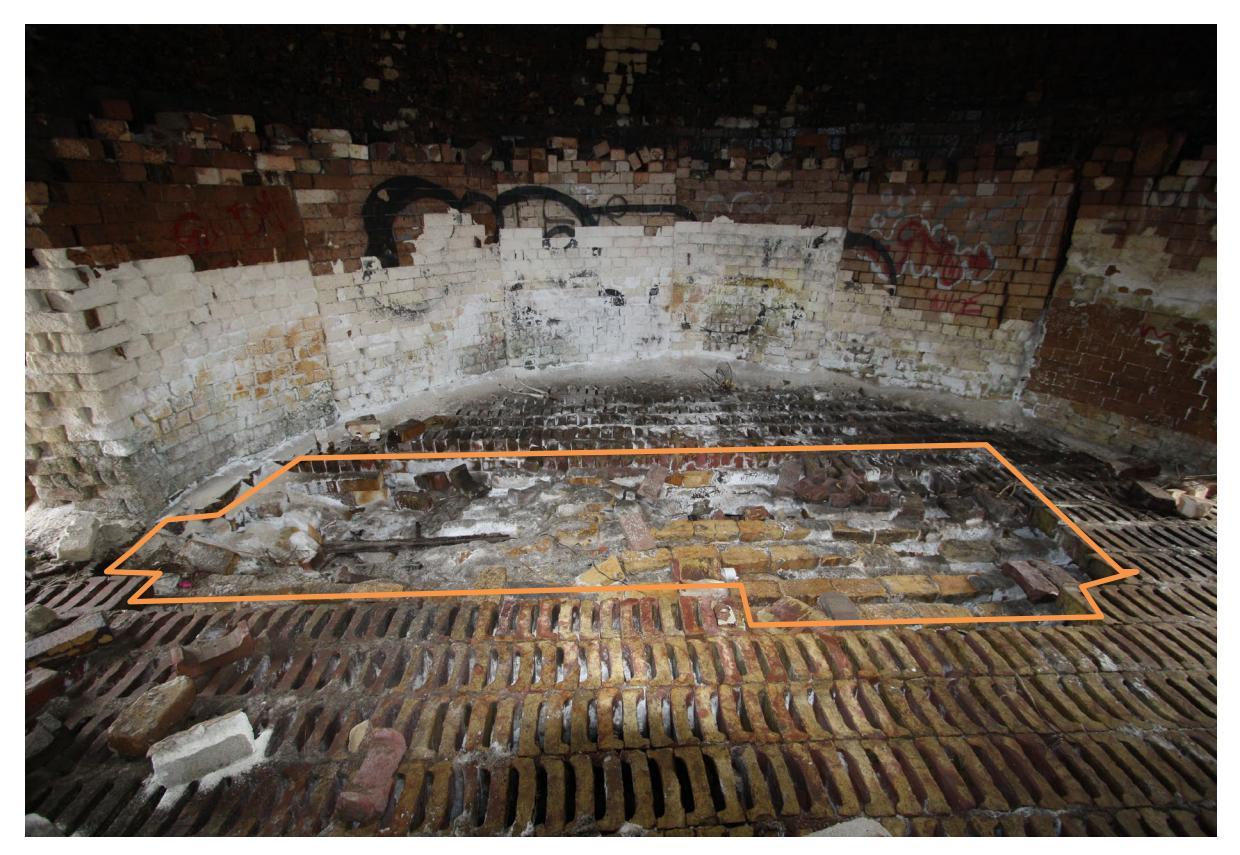
Kiln 5 has the largest expanse of damaged flooring caused by missing bricks. A trafficable glass floor is to be installed to cover the area after the subfloor has been cleaned out to provide visual access to the underground infrastructure allowing the interpretation of the connections to the chimney stacks.

Figure 10 Extent of new glass flooring to cover the large area of missing bricks in the floor of Kiln 5

To minimise impact to the structure and potential archaeological deposits, the works to the sub-floor will be monitored by an Archaeologist following the recommendations of the Archaeological Management Plan. This will ensure that any interpretation is appropriately presented and the new intrusive works are carefully detailed so as not to harm significant fabric.

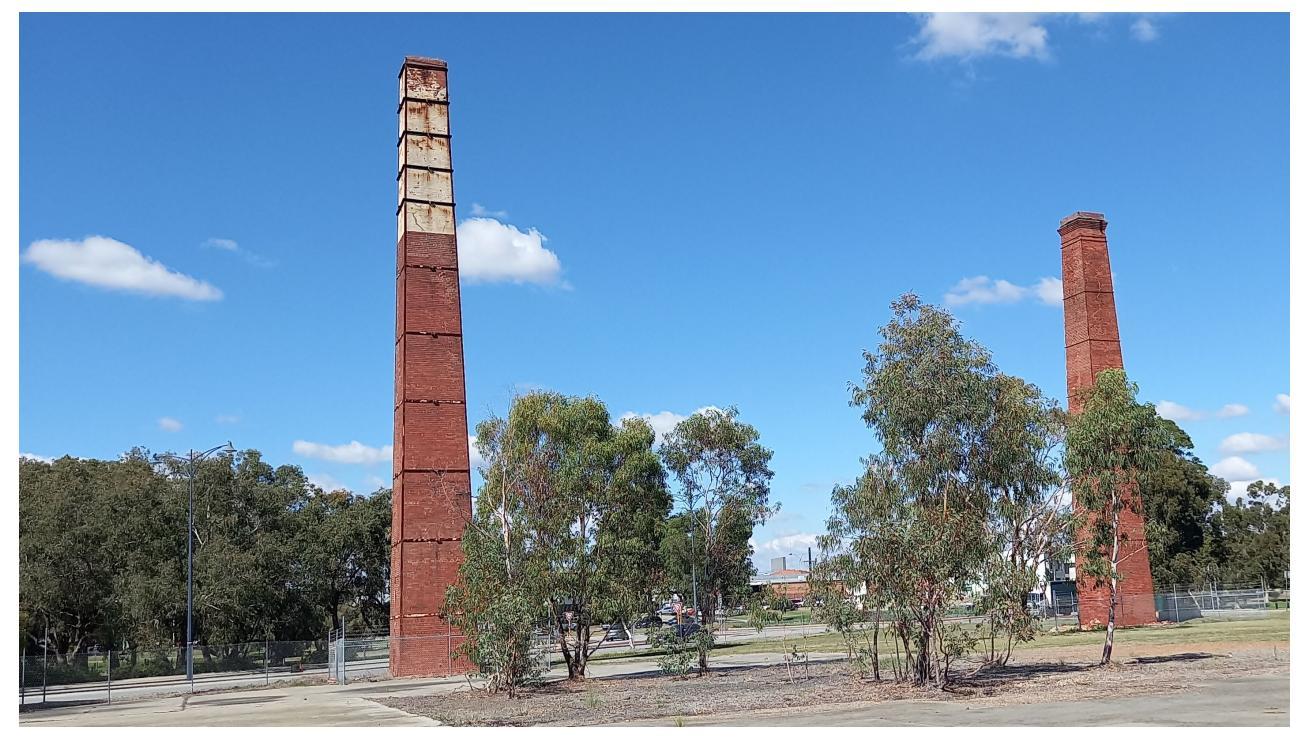
The five chimney stacks on site, are about 30 metres high with steel straps running vertically along each corner, and some horizontal steel members. The masonry presents various level of deterioration with evidence of lose bricks, cracking and spalling. The proposed works include:

Figure 11 The patina of chimney stacks S4 and S5 will be retained as much as possible in the conservation of these structures

- Conservation of the masonry walls by stabilizing loose bricks with lime mortar and rebuilding local sections that have become loose, severely cracked and have missing pointing. Large vertical cracks will be stitched using carbon fibre or glass fibre rods to avoid future corrosion issues and acrylic paint at low level removed to minimise efflorescence on the masonry.

- Cleaning and treatment of corroded steel straps to enhance their longevity.
- Chimney stacks S4 and S5 will have an additional grate installed at the opening of the tunnel at the base as these tunnels are above ground. The impact to heritage significance is minimal as it will be internal and out of view.

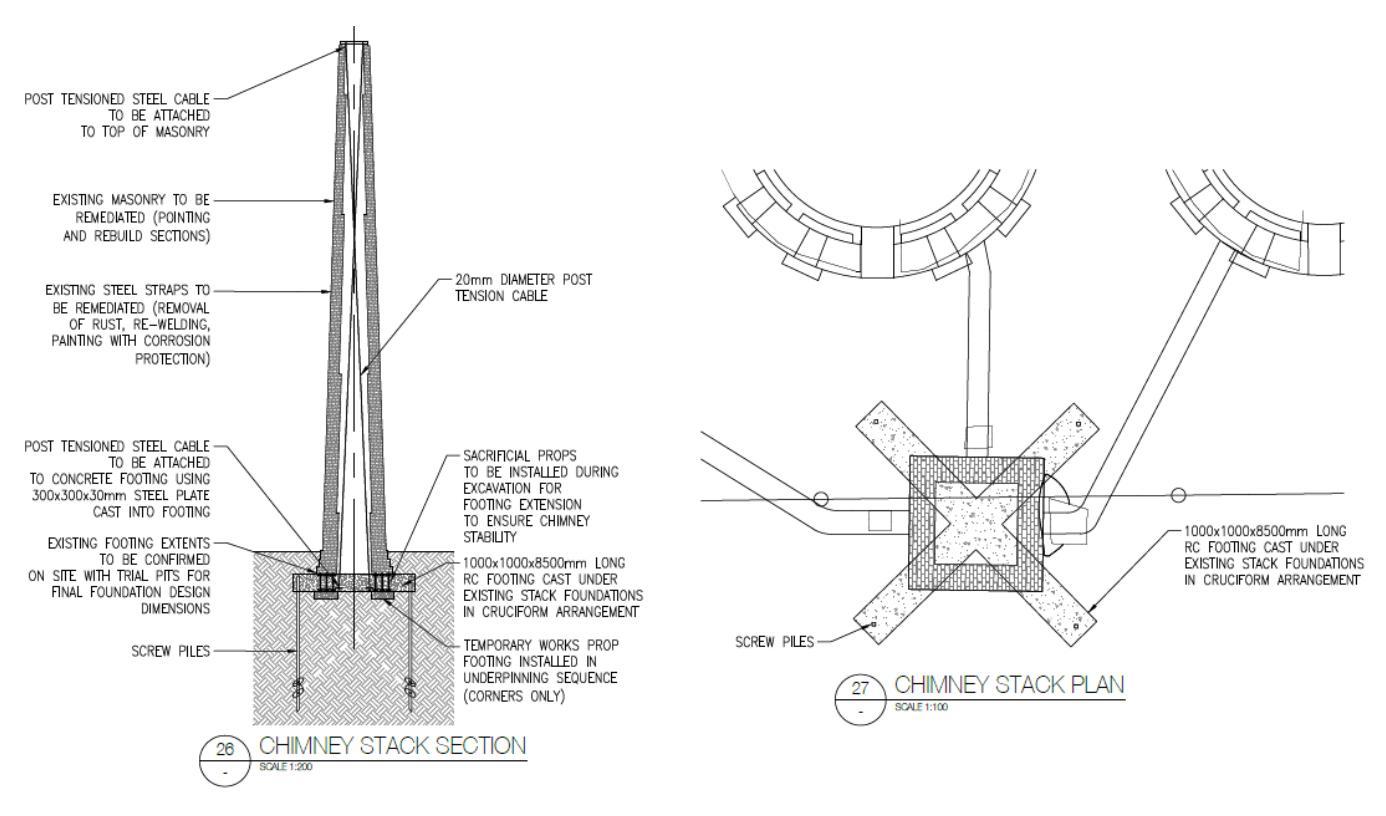
Figure 12 Post tensioned steel cables to be installed inside the chimney stacks and connected to new footings installed under the existing

- Stabilisation for wind and earthquake resistance using long post tensioning cables running from the top of the stacks to new footings cast under each chimney stack. The impact of this is neutral as the cables will be inserted internally and therefore will be out of sight.

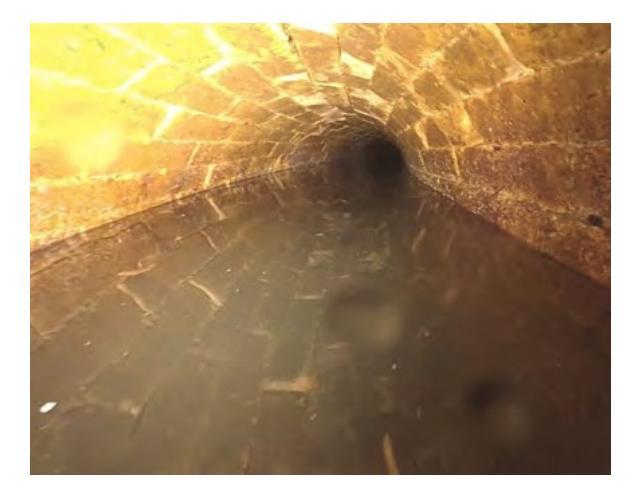
Figure 6 View of an underground tunnel

To repair collapsed sections of the tunnels a concrete culvert of a suitable diameter will be inserted from above, bricks re-laid over and the disturbed area of concrete patched up with new concrete to match existing. Though intrusive in nature the culvert will not be visible from above the ground.

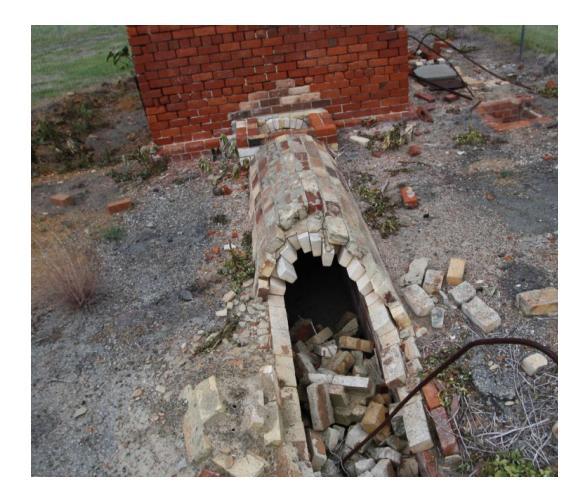
Figure 7 Exposed section of the tunnel at chimney S4

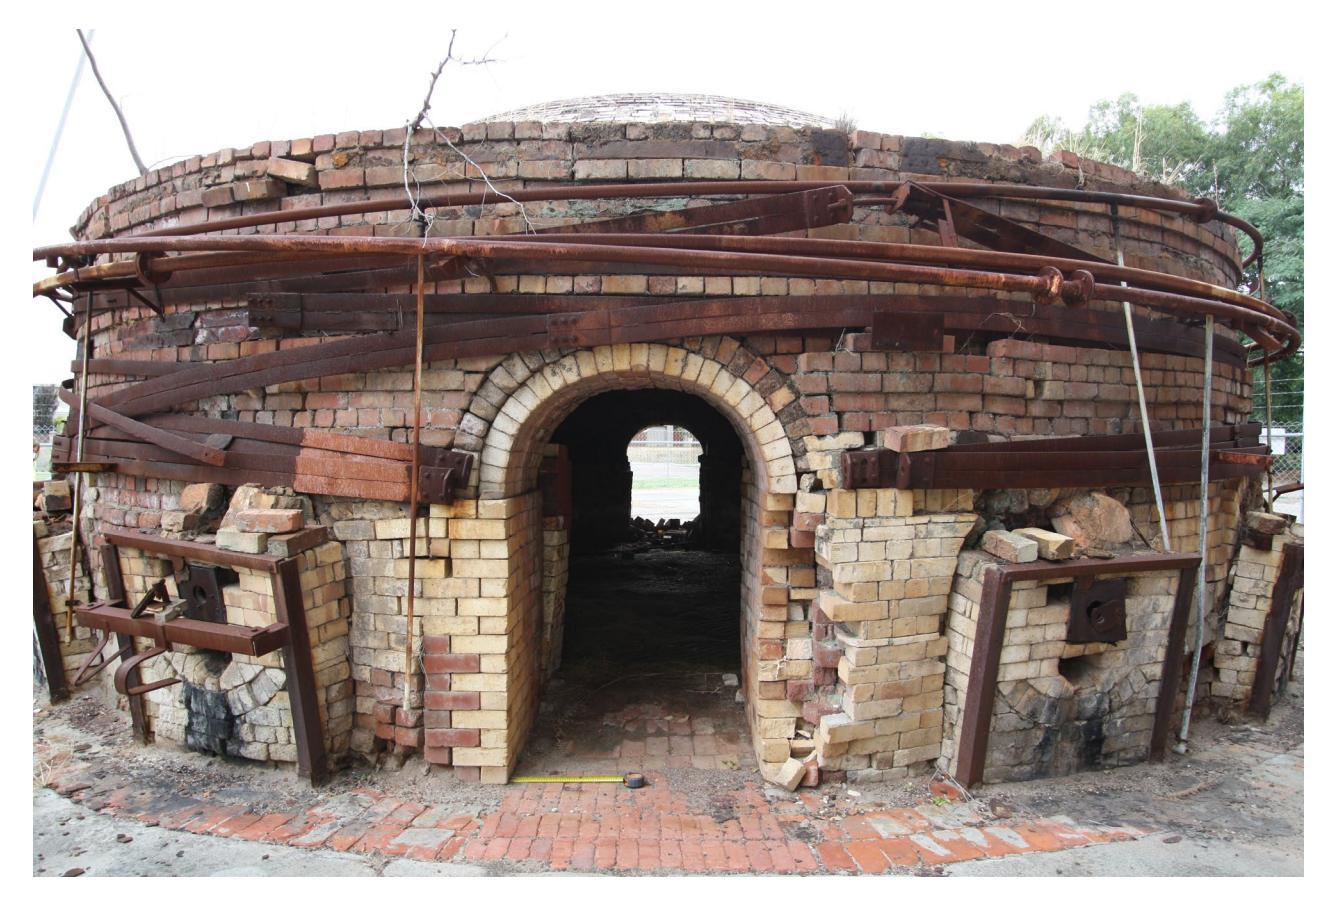
Figure 18 Kiln K5 previously earmarked for demolition will be repaired and preserved
