## **Heritage Impact Statement**

## Ascot Kilns Conservation Project

## Heritage Impact Statement

November 2021

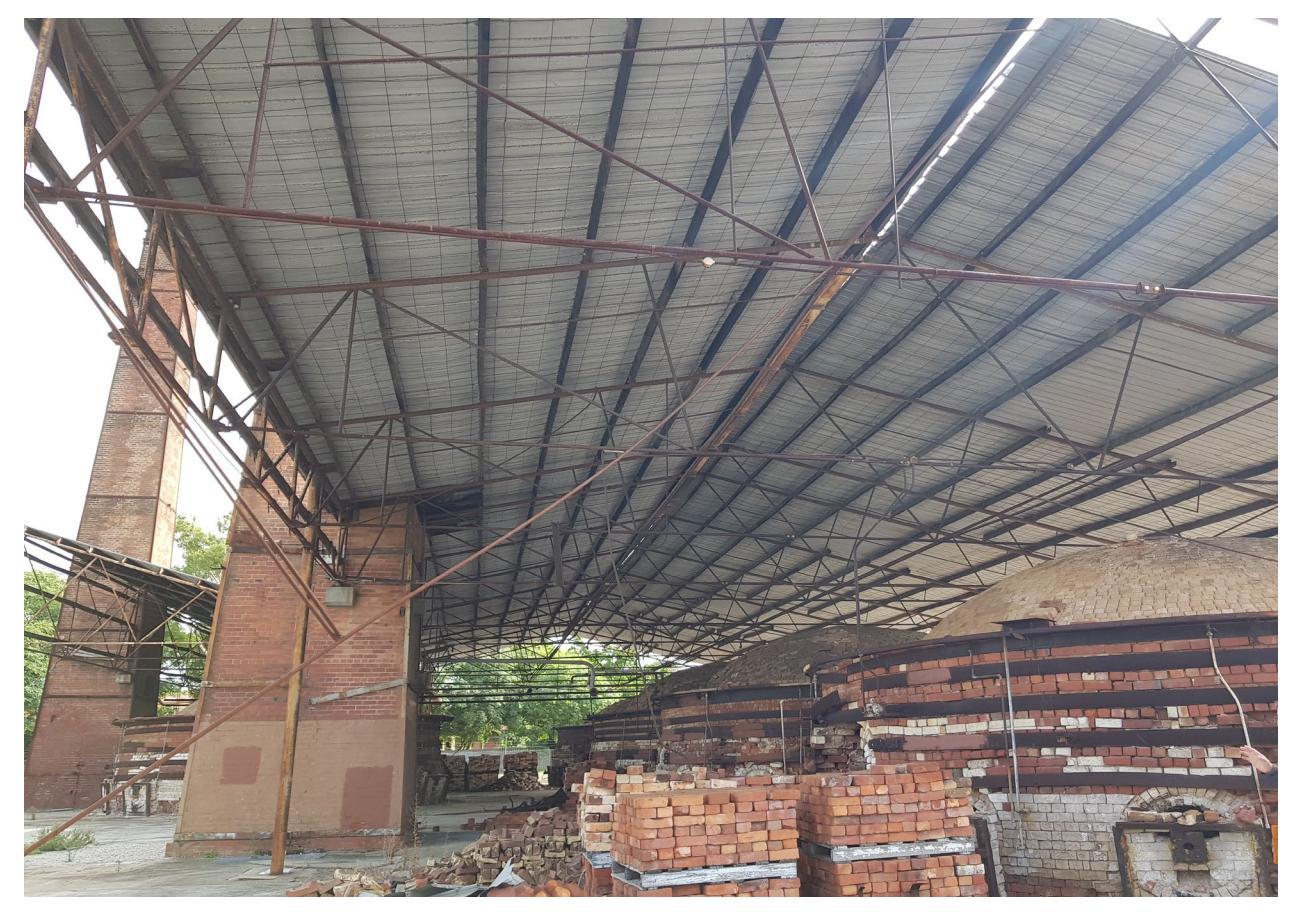
There are pallets of bricks on the site which are intended to be used where reconstruction of the structures is required to stabilise them.

Figure 3 Pallets of existing brickworks under the existing canopy to be used in the conservation works

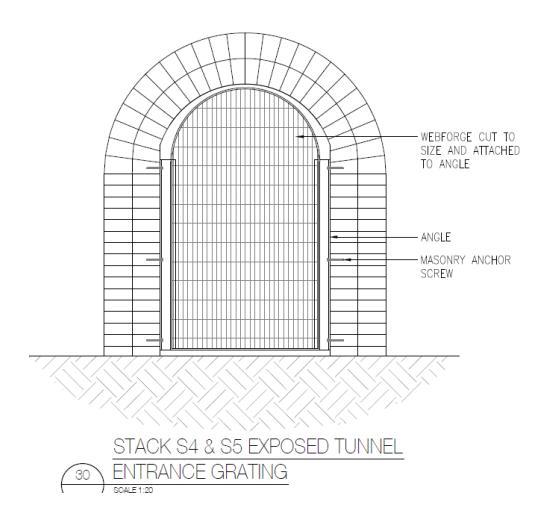
#### Figure 13 Sketch of the metal grating at the end of the tunnel and chimney stack opening

A steel pit grate will be installed above the openings to the existing tunnels providing greater level of security from unauthorised access compared to the existing steel mesh currently extant.

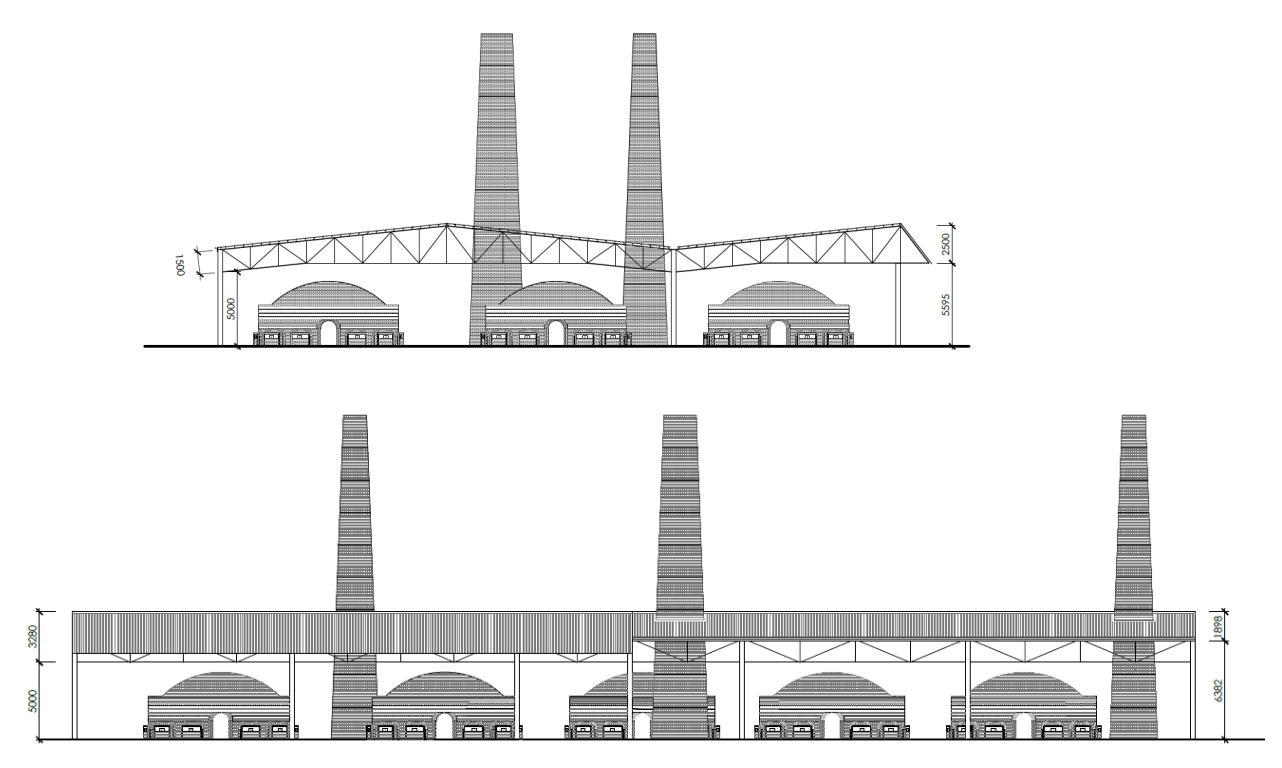
The existing roof canopy which partially covers the site was constructed in the 1990s, sheltering only 6 of the 8 kilns. It is made of a light steel structure and corrugated roof sheeting. The steel work presents a moderate corrosion, with some of the purlin in poor condition. A section of the structure along Grandstand Road has been compromised after a vehicle hit one of the steel posts.

Figure 14 Proposed new steel roof canopy providing support from the elements

It is proposed to replace the existing canopy and instal a new roof to shelter all the kilns present on site. It will be of similar height to the existing, a simple hipped profile that will blend with the palette of existing structures minimizing the visual impact but performing the vital role of protecting the heritage fabric below from the weather and related deterioration.

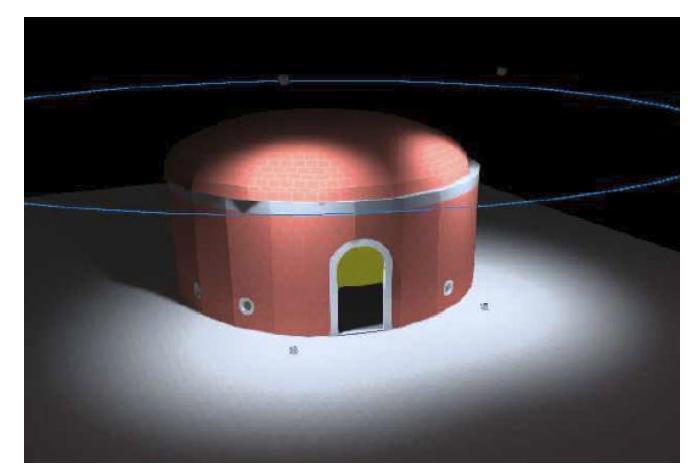
Figure 15 Concept of new external lighting to all Kilns with an internal lamp for Kiln 5

The site is to be equipped with security and decorative lighting to the structures. This will involve upgrading electricity services to the site and installing controls and physical cabling to strategically selected locations to minimize any impact on the existing above and below ground structures. It is proposed to run cables along the outer boundary walls and have wires for the lighting suspended from the new canopy structure to avoid damage to potential archaeological deposits.

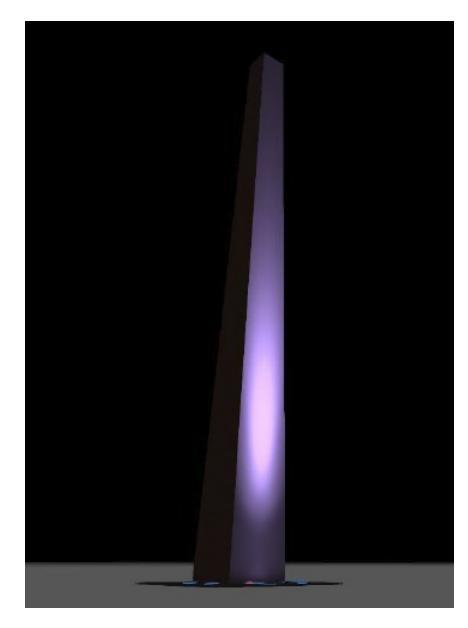
#### Figure 16 Concept of new external lighting to chimney stacks mounted at the base of \$4 and \$5

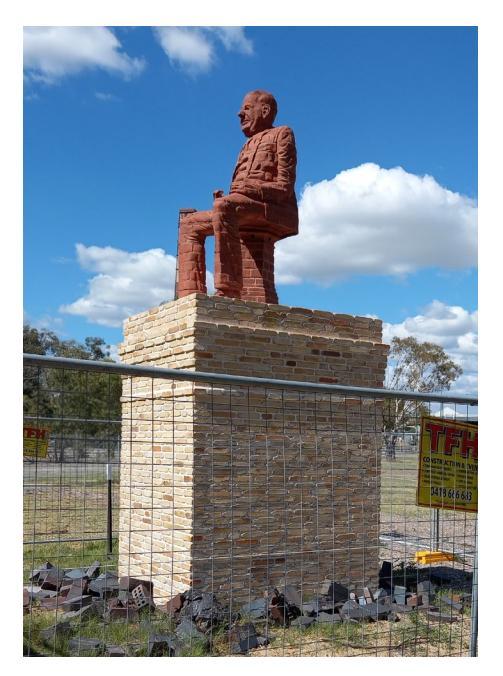
Figure 17 The existing 'Brick Man' statue to be relocated to a more appropriate location on the site

The brick statue which was installed south of the kilns in late 2020 is assumed to be of the late Sir HL Brisbane who developed the Bristile building empire in the 1930s. It will be relocated to a more appropriate location on the site after the completion of the conservation works with interpretive signage. These details will be provided when the specifics have been finalised.
