TREE ASSESSMENT RESULTS

A total of **323** 'significant trees' were inspected against the previously mentioned criteria.

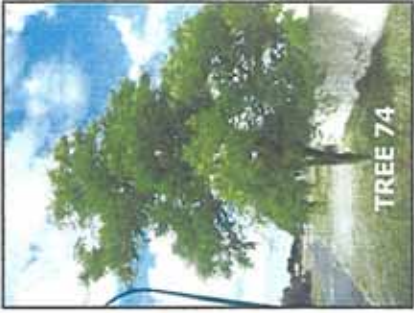
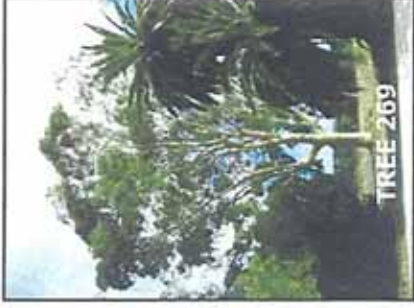
Overall the tree population present on site is seen to be in a reasonable condition in both health and structure. There are some fine specimens of semi-mature Jacaranda along Rowe Avenue which given the correct Arboricultural care during the construction phases of the development could continue to mature and provide a valuable amenity for the area for many decades to come.

There are also a number of mature Spotted Gum, Lemon Scented Gum, Sugar Gum, Jacaranda, Stone Pine, and Hills Fig which are all good specimens of the species.

Due to their size, stature, and current condition, these specimens should be considered for retention within the proposed development (which may come at the detriment of other specimens nearby) providing preservation guidelines to be detailed in this report can be adhered to during all planning and construction phases of the development.

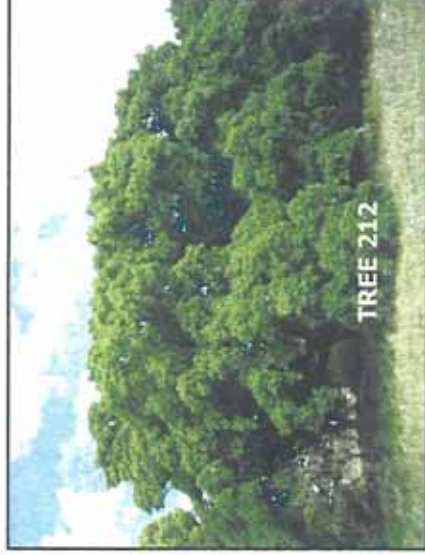
An additional 3 of these 57 category specimens are of particular note (trees 64, 212, and 269), and they are strongly recommended to be retained and preserved.

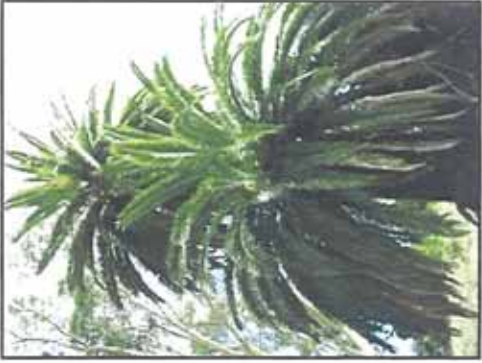
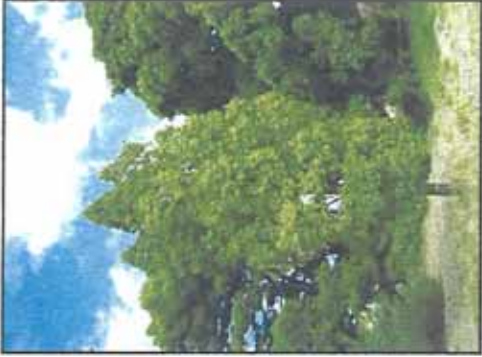
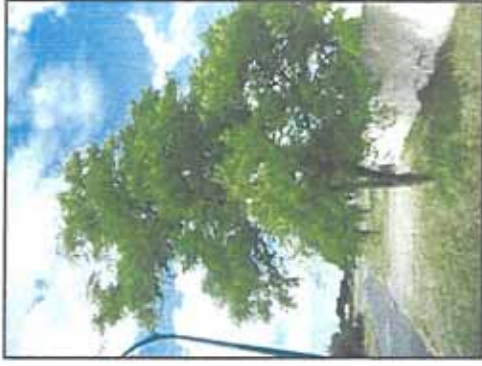
During the inspection, it was noted that there is a reasonable number of potential transplant specimens on site.

This includes a number of Jacaranda's, Norfolk Island Pines, Brachychiton species, Date Palms, Olives, Loquats, a Liquidambar and a number of smaller White Cedars.
