# Minutes

Wednesday 3 June 2026

# BELMONT TRUST LANDSCAPE MASTER PLAN

# Geotechnical Investigation

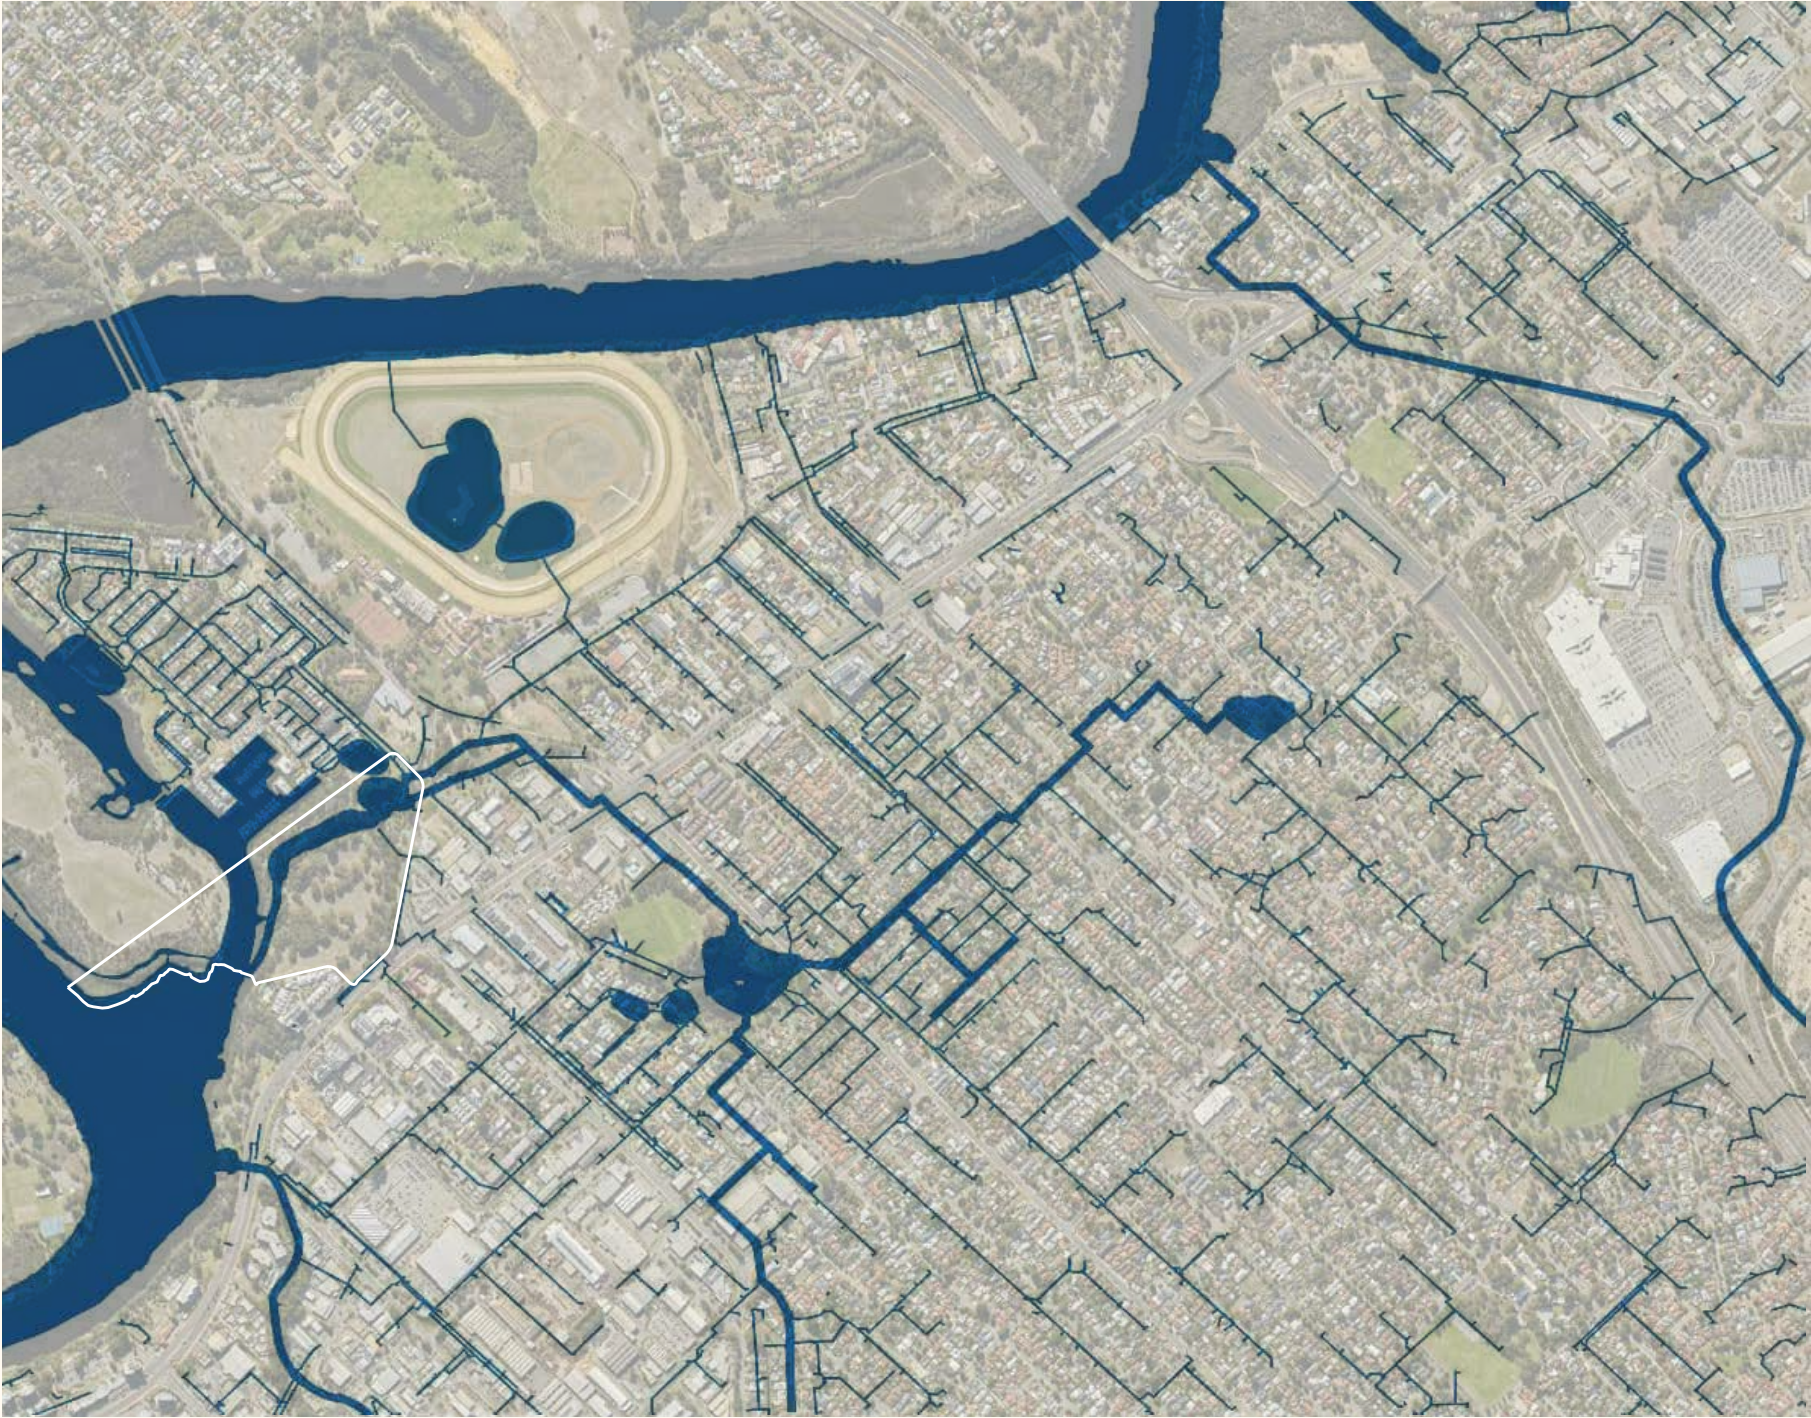
The Belmont Trust site is the last opportunity to provide stormwater quality treatment for a significant drainage catchment as shown within this diagram.

- Site Boundary
- Local waterways and drains (source: city of Belmont)

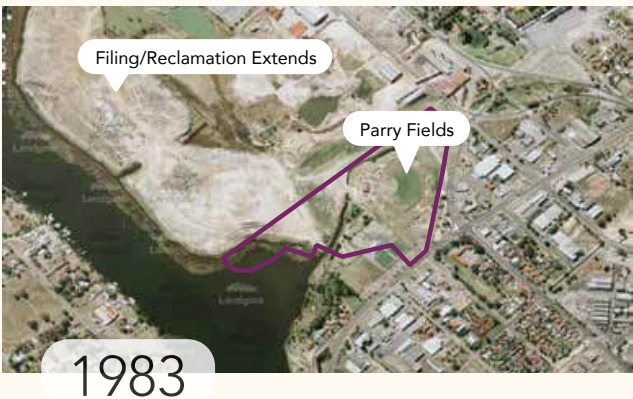
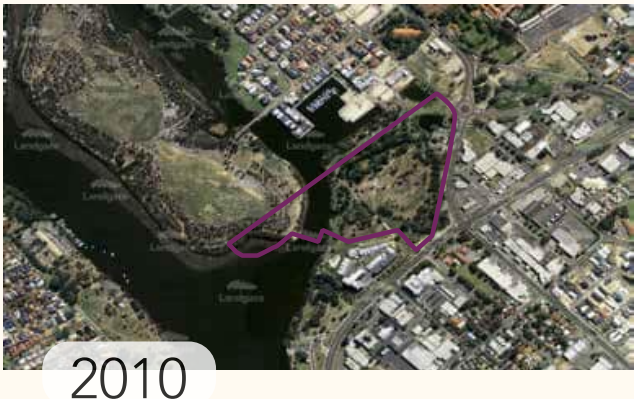
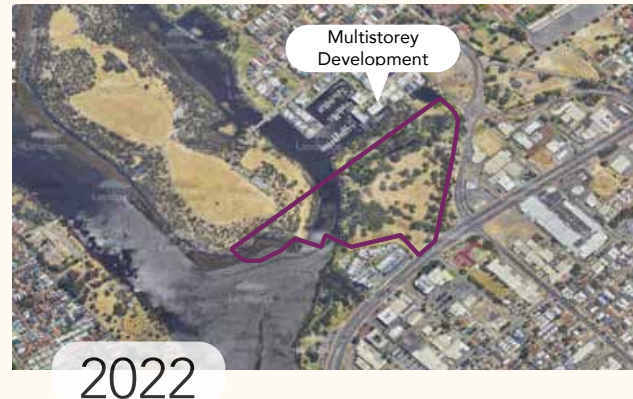
Development associated with Ascot Waters residential area brought about significant disturbance and reclamation (filling) of the low lying wetland areas. A plume of fill can be identified growing from the east to west to formalise Kuljak island.

Following reclamation in year 2000 a channel was re-established to connect the river into the Ascot Waters marina.

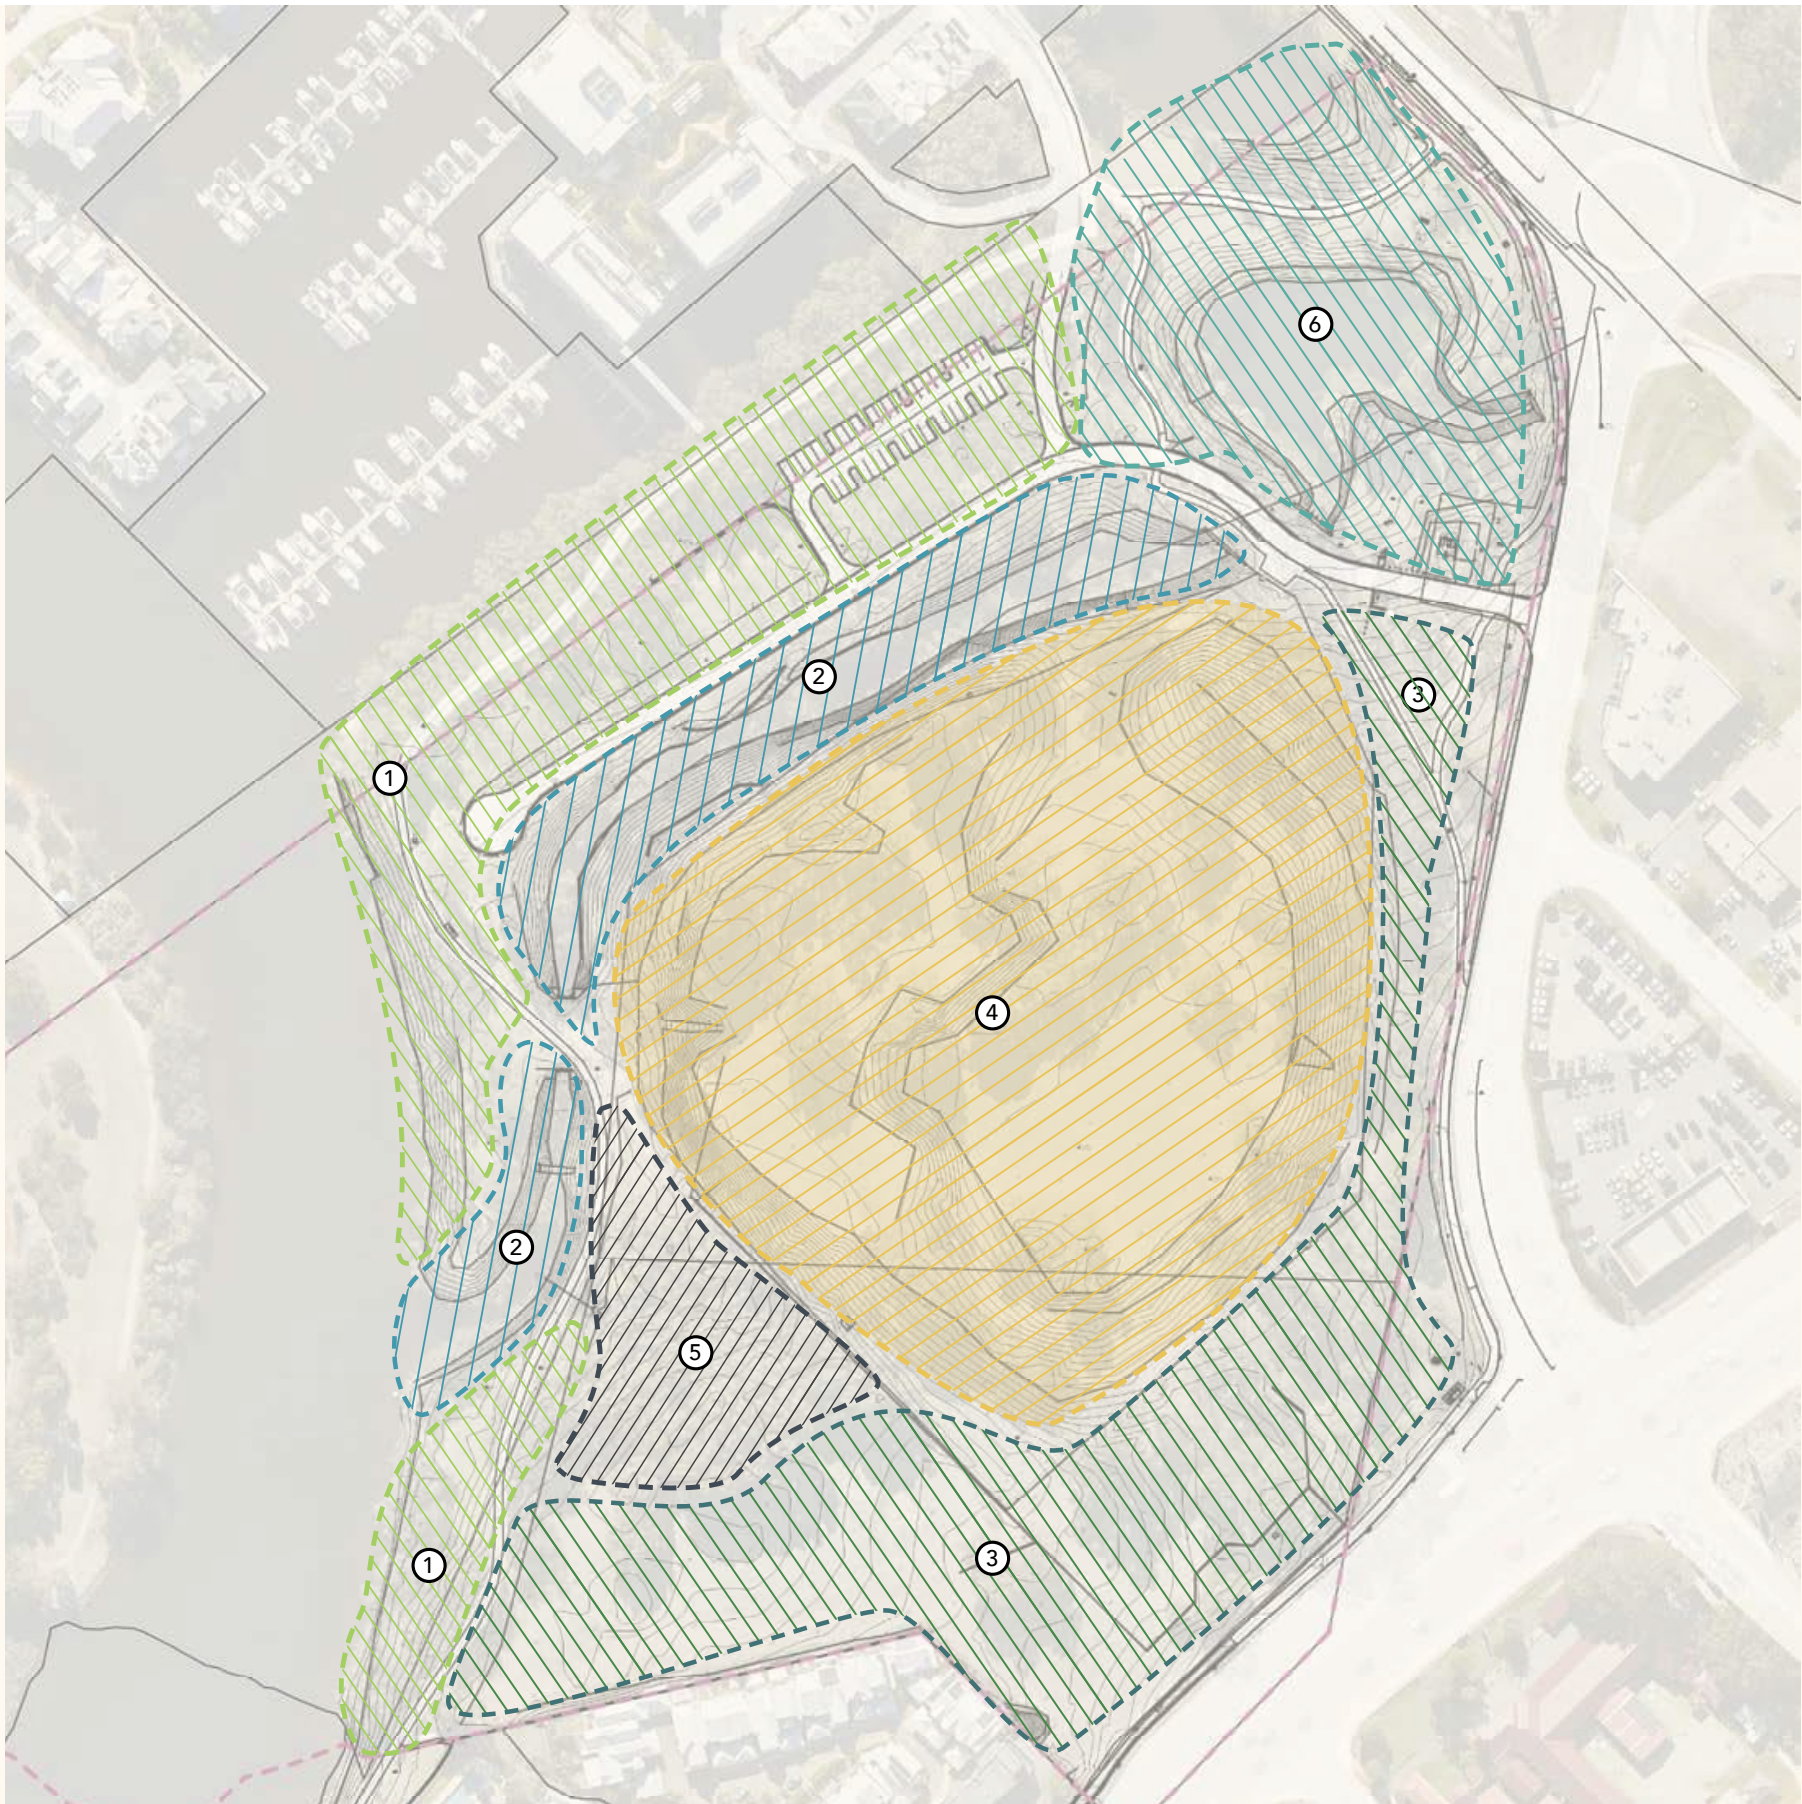
site feature survey & services

- Site Boundary
- SEWER
- SEWER UNUSED
- LOW VOLTAGE ELEC
- HIGH VOLTAGE ELEC
- GAS
- WATER
- NBN
- COMMS TELSTRA
- COMMS OPTUS

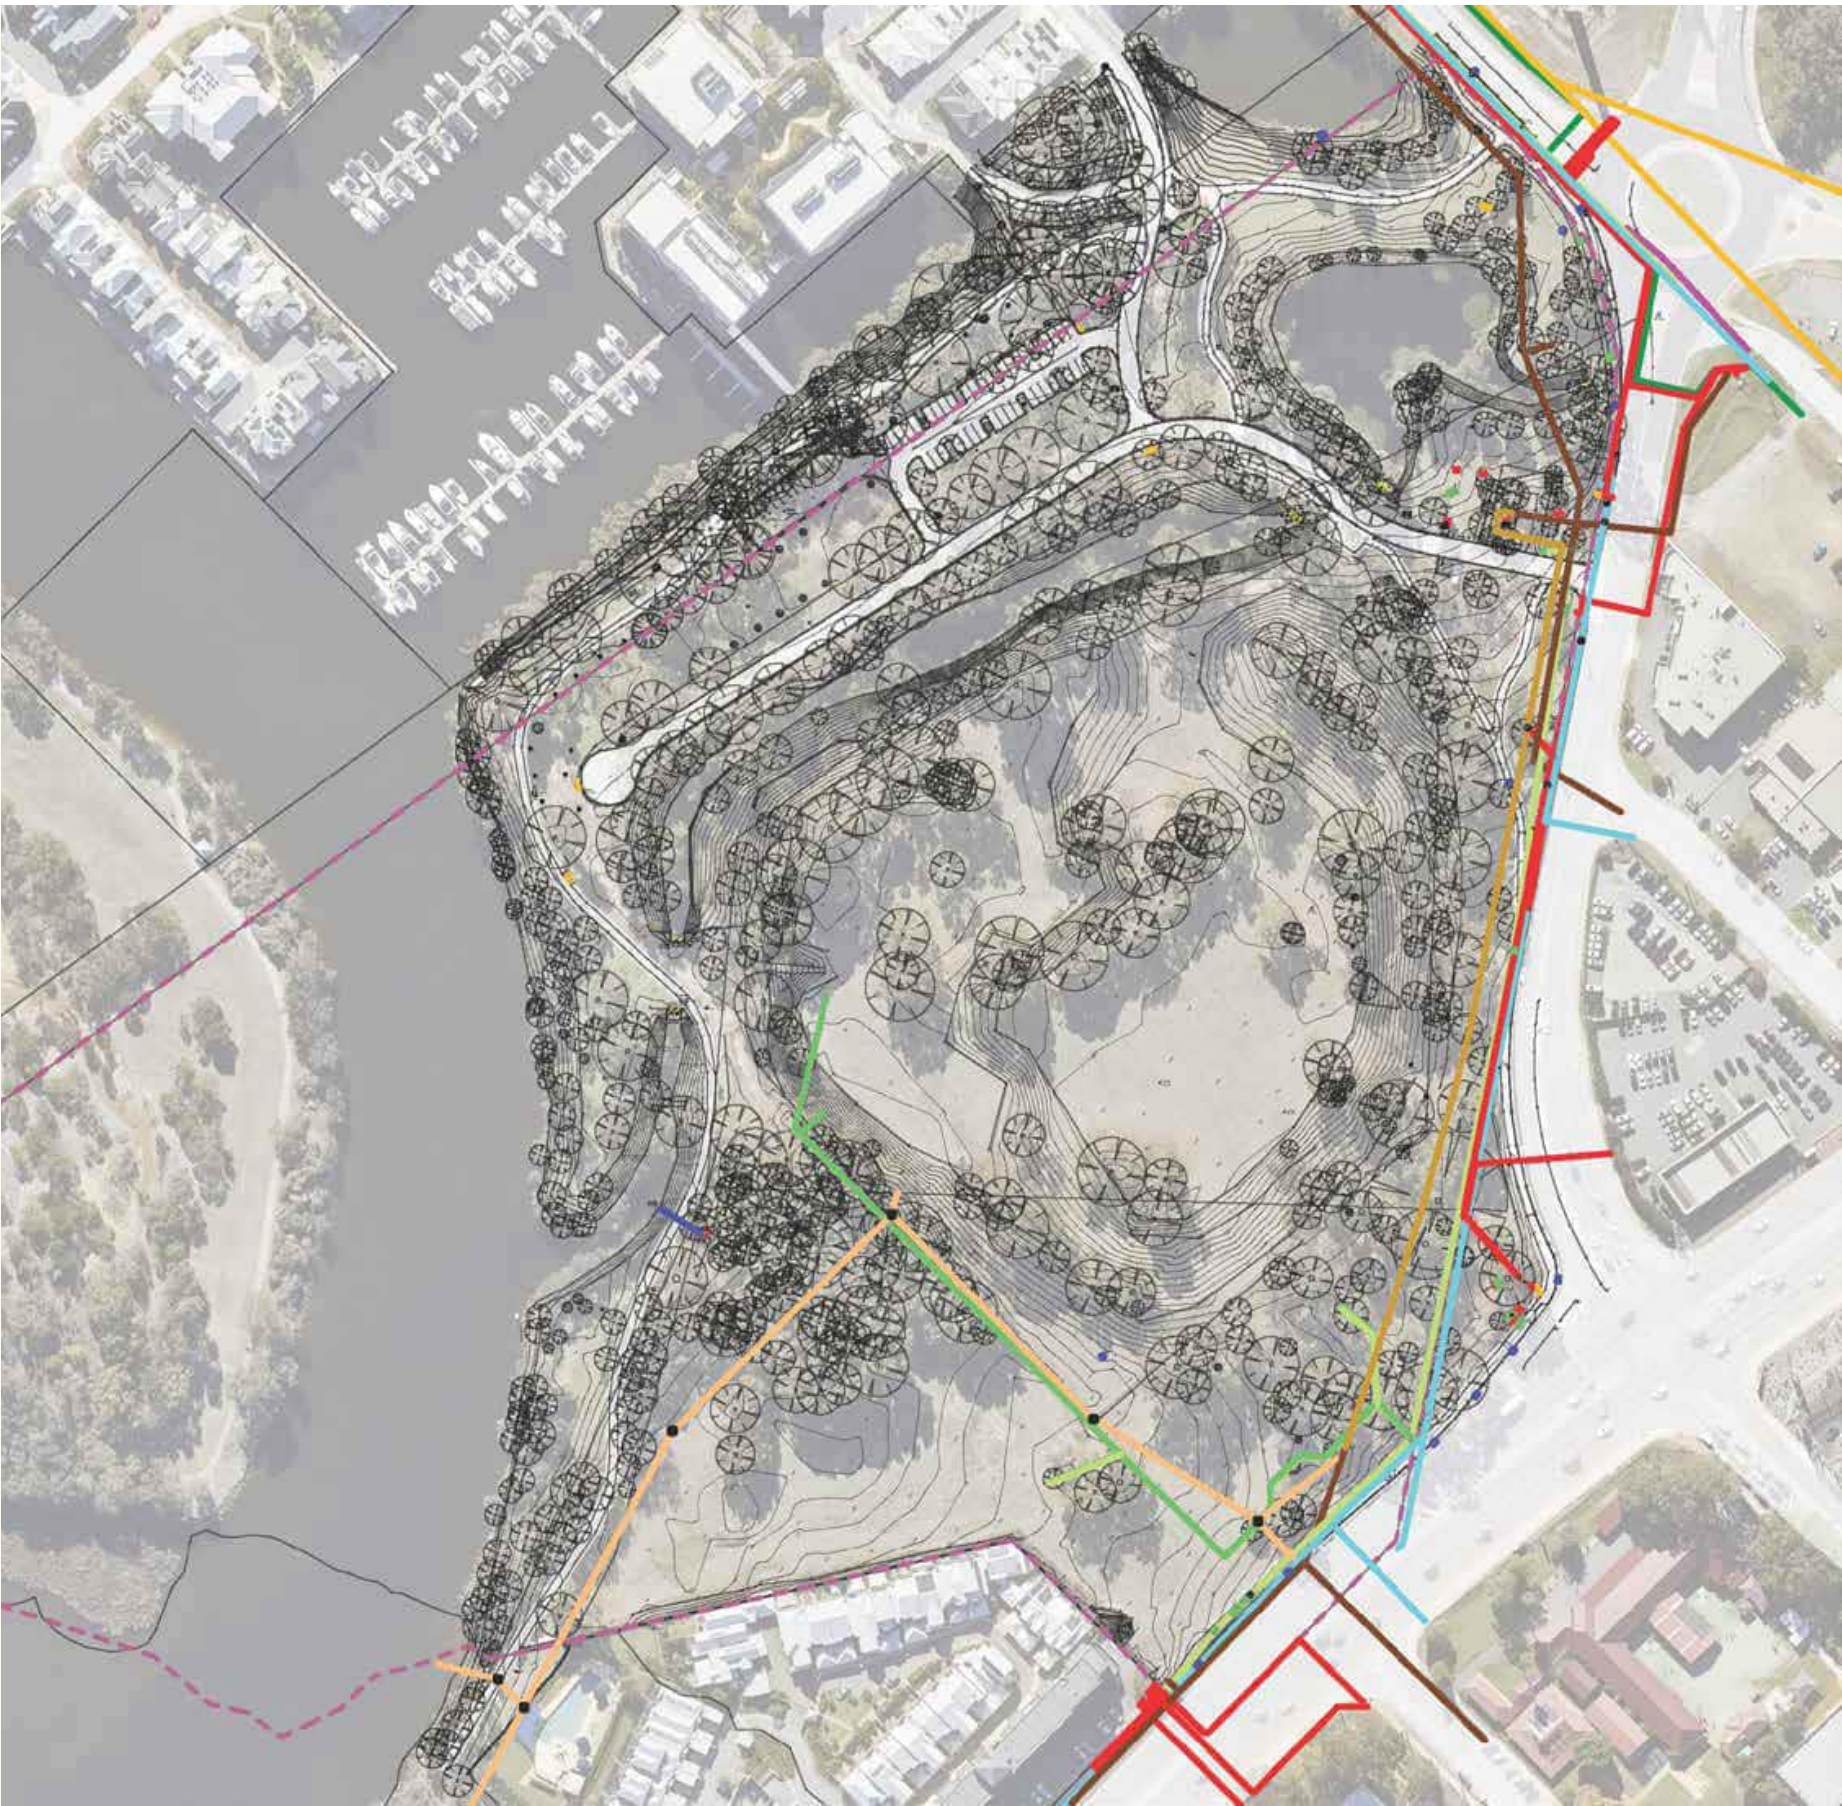
## waterways and flooding

Source: Western Australia Floodplain Mapping (DWER/Landgate 2017)

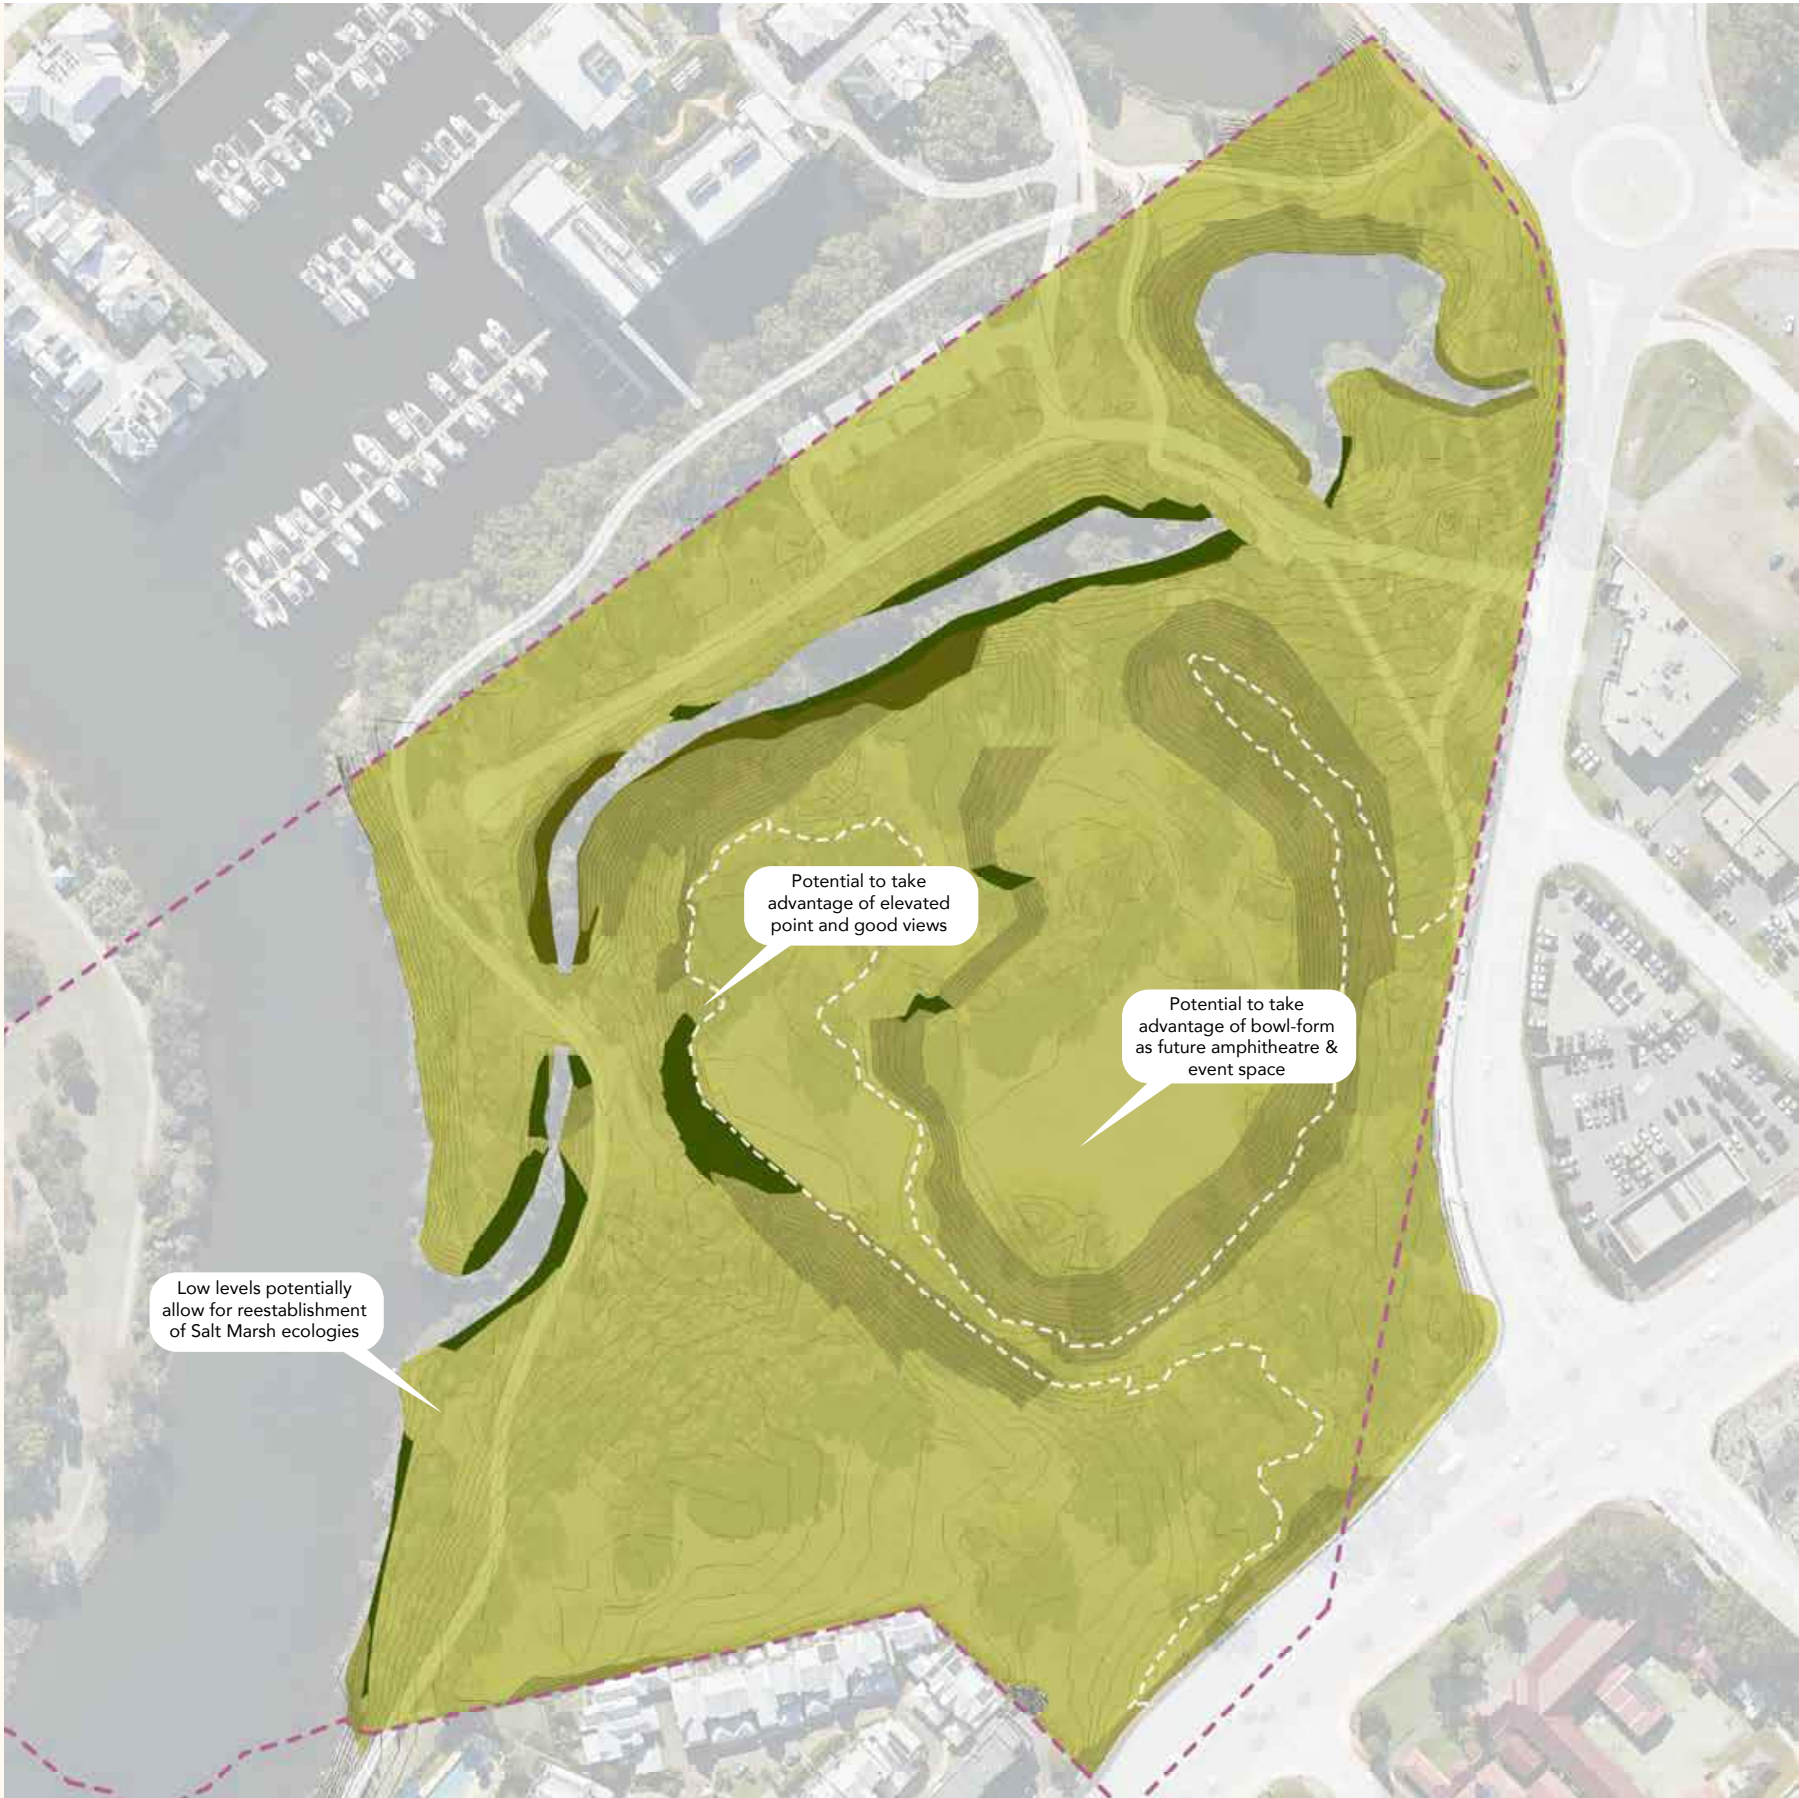
vegetation & soils

- Site Boundary
- Pinjarra System  
The Pinjarra soil system is characterized by poorly drained, alluvial soils found on the Pinjarra Plain, a flat area between the Bassendean dunes and the Darling Scarp. It is a complex soil system with a variety of soil types, including grey deep sandy duplexes, brown shallow loamy duplexes, and cracking clays. While fertile clays and loams are present, other areas are prone to waterlogging and salinity.
- Bassendean System  
The Bassendean soil system is an ancient, infertile dune system on the Swan Coastal Plain, composed of highly leached, pale grey or yellow, quartz-rich sands. It is acidic, low in organic matter and nutrients, and has poor water and nutrient retention. The system features low-lying, swampy interdune areas that contain peaty, organic soils, and higher ridges with deeper, bleached sands.

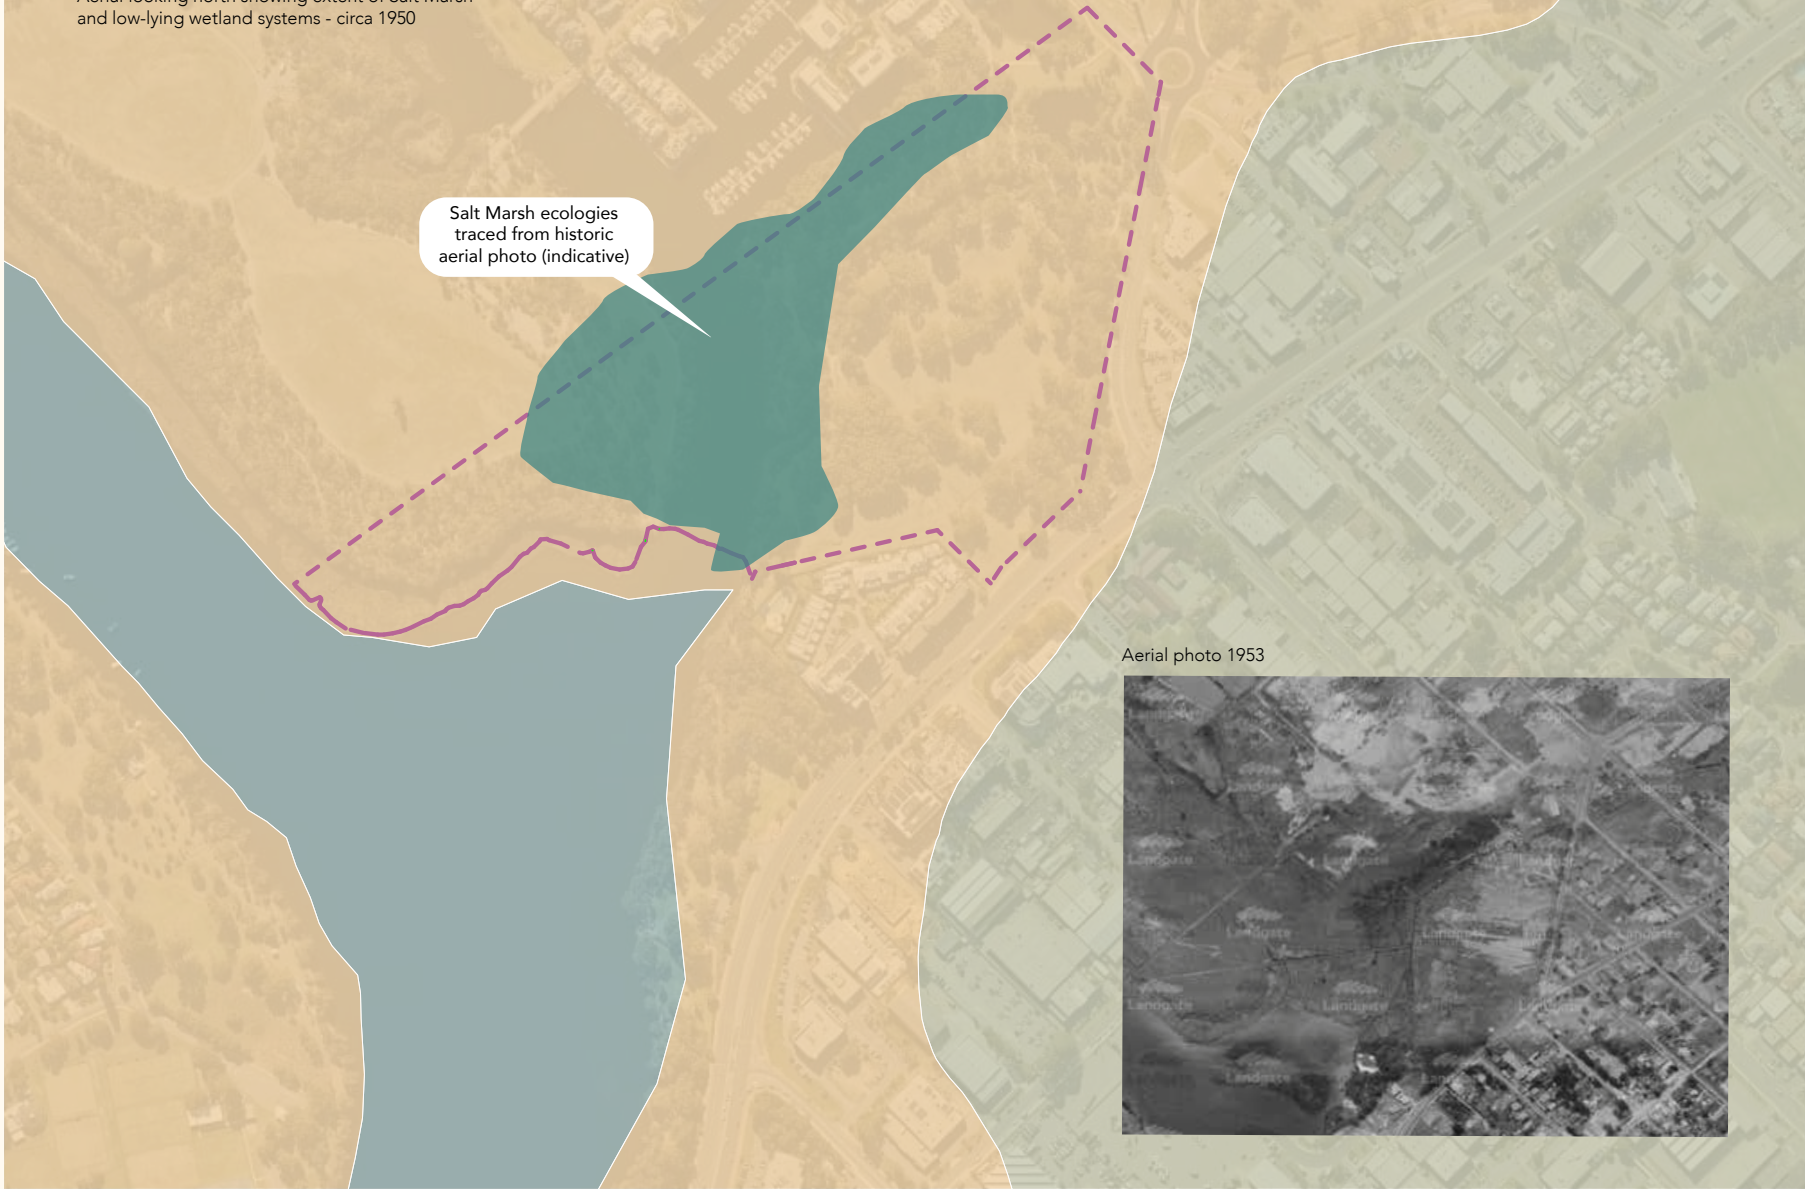
Aerial looking north showing extent of Salt Marsh and low-lying wetland systems - circa 1950

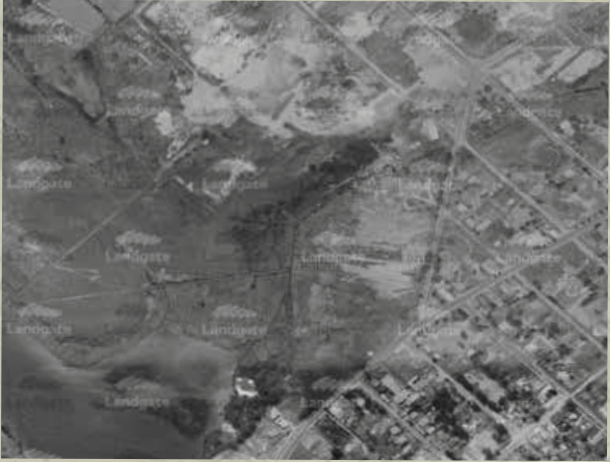
Aerial photo 1953

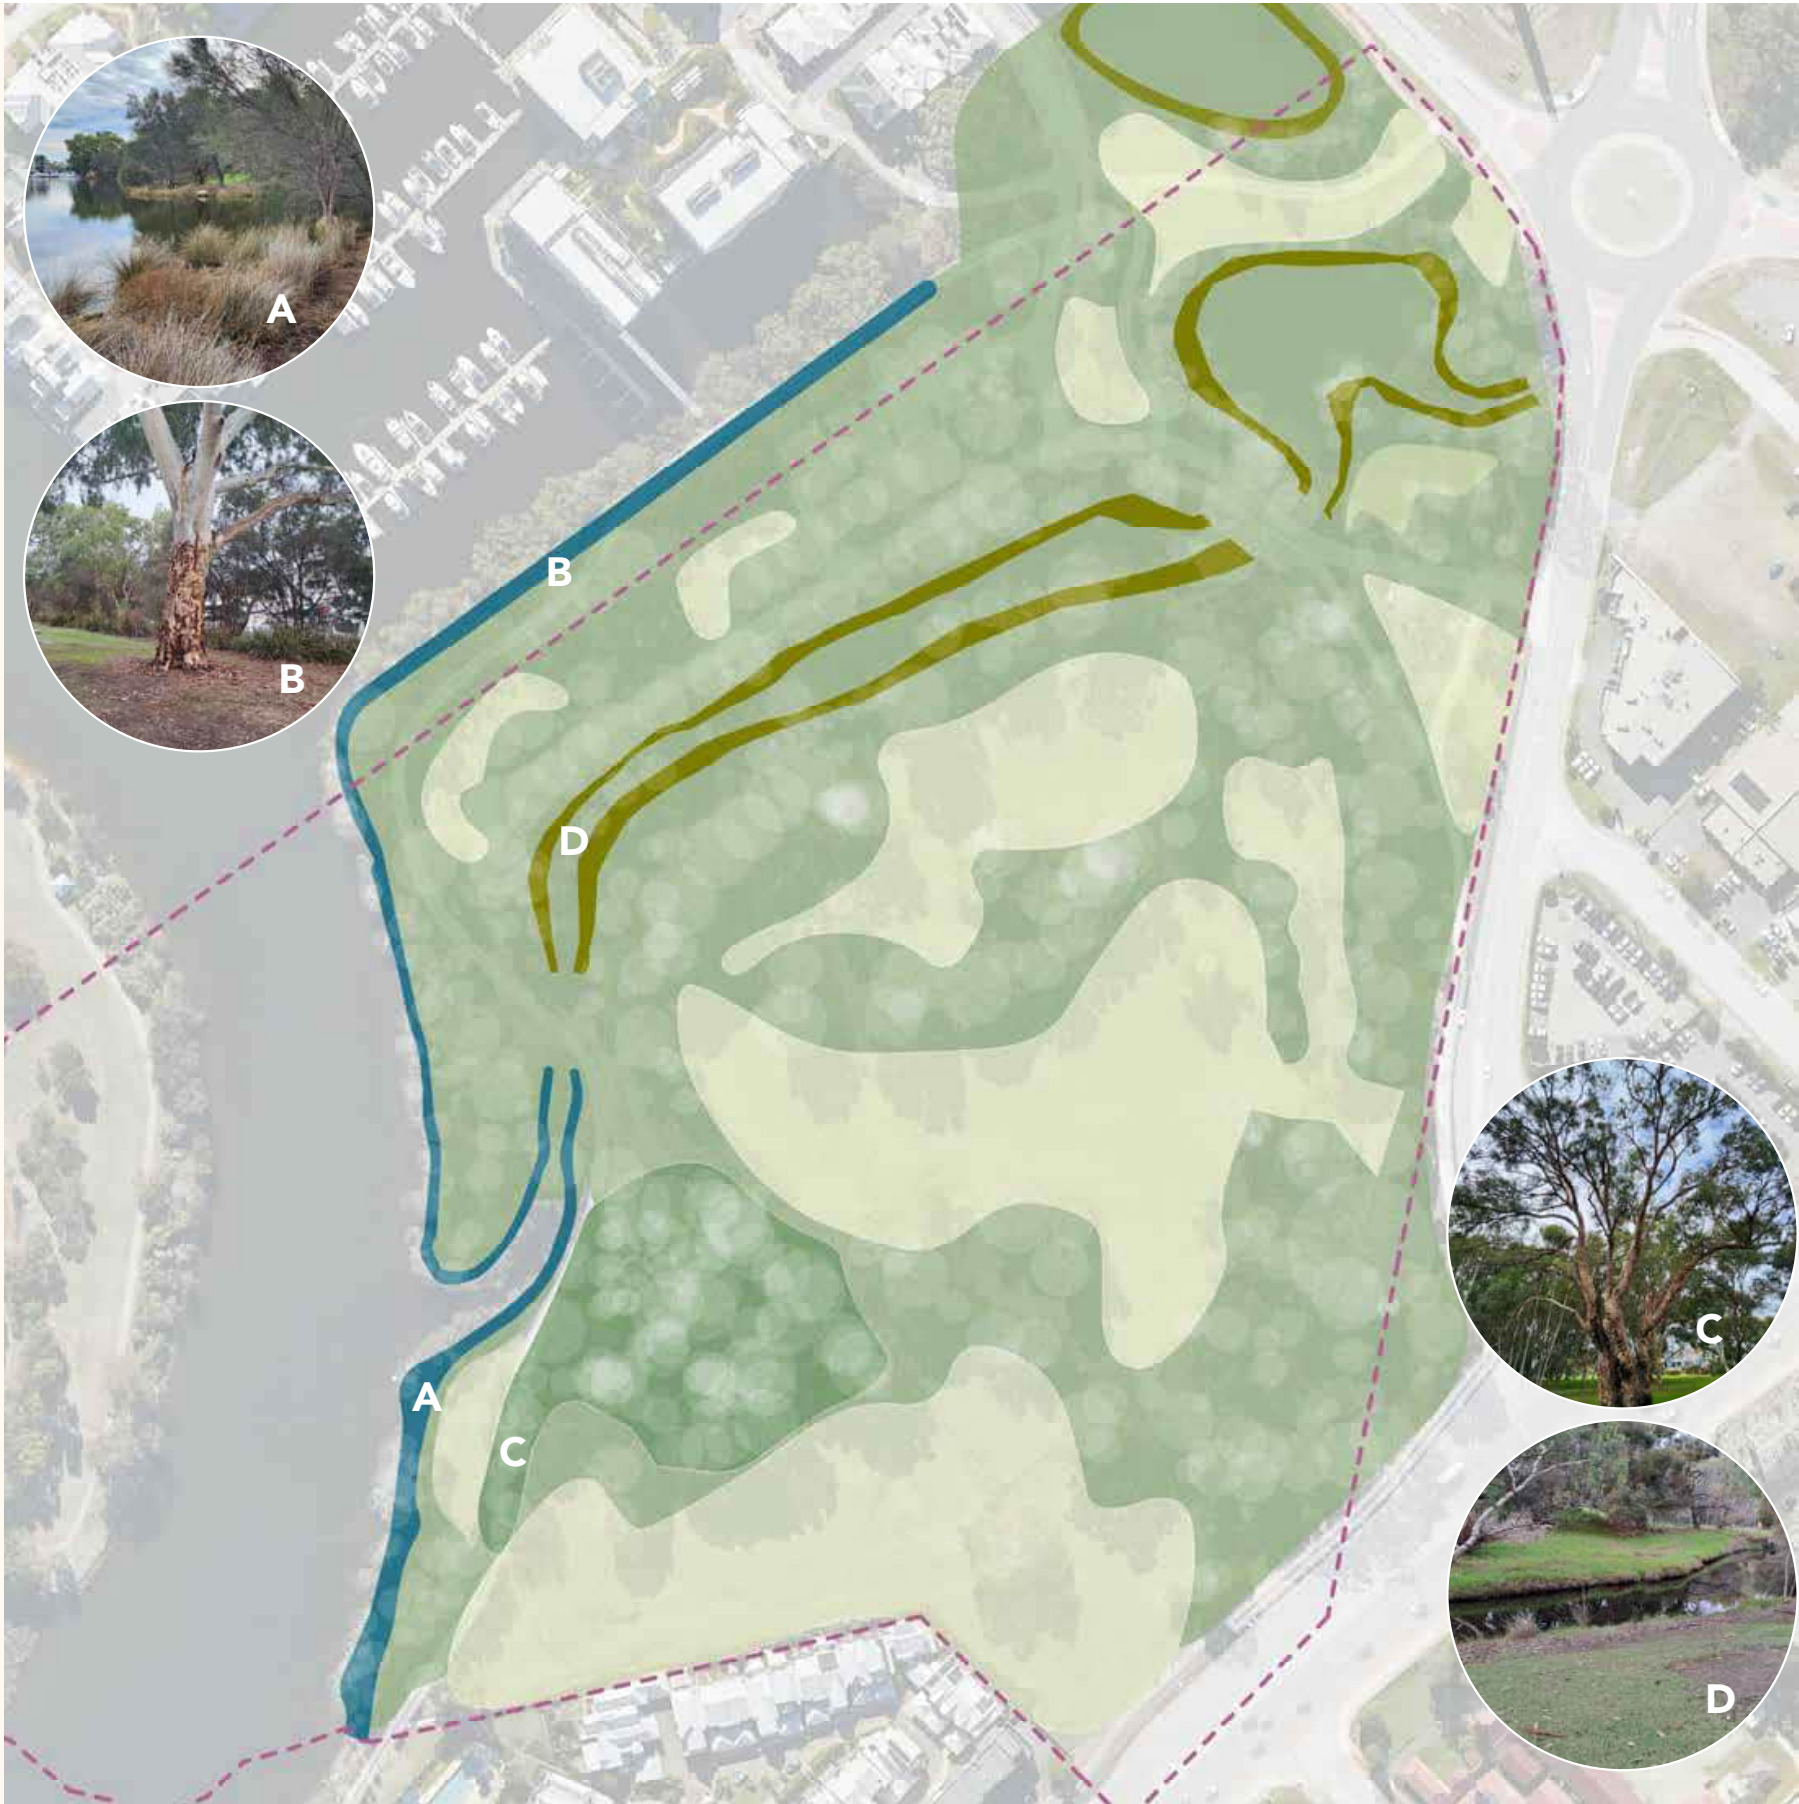
Areas of self seeded *Eucalyptus camuldulensis* are found in large groves. The non native River Red Gum can be problematic for it's ability to self-seed, and also hybridises with the local Flooded gum reducing the genetic diversity for this species. (Image B)

Small pockets of local species such as *Melaleuca raphiophylla* (Freshwater paperbark) and *E. rudis* (Flooded gums) are found across the site, however these are in the minority. (Image C)

Grass edges along the channel, with areas of *Casuarinas* and reeds. (Image D)

- Site Boundary
- Riparian / Fringing Vegetation - Saline (understory and canopy)
- Riparian / Fringing Vegetation - Stormwater (understory and canopy)
- Parkland with Dense Tree Canopy
- Open Parkland Areas (trees and grass)
- Open turf area

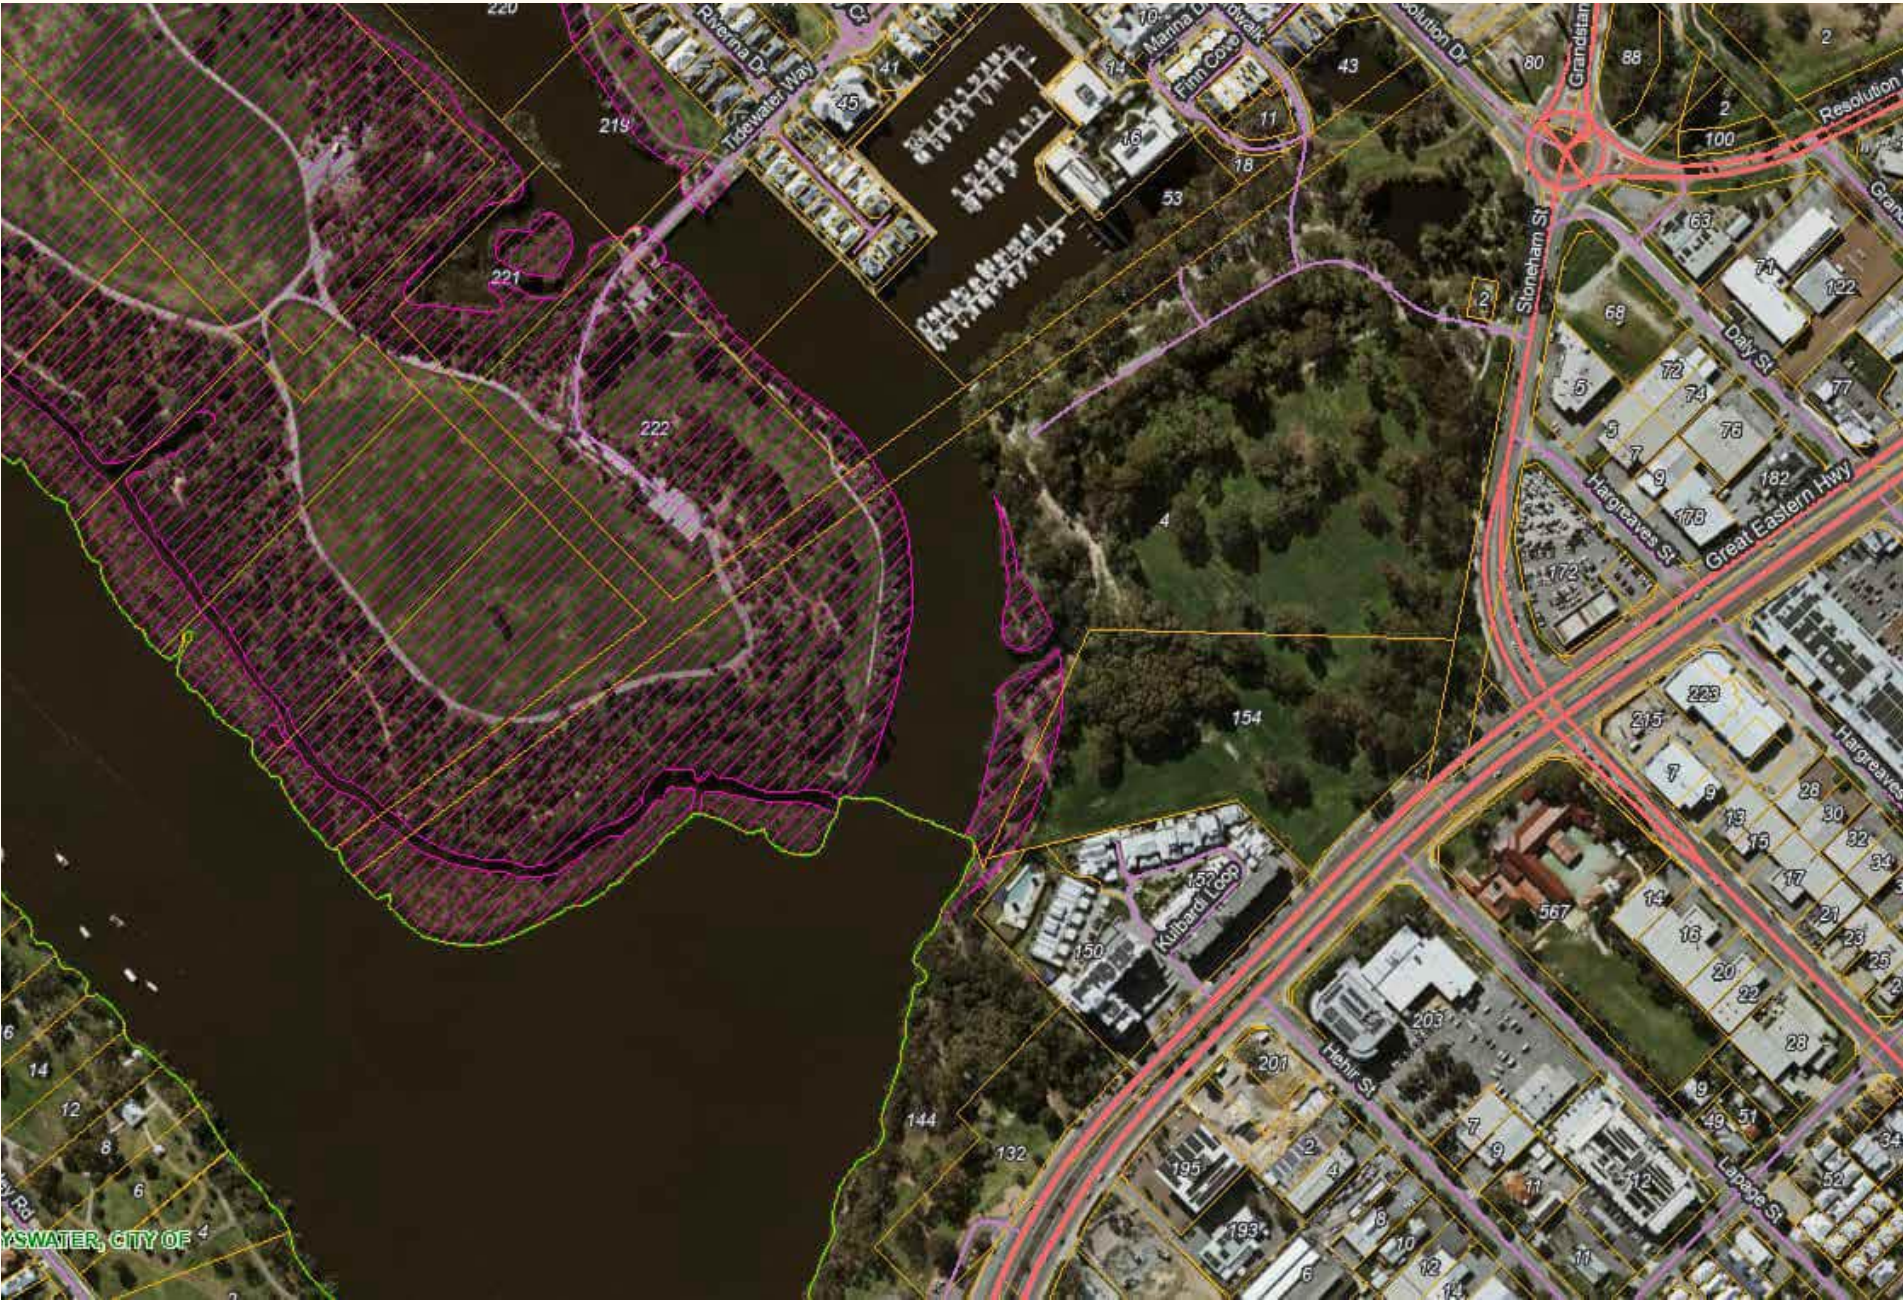
Bush Fire Prone Areas (DFES)

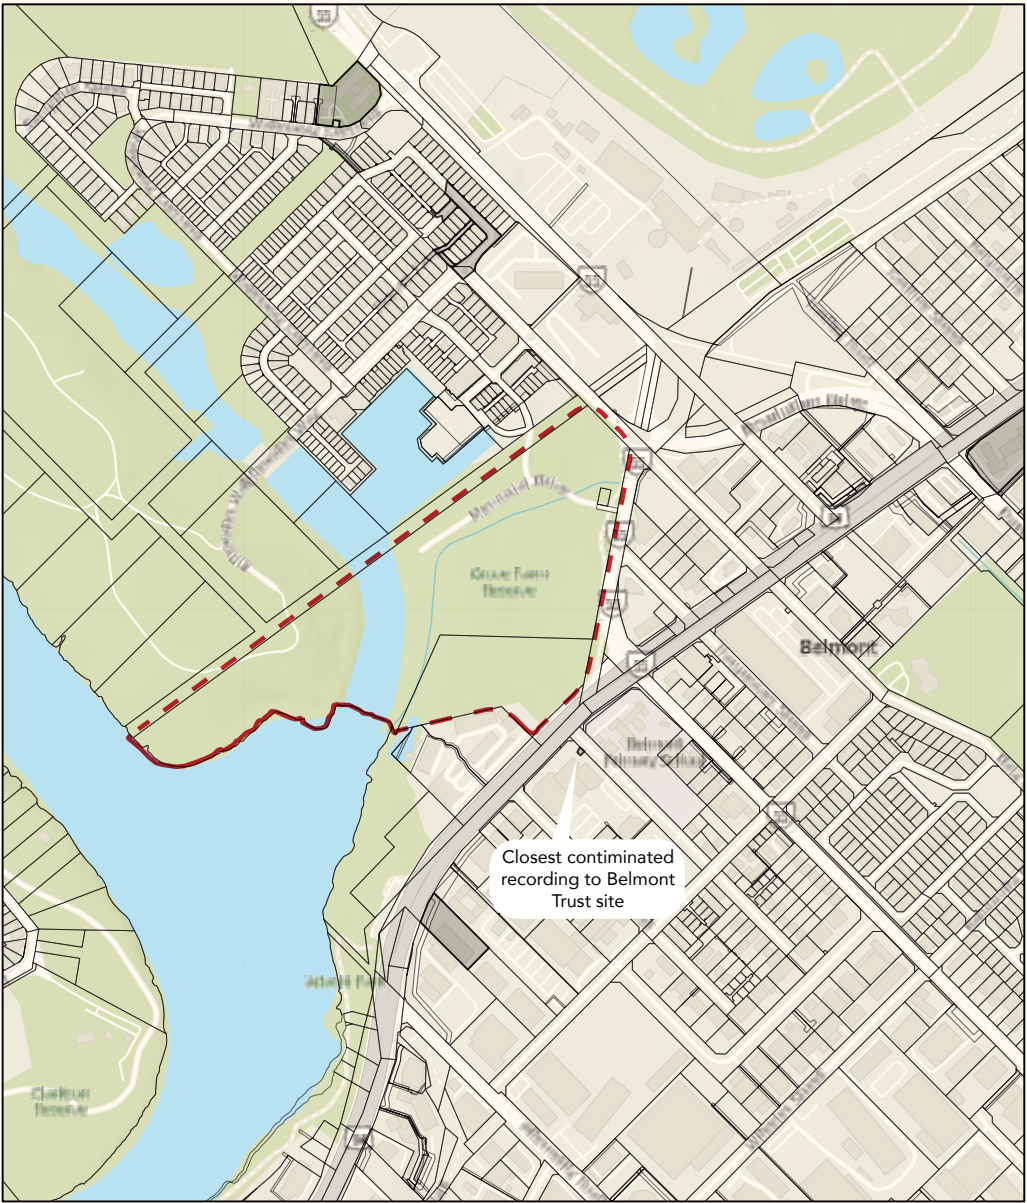
**No site contamination** - As per diagram opposite from the Department of Water the Belmont Trust site has no recorded contamination.
