# Minutes

Wednesday 3 June 2026

# BELMONT TRUST LANDSCAPE MASTER PLAN

# Geotechnical Investigation

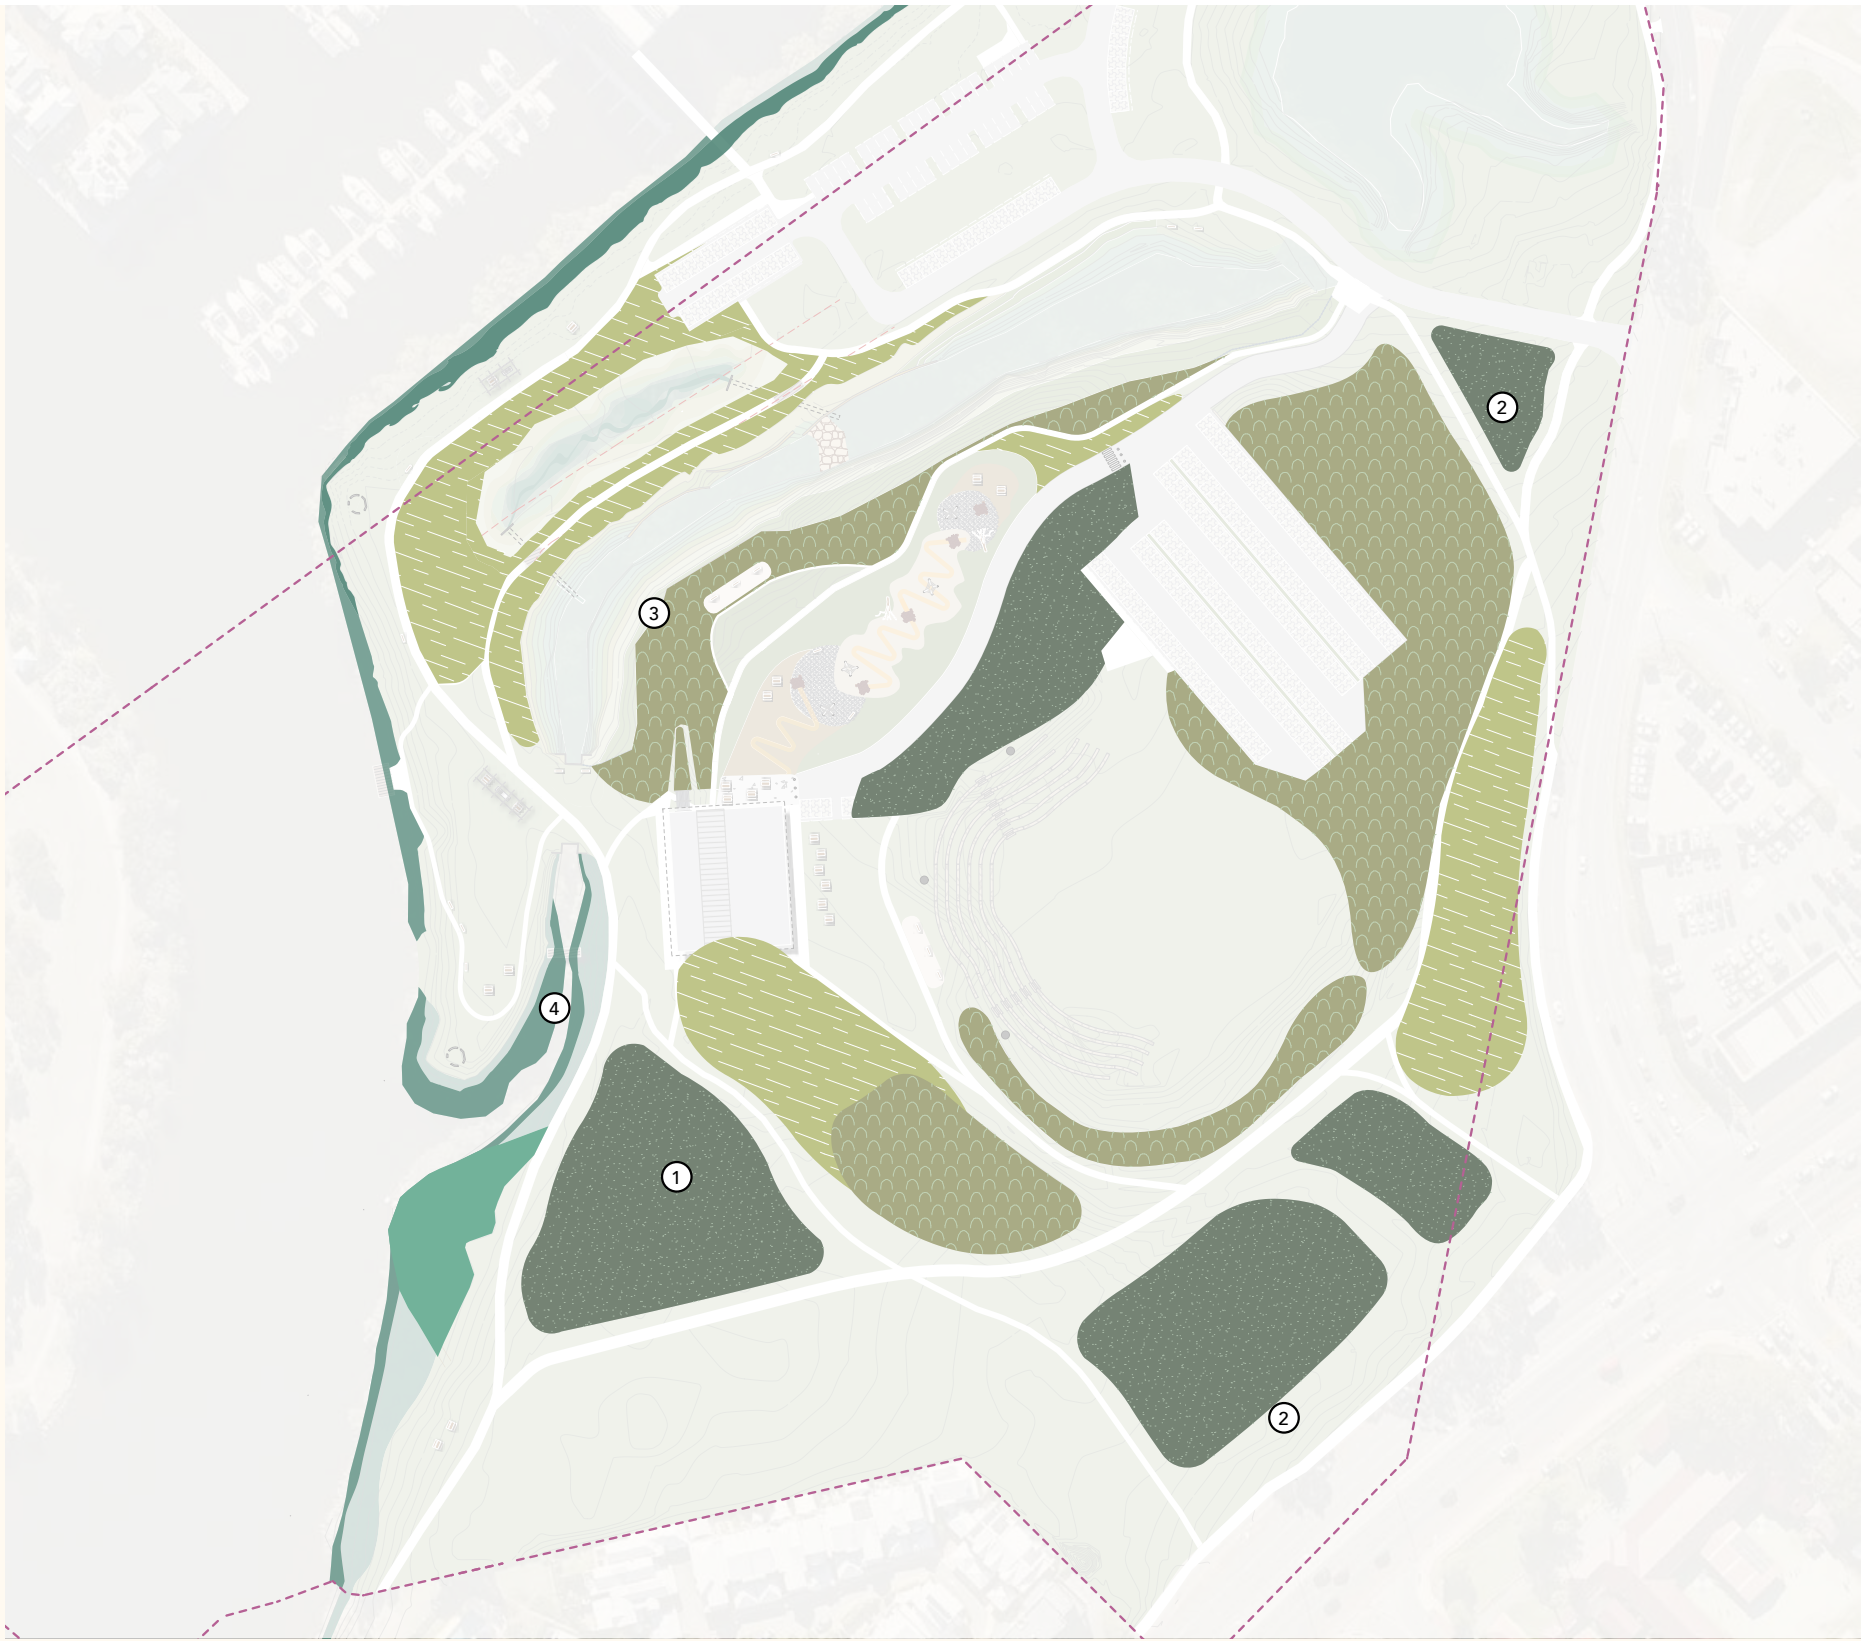
### Legend

- Jarrah Forest Regeneration
- Banksia Woodlands Regeneration
- Wandoo Woodlands Regeneration
- Saltmarsh Regeneration
- Turf and Trees Only (CPTED)
- Non-Irrigated Turf
- Irrigated Turf

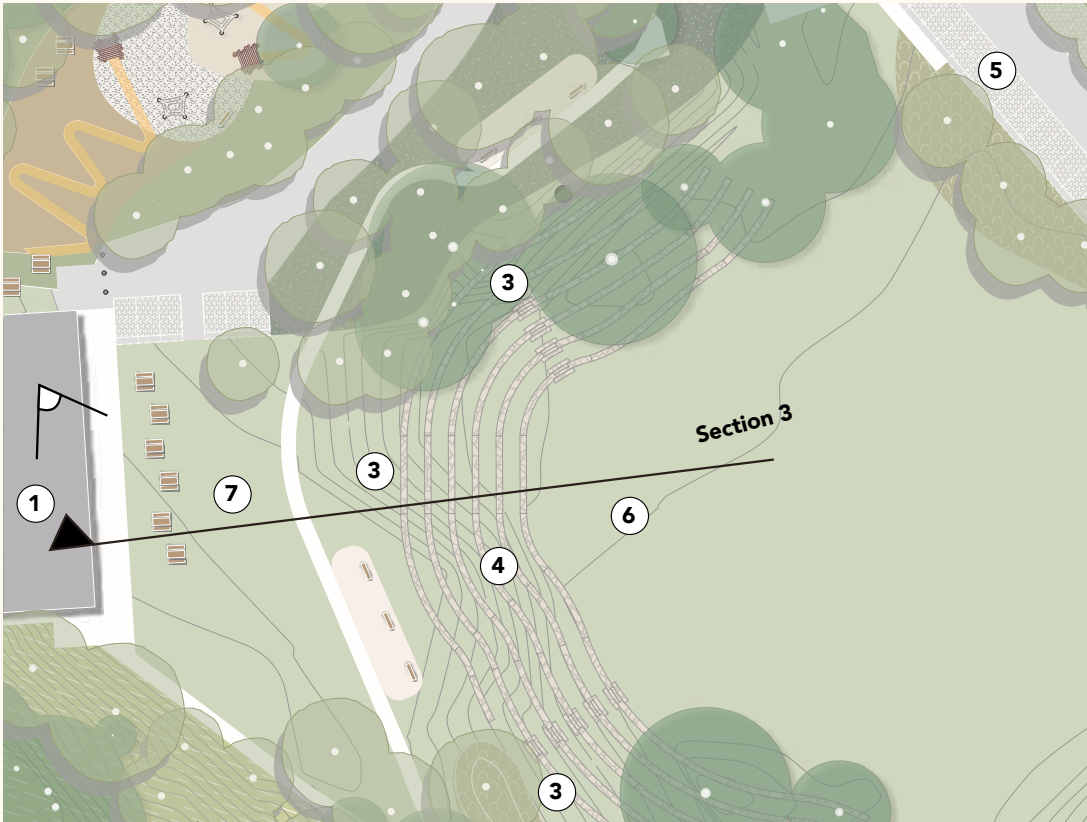
Section 3: The Swan River Amphitheatre Outdoor Space  
1:100 at A3

Swan River Amphitheatre Outdoor Cultural and Education Event Space
- 7

Event Lawn (for Marquees etc)

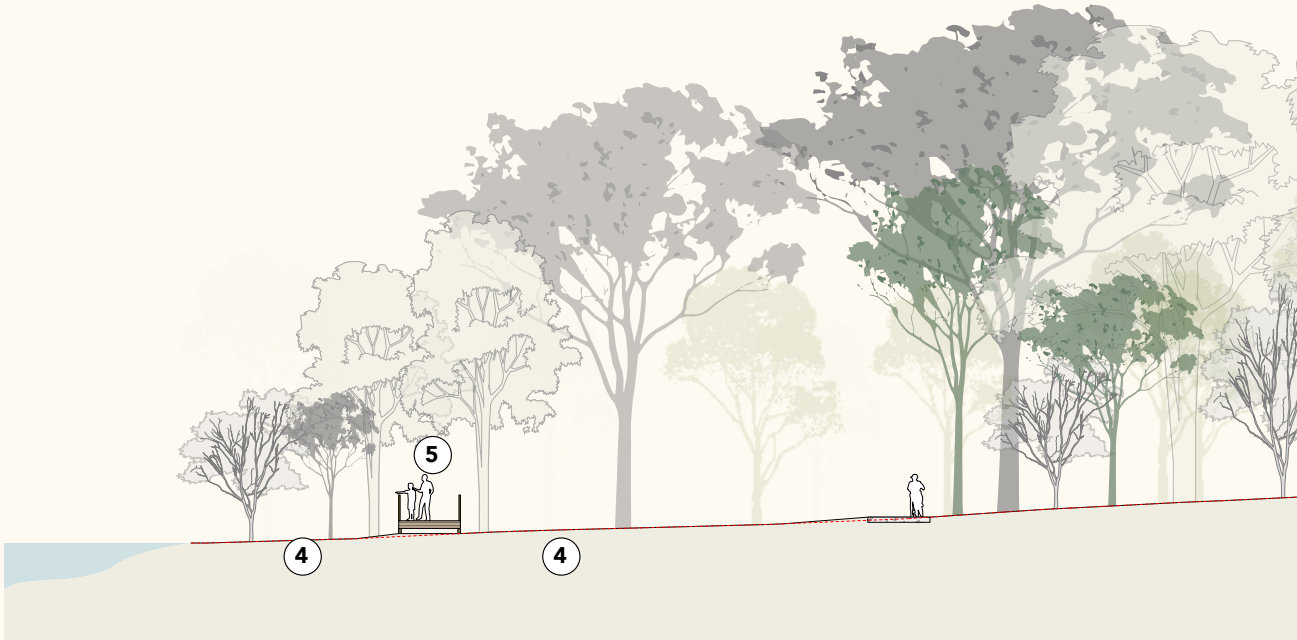
Section 5: River Edge Deck

6 Eco-Education Outdoor Space (at lower level)

7 Jetty structure to support river access

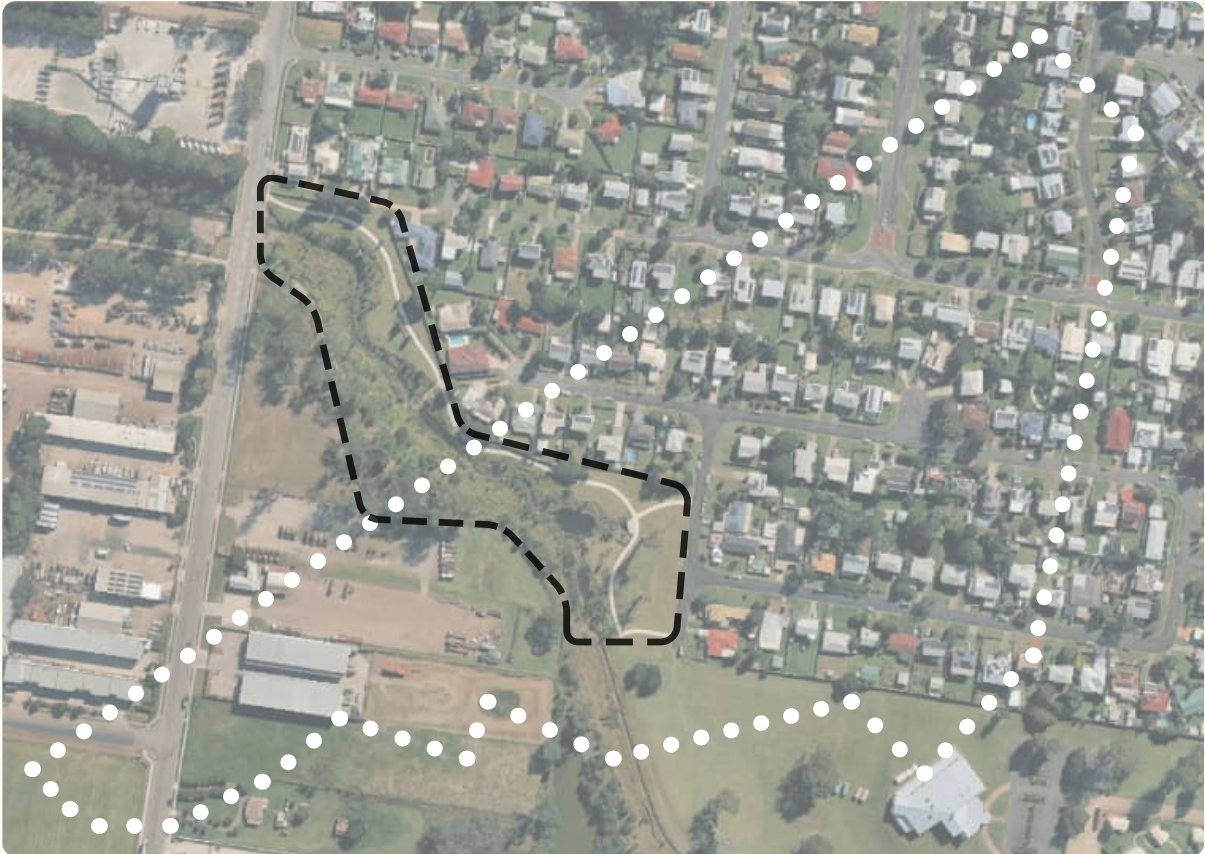
**Project:**  
The Small Creek project in Ipswich transformed a concrete drain into a vibrant, natural waterway to improve water quality, create habitats, and enhance community spaces with new pathways and play areas.

- Key Aspects:**
- Naturalisation by replacing the concrete channel with a natural waterway, fostering native flora and fauna and improving water quality.
  - Habitat Restoration through significant planting of trees and ground covers created new habitats and shade, cooling water and reducing air temperatures.
  - Community Engagement leading to new pathways, discovery trails, and play spaces for residents to interact with the creek.
  - Flood Management
  - Aesthetic and Economic Benefits

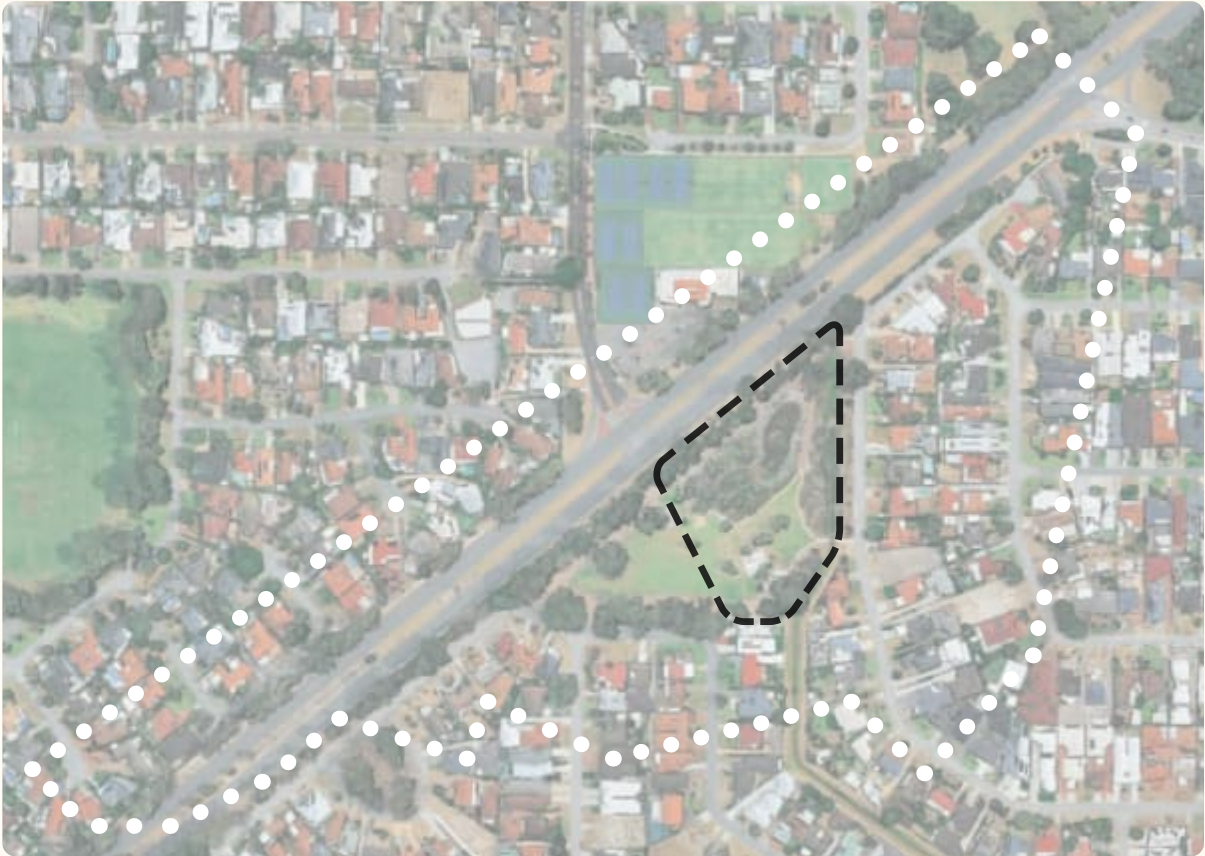
- Modification of original drain to mimic natural stream
- Construction of wetlands and basins
- Improvement of water quality, filtering stormwater
- Providing habitat for flora and fauna
- Enhanceing park’s amenity
- Water Oxygenation with installation of Riffles
- Extensive native planting to stabilize the banks and enhance the ecosystem
- Enhancements such as footpaths and a footbridge.

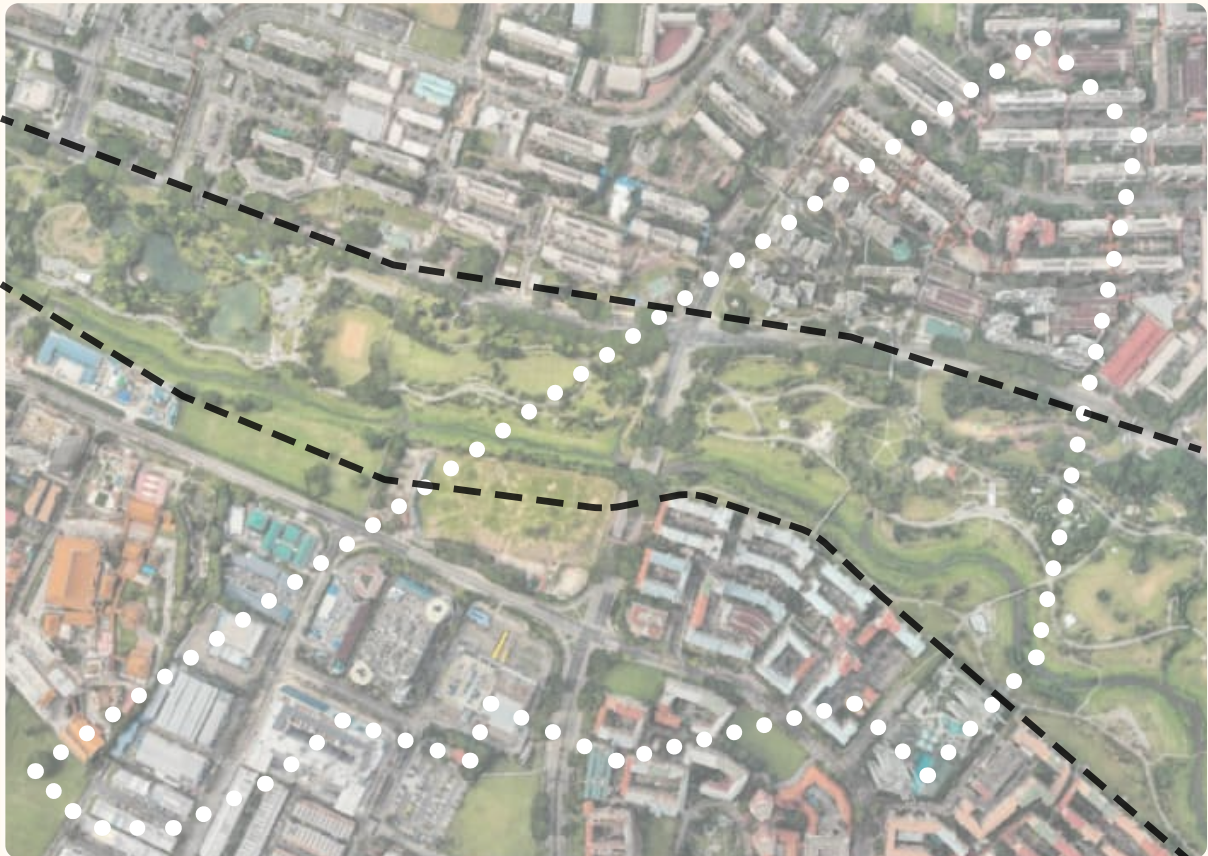
**Project:**  
Ecological estoration project that transformed the Kallang River from a concrete canal into a natural, meandering river to manage flooding and improve the urban environment in Singapore.

- Key Aspects:**
- Naturalized stormwater management
  - Creation of a biodiverse riverine habitat
  - Development of recreational spaces like river plains and ponds
  - Community engagement through educational programs
  - Seamless integration with the surrounding urban area.

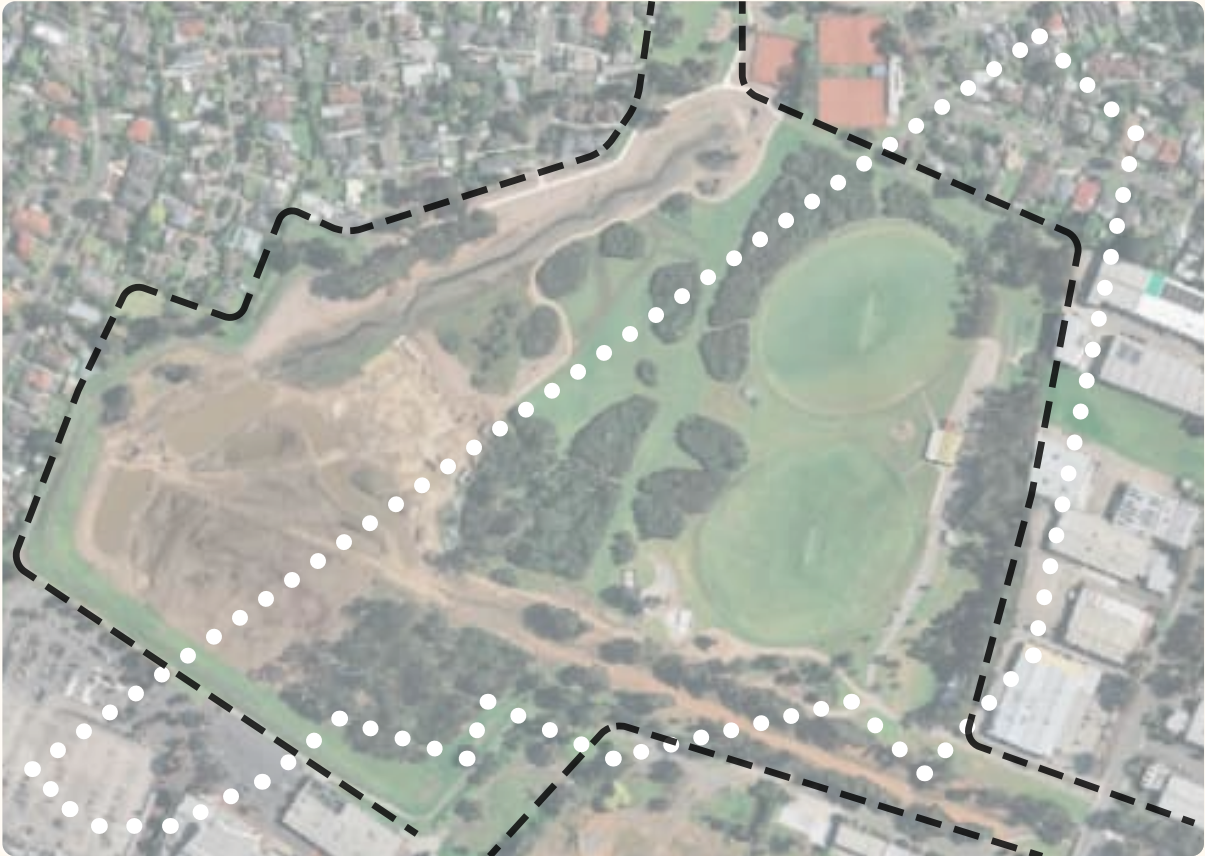
- Renaturalisation by converting concrete drain into living waterway
- Flood mitigation through building wetlands and ponds
- Water quality improvemt
- Water reuse to irrigate local sports ovals and community gardens
- Habitat for flora and fauna
- Recreational opportunities

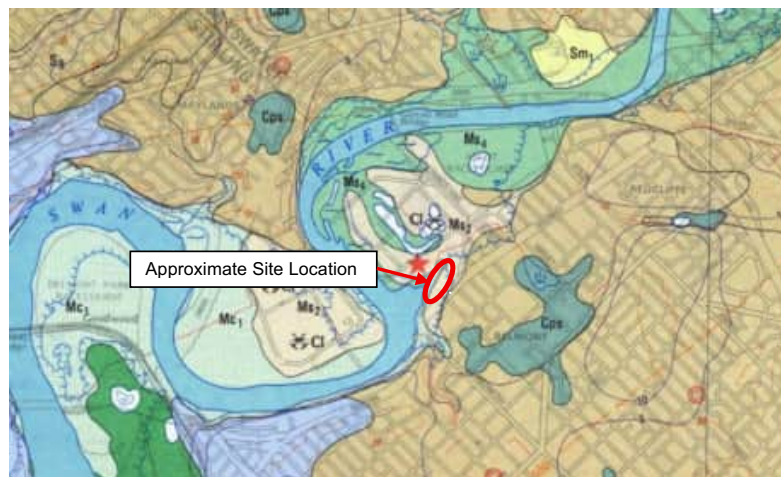
The Perth sheet 1: 50,000 Environmental Geology Series (Part Sheets 2034 III and 2134 III, 1986) prepared by the Geological Survey of Western Australia indicates that the following geological layers underlie the site:

Clayey SILT (Mc<sub>2</sub>) – yellow brown to strong brown, blocky, mottled, soft, with variable clay content, dispersive in part, of alluvial origin (Alluvium, Qha), underlain by

The soils encountered are consistent with the expected site conditions as predicted from the Environmental Geology Map. It is important to note that there may be pockets of fill on site that are deeper than that encountered by the investigation boreholes. The subsurface soil conditions encountered are presented in the bore logs, within Appendix C.

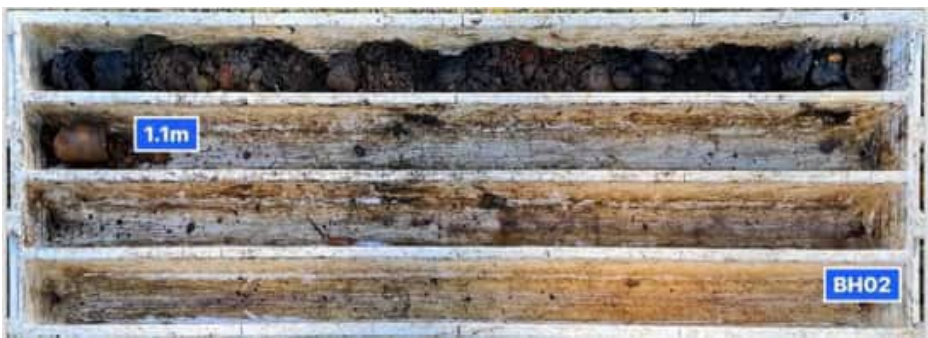
Depth: 0 m - BH2

| <div> <b>Borehole Record: BH02</b> </div> | | | | | | | | | | |
|---|---|---|---|---|---|---|---|---|---|---|
| | | Natural | | CI | Sandy Clay (CI): firm, medium plasticity, brown. | | F | | | |
| | | | | | <b>BH02 Refusal at 1.1m (Refusal)</b> | | | | | |

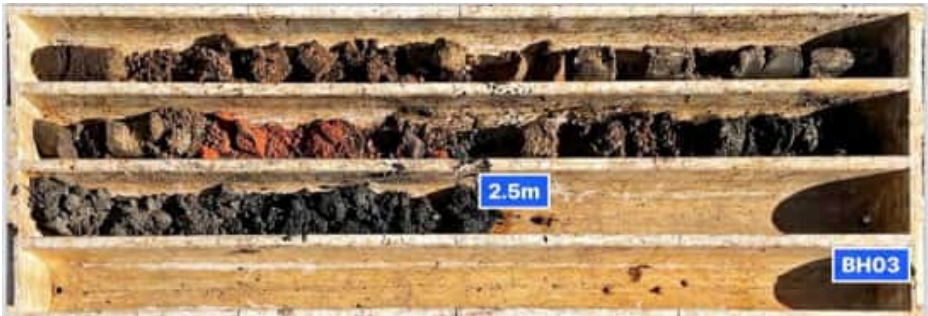
Depth: 0 m - BH3

| <div> <b>Borehole Record: BH03</b> </div> | | | | | | | | | | |
|---|---|---|---|---|---|---|---|---|---|---|
| | 2 | | | SC | Clayey Sand (SC): loose, poorly graded, medium grained, low plasticity clay, grey and dark grey, wet. | W | L | | | |
| | | | | | <b>BH03 Terminated at 2.5m (target depth)</b> | | | | | |

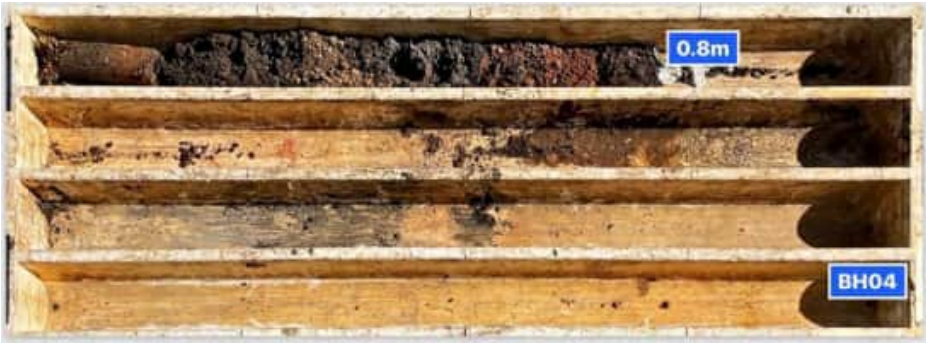
| | | Fill | | SP | gravelly Sand (SP): medium dense, poorly graded, medium grained, medium sized gravel, grey and brown, trace building rubble, trace clay, moist | M | D-VD | | | |
| GWL | | | | | BH04 Refusal at 0.8m (Refusal) | | | | | |

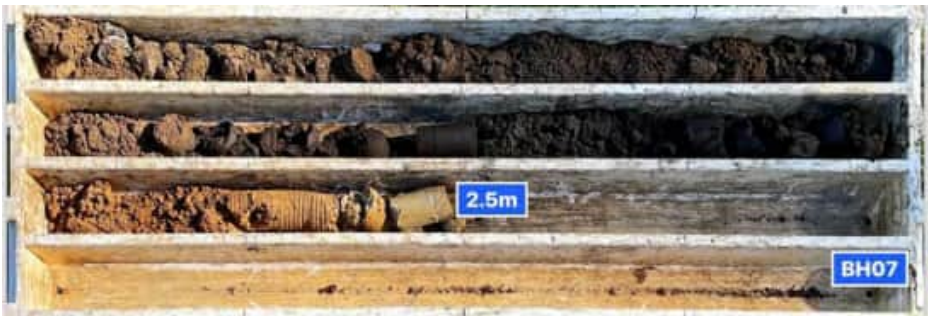
Depth: 0 m - BH7

| <div style="display: flex; justify-content: space-between; align-items: center;"> <div> </div> <div> <h2 style="margin: 0;">Borehole Record: BH07</h2> </div> </div> | | | | | | | | | | |
|---|---|---|---|---|---|---|---|---|---|---|
| | | | | SC | Clayey Sand (SC): medium dense, poorly graded, medium grained, pale brown, moist. | M | MD | | | |
| | | | | | <b>BH07 Terminated at 2.5m (target depth)</b> | | | | | |

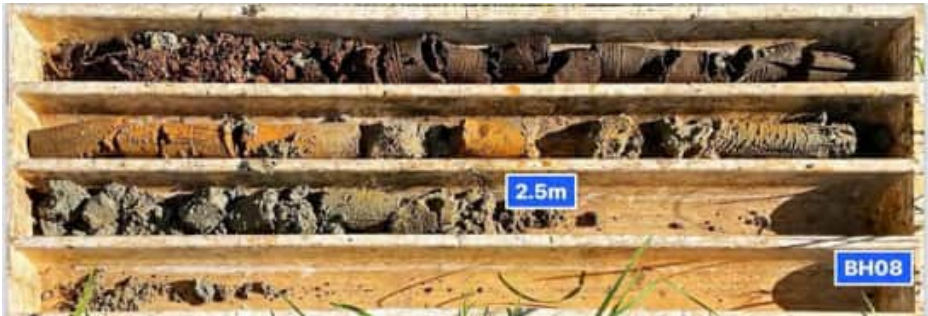
Depth: 0 m - BH8

| <div> <b>Borehole Record: BH08</b> </div> | | | | | | | | | | | |
|---|---|---|---|---|---|---|---|---|---|---|--|
| | SC | | | Clayey Sand (SC): medium dense, poorly graded, medium grained, low plasticity clay, orange mottled pale grey, moist to wet. | W-M | MD | 14 | | | | |
| | | | | | BH08 Terminated at 2.5m (target depth) | | | | | | |

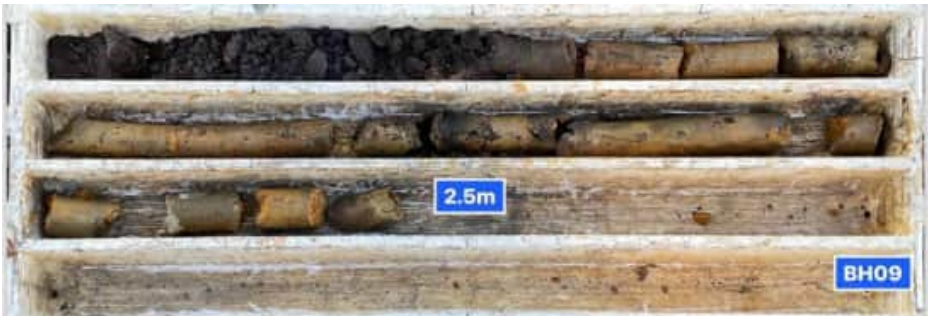
Depth: 0 m - BH9

| <div> <b>Borehole Record: BH09</b> </div> | | | | | | | | | | |
|---|---|---|---|---|---|---|---|---|---|---|
| | 2 | | | SC | Clayey Sand (SC): medium dense, poorly graded, medium grained, low plasticity clay, orange mottled pale grey, wet to moist. | W-M | MD | 9 | | |
| | | | | | <b>BH09 Terminated at 2.5m (target depth)</b> | | | | | |

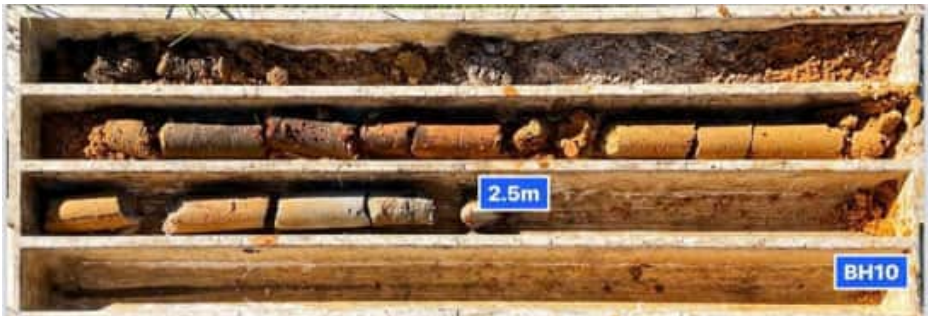
Depth: 0 m - BH10

| <div style="display: flex; justify-content: space-between; align-items: center;"> <div> </div> <div> <h2 style="margin: 0;">Borehole Record: BH10</h2> </div> </div> | | | | | | | | | | |
|---|---|---|---|---|---|---|---|---|---|---|
| | | | | SC | Clayey Sand (SC): medium dense, poorly graded, medium grained, low plasticity clay, pale yellow mottled pale grey, wet to moist. | W-M | MD | | | |
| | | | | | BH10 Terminated at 2.5m (target depth) | | | | | |

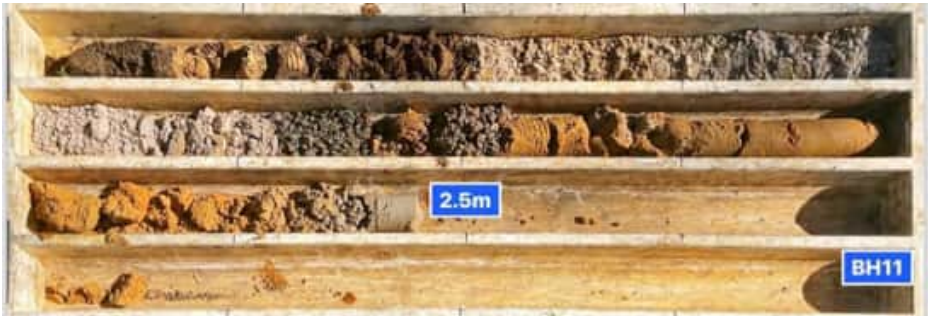
Depth: 0 m - BH11

| <div style="display: flex; justify-content: space-between; align-items: center;"> <div> </div> <div> <h2 style="margin: 0;">Borehole Record: BH11</h2> </div> </div> | | | | | | | | | | |
|---|---|---|---|---|---|---|---|---|---|---|
| | 2 | Natural | | SC | Clayey Sand (SC): medium dense, poorly graded, medium grained, low plasticity clay, pale brown and pale grey, wet. | W | MD | | | |
| | | | | | BH11 Terminated at 2.5m (target depth) | | | | | |

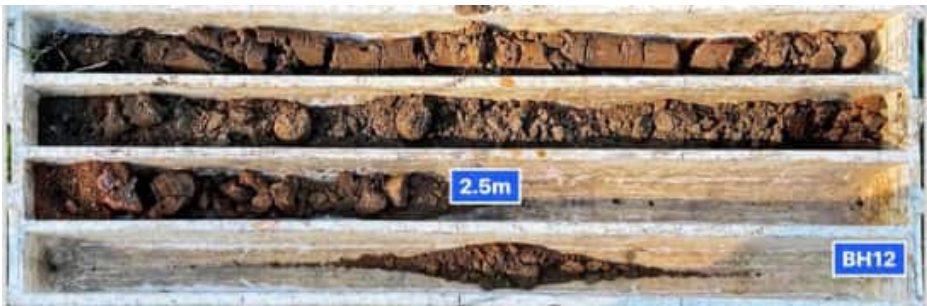
Depth: 0 m - BH12

| <div> <div>Borehole Record: BH12</div> </div> | | | | | | | | | | |
|---|---|---|---|---|---|---|---|---|---|---|
| | | | | | Natural | SC | Clayey Sand (SC): loose to medium dense, poorly graded, medium grained, brown, trace medium gravel, moist. | | | |
| | | | | | BH12 Terminated at 2.5m (target depth) | | | | | |

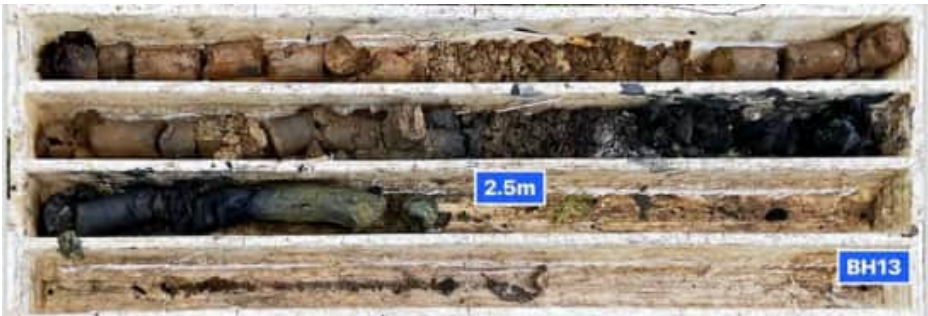
| <div> <b>Borehole Record: BH13</b> </div> | | | | | | | | | | |
|---|---|---|---|---|---|---|---|---|---|---|
| | | | | CI | Sandy Clay (CI): firm, medium plasticity, medium grained sand, pale brown. | | F | 6 | | |
| | | | | | <b>BH13 Terminated at 2.5m (target depth)</b> | | | | | |

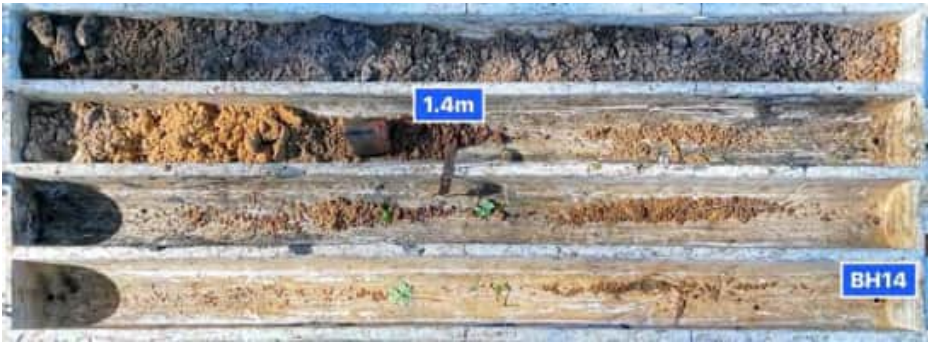
Depth: 0 m - BH14

| <div> <b>Borehole Record: BH14</b> </div> | | | | | | | | | | | |
|---|---|---|---|---|---|---|---|---|---|---|--|
| | | Natural | | CI | Sandy Clay (CI): firm, medium plasticity, medium grained sand, brown, with medium gravel. | | F | | | | |
| GWL | | | | | <b>BH14 Refusal at 1.4m (Stiff Clay)</b> | | | | | | |

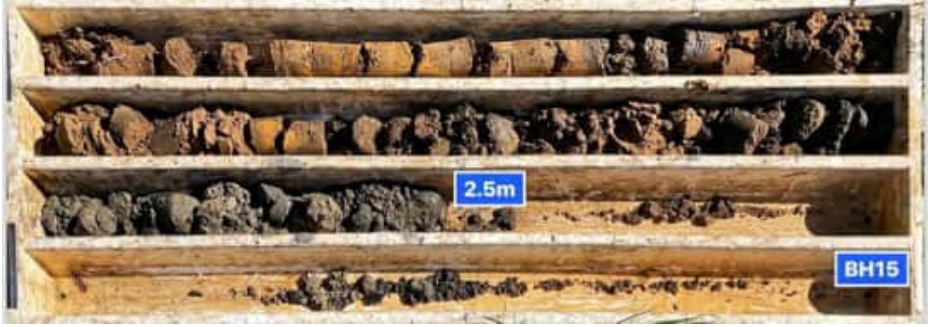
Depth: 0 m - BH15

| <div> <b>Borehole Record: BH15</b> </div> | | | | | | | | | | |
|---|---|---|---|---|---|---|---|---|---|---|
| | | Natural | | CI | Sandy Clay (CI): firm, medium plasticity, medium grained sand, brown and grey. | | F | | | |
| | | | | | BH15 Terminated at 2.5m (target depth) | | | | | |

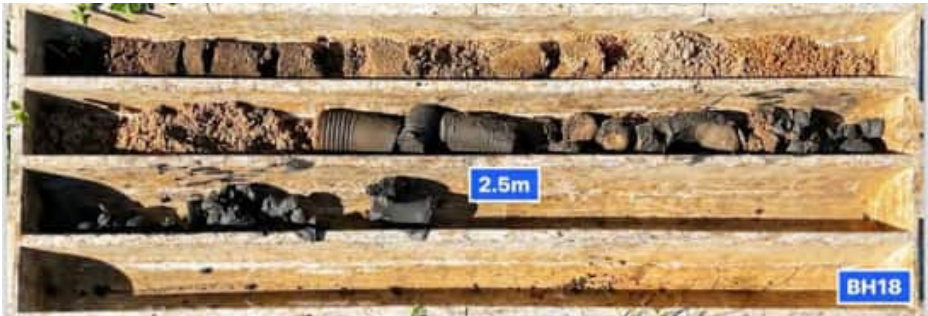
Depth: 0 m - BH18

| <div> <b>Borehole Record: BH18</b> </div> | | | | | | | | | | |
|---|---|---|---|---|---|---|---|---|---|---|
| | | Natural | | CH | Sandy Clay (CH): very soft, high plasticity, medium to fine grained sand, grey, trace organic material. | VS | | | | |
| | | | | | BH18 Terminated at 2.5m (target depth) | | | | | |

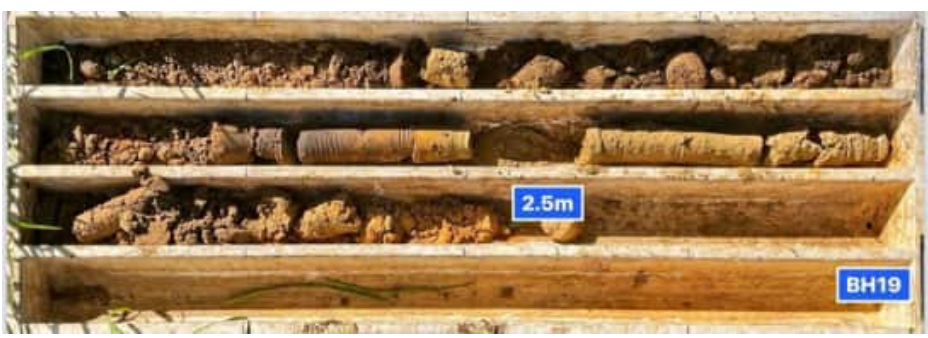
| <div style="display: flex; justify-content: space-between; align-items: center;"> <div> </div> <div> <h2 style="margin: 0;">Borehole Record: BH19</h2> </div> </div> | | | | | | | | | | |
|---|---|---|---|---|---|---|---|---|---|---|
| <b>BH19 Terminated at 2.5m (target depth)</b> | | | | | | | | | | |

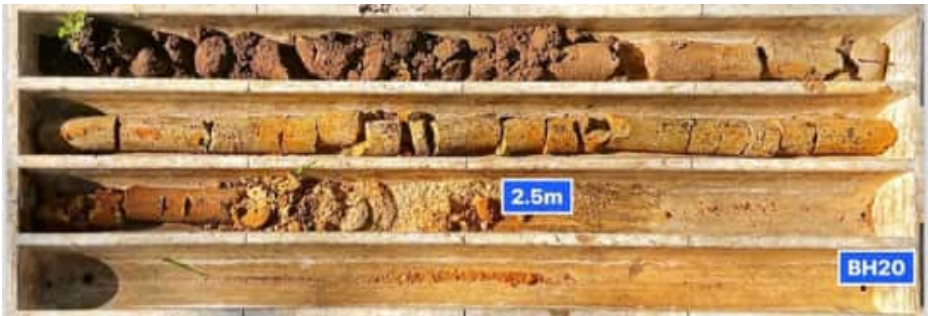
| <div style="display: flex; justify-content: space-between; align-items: center;"> <div> </div> <div> <h2 style="margin: 0;">Borehole Record: BH20</h2> </div> </div> | | | | | | | | | | |
|---|---|---|---|---|---|---|---|---|---|---|
| <b>BH20 Terminated at 2.5m (target depth)</b> | | | | | | | | | | |

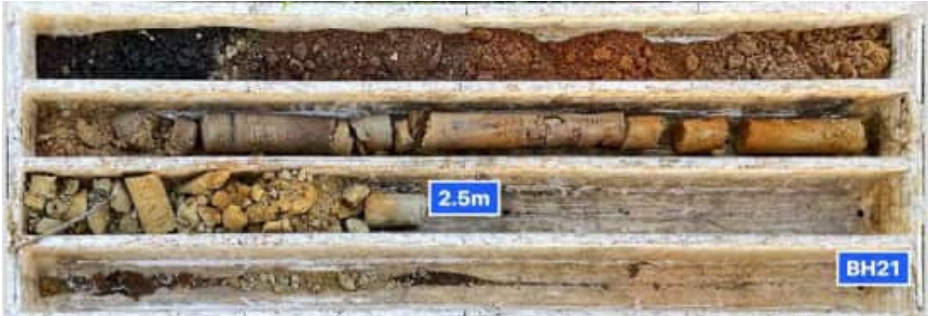
Depth: 0 m - BH21

| <div> <b>Borehole Record: BH21</b> </div> | | | | | | | | | | |
|---|---|---|---|---|---|---|---|---|---|---|
| | | Natural | | CI | Sandy Clay (CI): medium plasticity, medium grained sand, pale brown mottled pale grey. | | | | | |
| | | | | | <b>BH21 Terminated at 2.5m (target depth)</b> | | | | | |

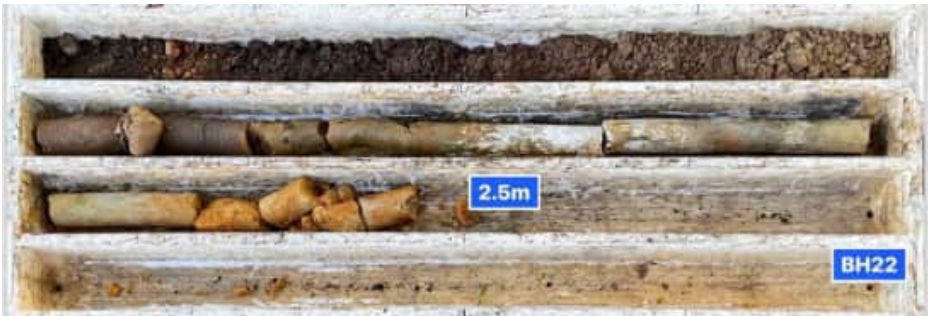
Depth: 0 m - BH22

| <div> <b>Borehole Record: BH22</b> </div> | | | | | | | | | | |
|---|---|---|---|---|---|---|---|---|---|---|
| | | Natural | | CI | Sandy Clay (CI): medium plasticity, medium grained sand, pale brown mottled pale grey. | | | | | |
| | | | | | <b>BH22 Terminated at 2.5m (target depth)</b> | | | | | |

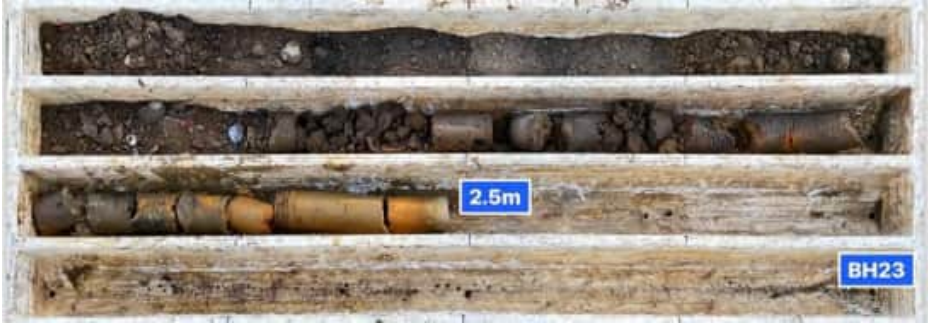
Depth: 0 m - BH23

| <div> <b>Borehole Record: BH23</b> </div> | | | | | | | | | | |
|---|---|---|---|---|---|---|---|---|---|---|
| | 2 | Natural | | Cl | Sandy Clay (Cl): stiff to firm, medium plasticity, medium grained sand, brown and pale orange. | | F-St | | | |
| | | | | | <b>BH23 Terminated at 2.5m (target depth)</b> | | | | | |

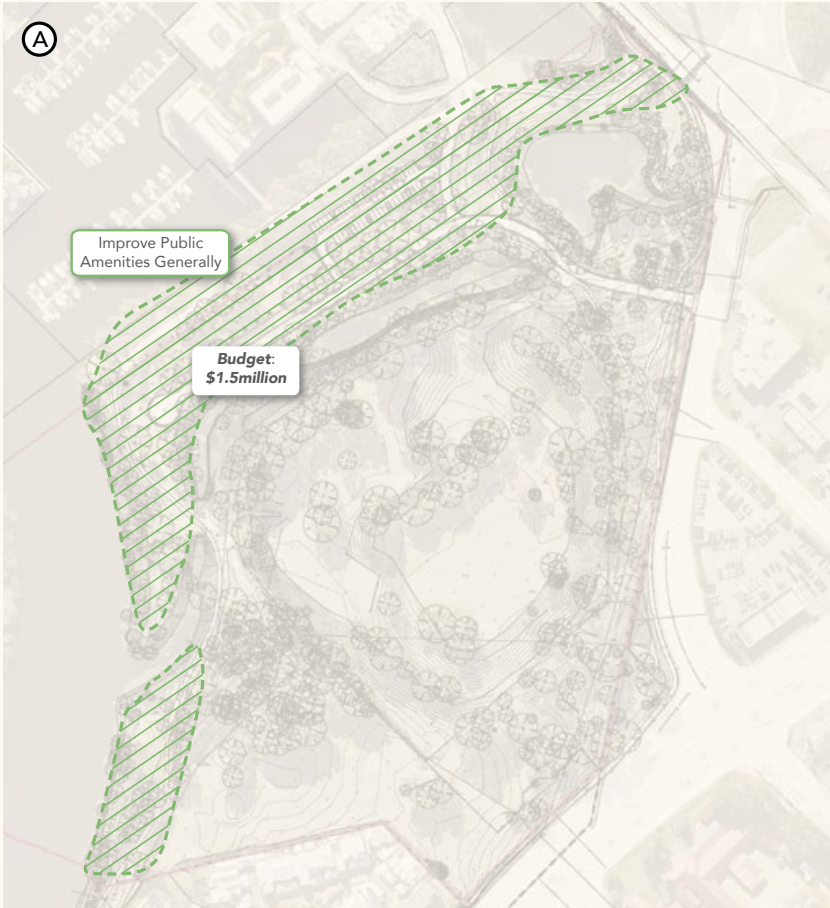
- Legend
- Low budget options based on a \$1.5mill budget:
    - 1a - Enhance passive recreational amenities (BBQ facilities, Shelters, Seating nodes, Interpretive Signage)
    - 1b – Enhance ecological / biodiversity values of riparian zones (Regrade select banks, Plant Batters/Riparian Zones, Add Riffle Zones, Habitat Fencing, Access points)
    - 1c – Establish small commercial activity (if economically feasible) (Small Cafe building & Toilet with external seating area)
    - 1d – Establish site as a flexible outdoor venue for events (Development of outdoor cultural / event space infrastructure - establish 3 phase power, simple lighting, in-ground services only)

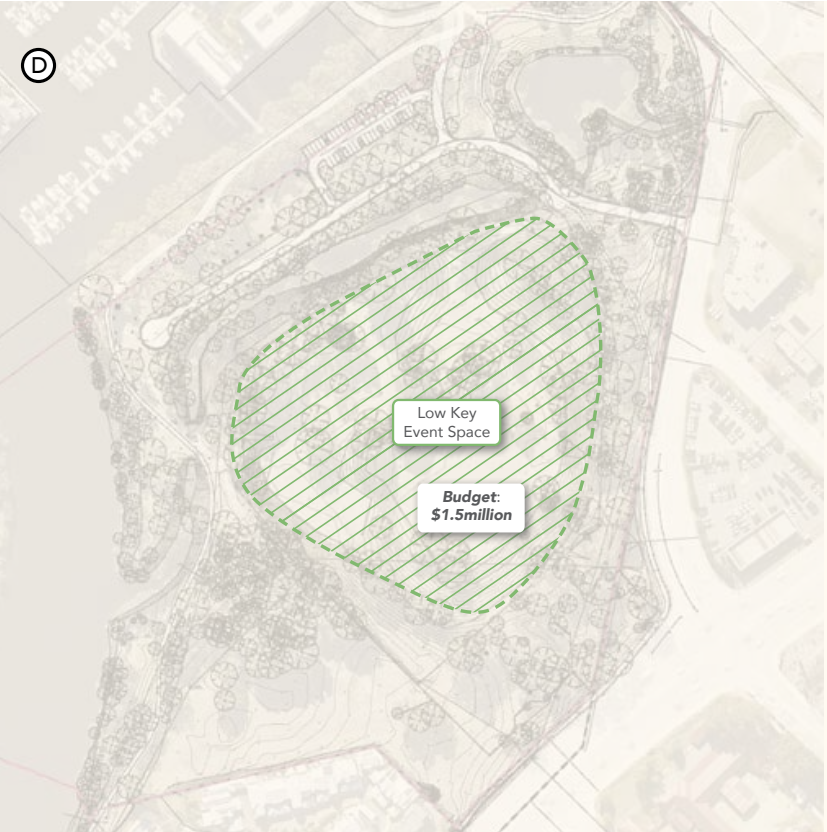
1b – Enhance ecological / biodiversity values

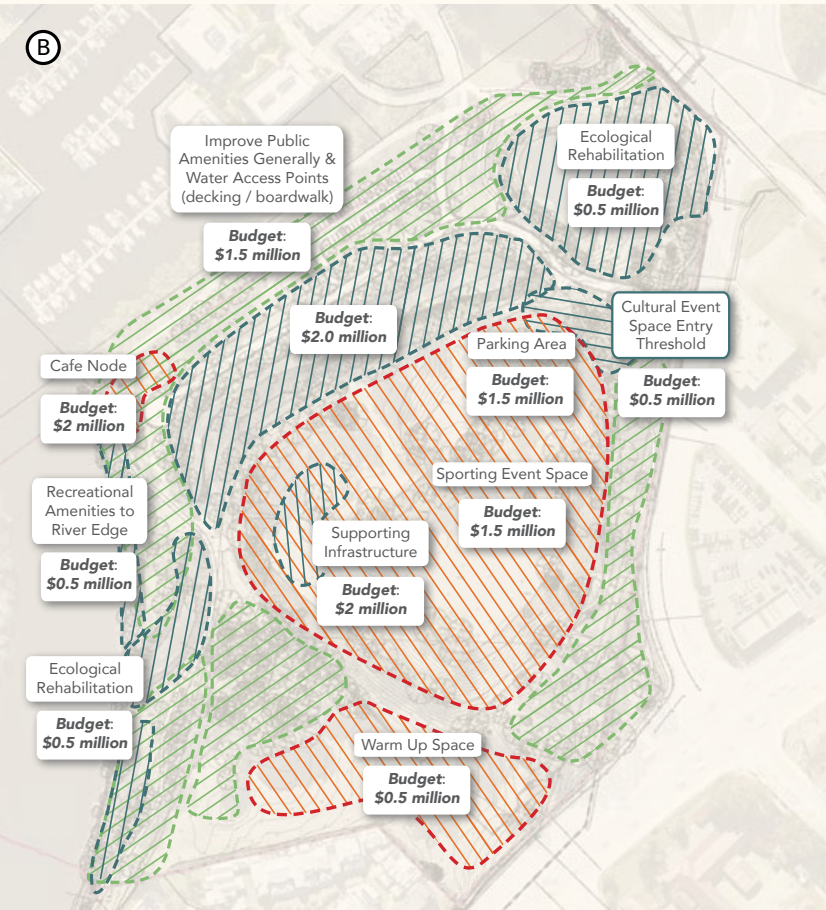
3a – All the above enhanced + Cultural / Event / Community Space.
