# Belmont Trust

# Minutes

# BELMONT TRUST LANDSCAPE MASTER PLAN

# Geotechnical Investigation

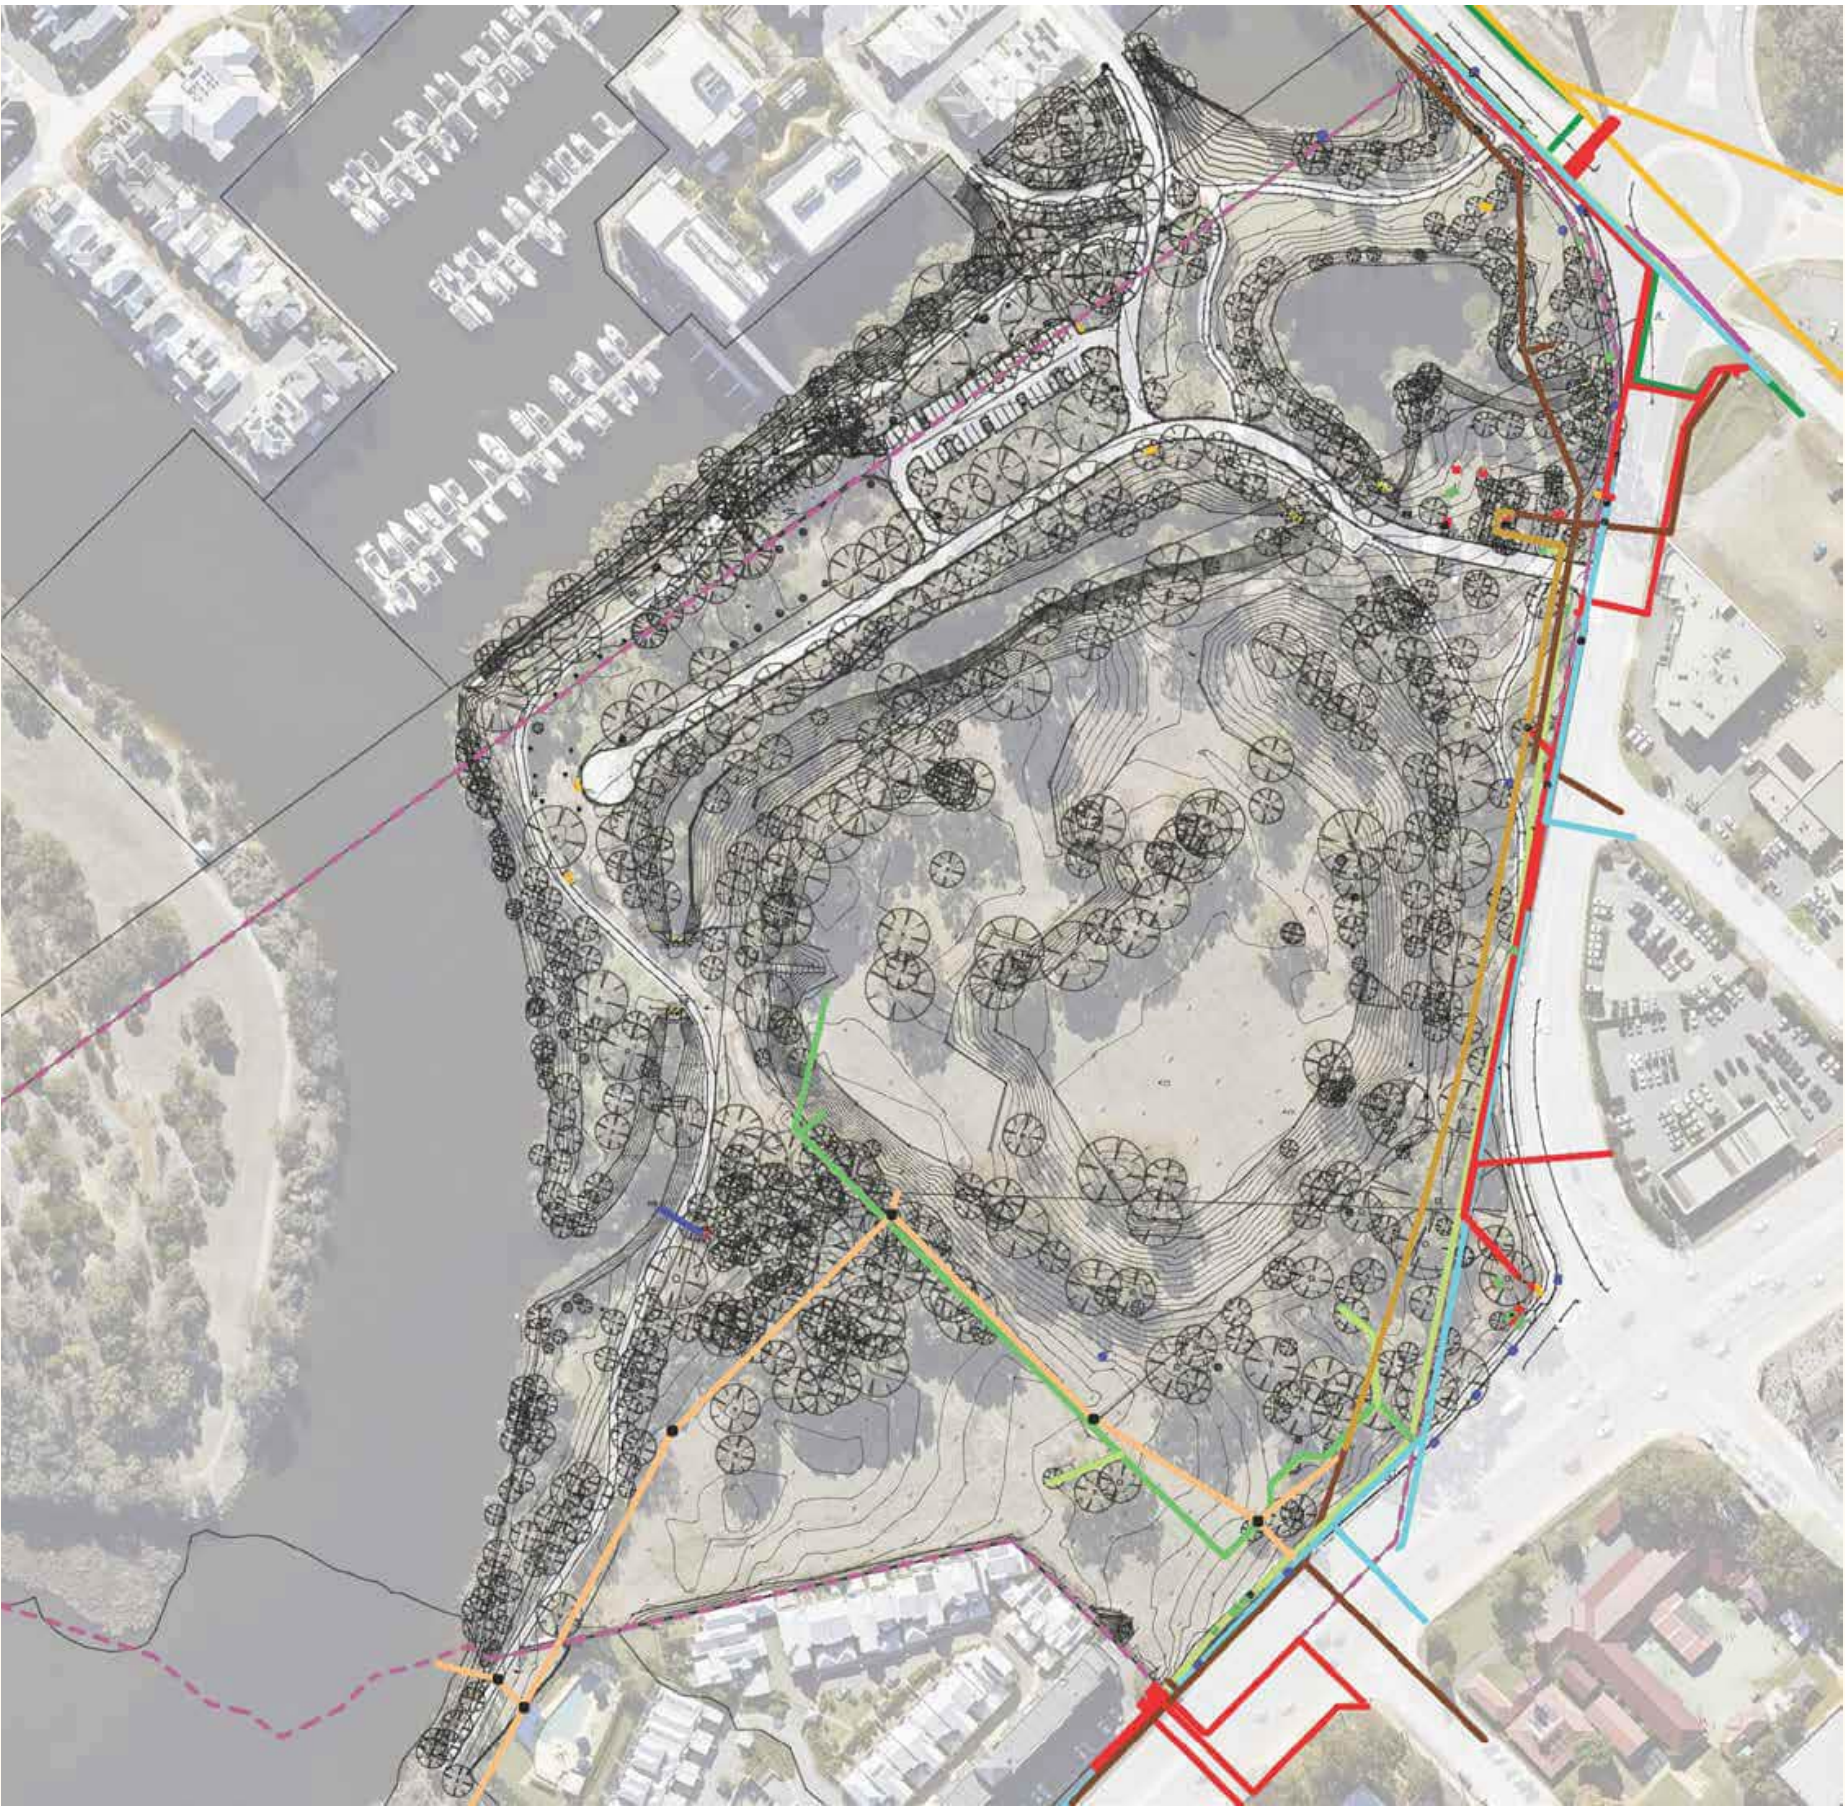
site feature survey & services

- Site Boundary
- SEWER
- SEWER UNUSED
- LOW VOLTAGE ELEC
- HIGH VOLTAGE ELEC
- GAS
- WATER
- NBN
- COMMS TELSTRA
- COMMS OPTUS

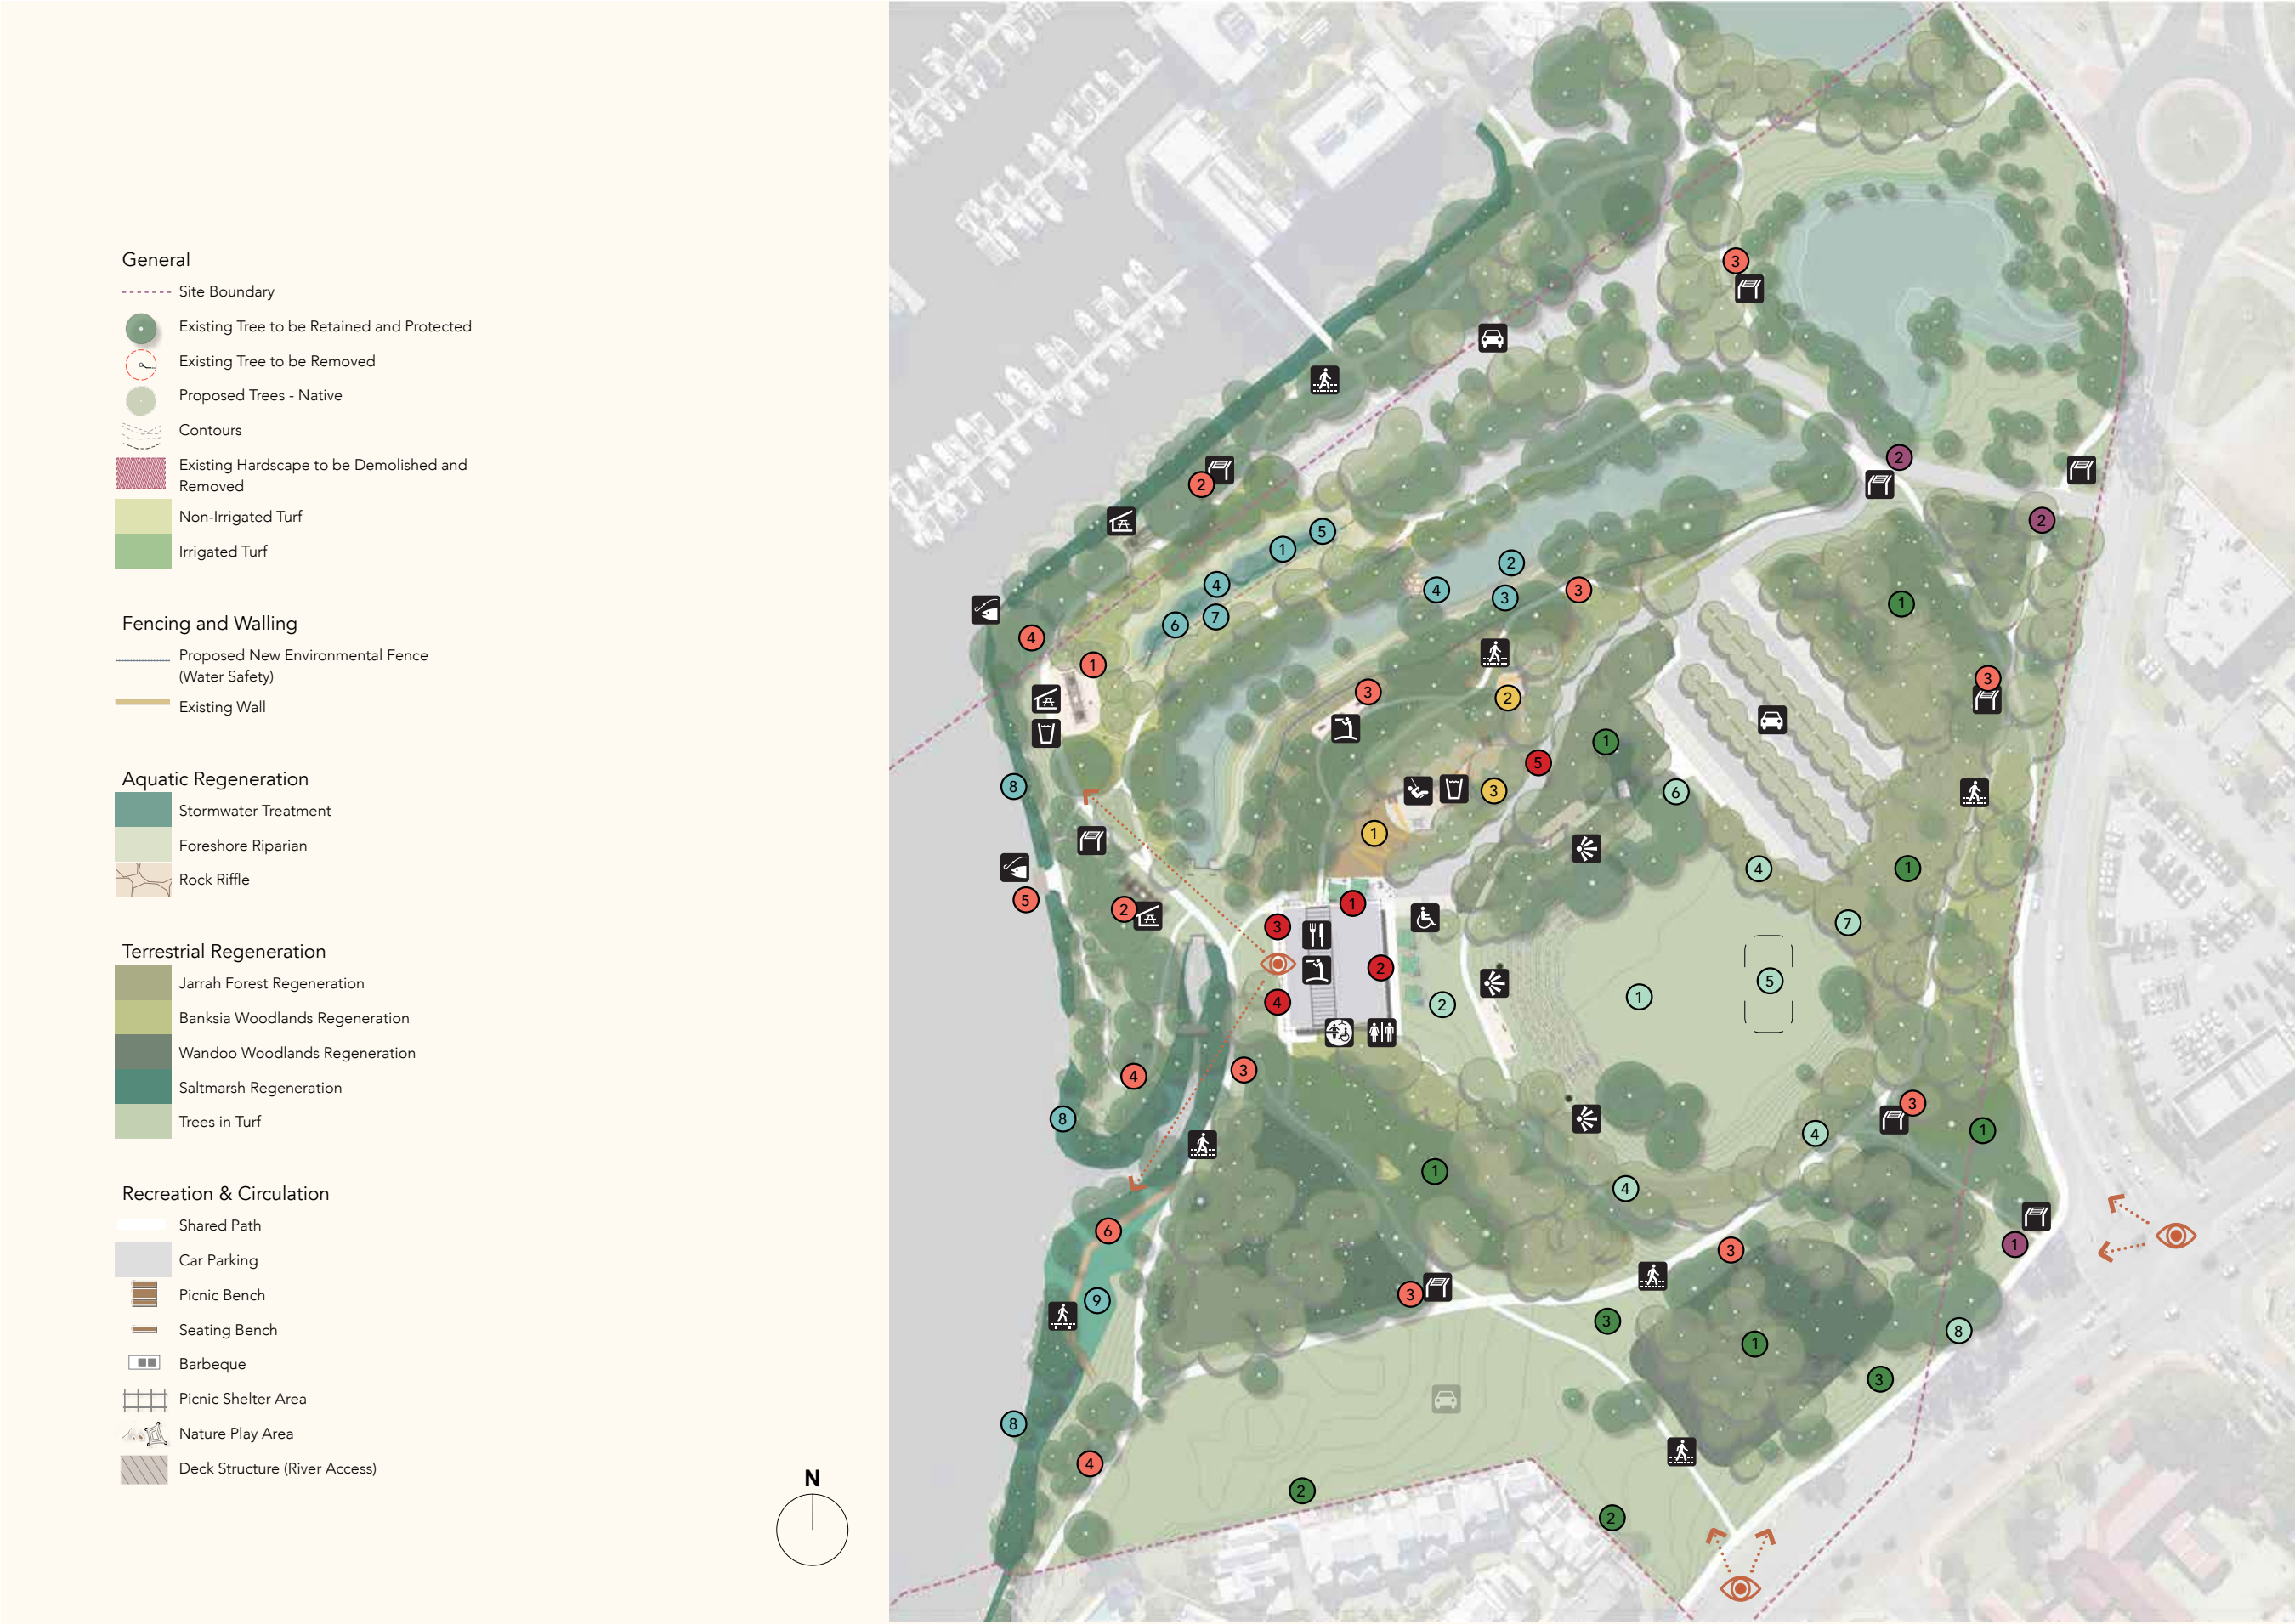
# the master plan

## illustrative landscape plan
